# Baker, MT Tornado of June 11, 2016

## Overview

Updated June 29, 2016

Officials from NOAA's National Weather Service in Billings completed an assessment of the tornado that occurred in the town of Baker, MT (and surrounding areas) the evening of June 11, 2016. The assessment included a survey of the damage, eyewitness reports, and an aerial survey.

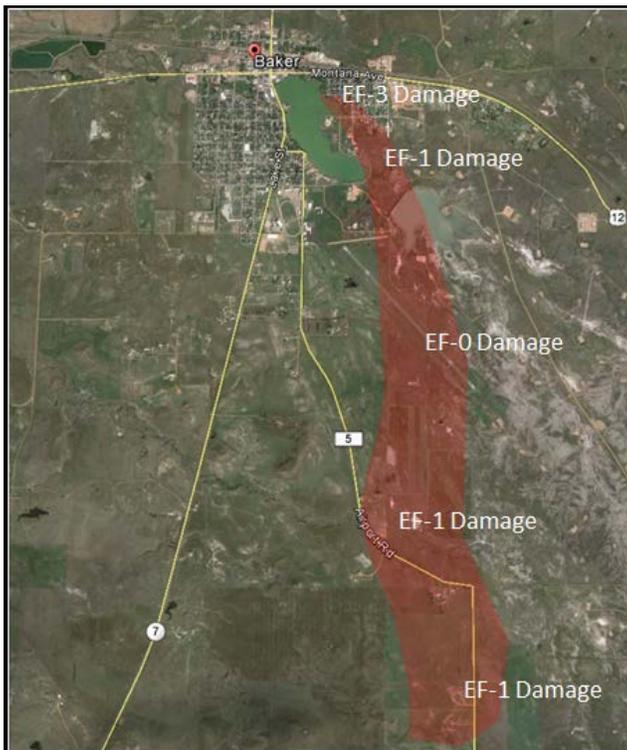
Figure 1: General Tornado Damage Path

The first indication of damage occurred approximately 3 miles south of Baker, with periodic damage along a northward path through Baker Municipal Airport to just northeast of Baker Lake (Figure 1). There was not a continuous path of damage and eyewitness reports indicate that the circulation on the ground likely lifted and reformed at times with multiple circulations occurring at the same time. Reports indicate that the tornado remained stationary in that region just northeast of Baker Lake for a short period before shifting west over the lake and dissipating shortly after 7 pm.

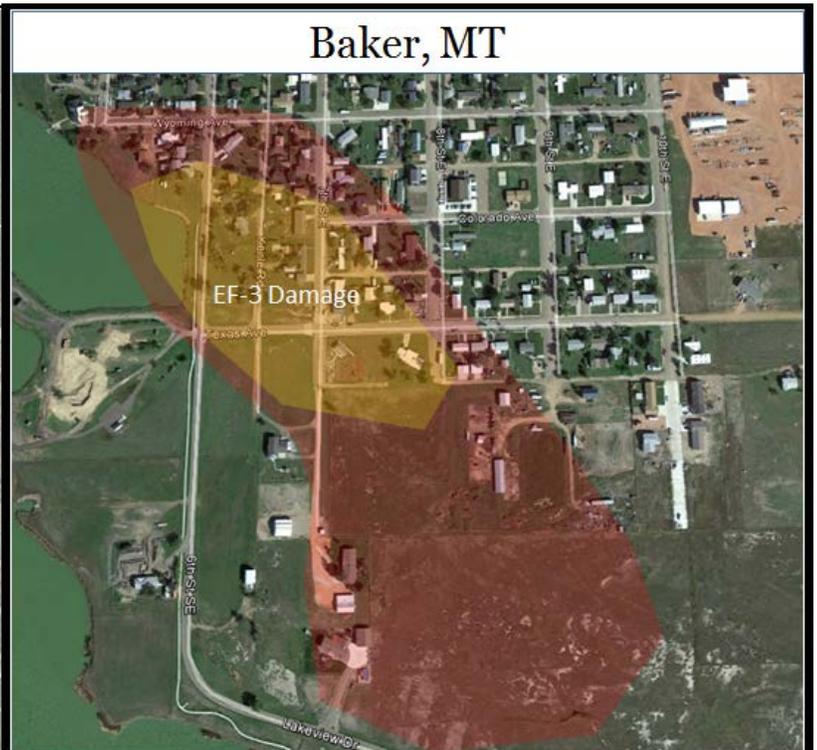
Figure 2: Baker, MT Damage Path

Based on the observed damage, a majority of the damage was EF-0 to EF-1 (winds upwards of 110 mph) on the Enhanced Fujita Scale. However, the strongest portion of the tornado is being classified as an EF-3. Wind speeds within an EF-3 tornado range from 136-165 mph. The most severe damage occurred in about a square block area in the town of Baker, in a subdivision just northeast of Baker Lake (Figure 2). Given that the tornado was reported as remaining stationary over that particular area for a short period of time likely led to the more significant damage.

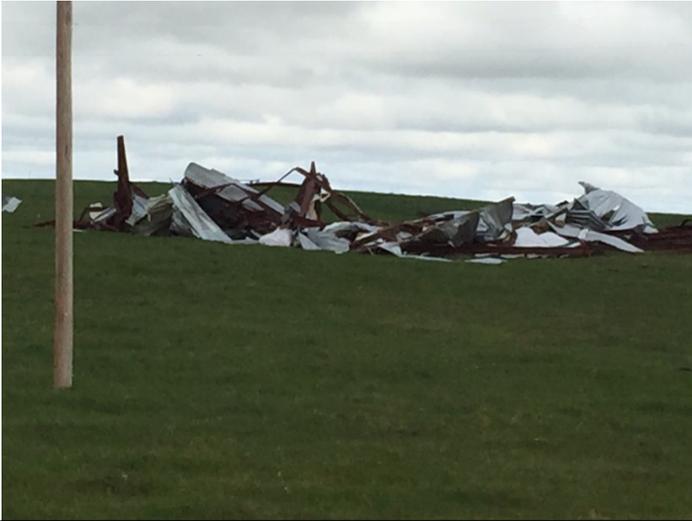
In an area approximately 3 miles south of Baker, where the first reports of damage occurred, a steel framed barn was destroyed, three RV's were destroyed, several homes sustained minor damage and several horses were killed.

Figure 3: Survey Photo – Steel Framed Barn Destroyed

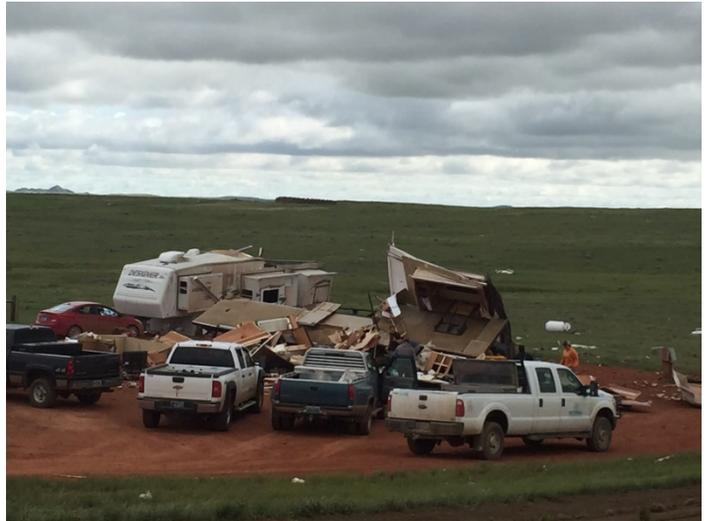
Figure 4: Survey Photo – RV's damaged

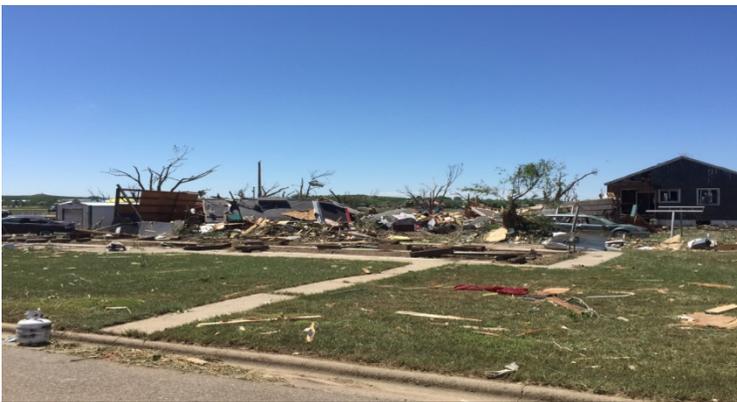
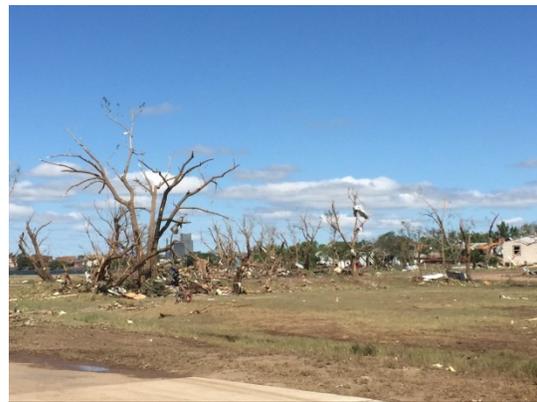
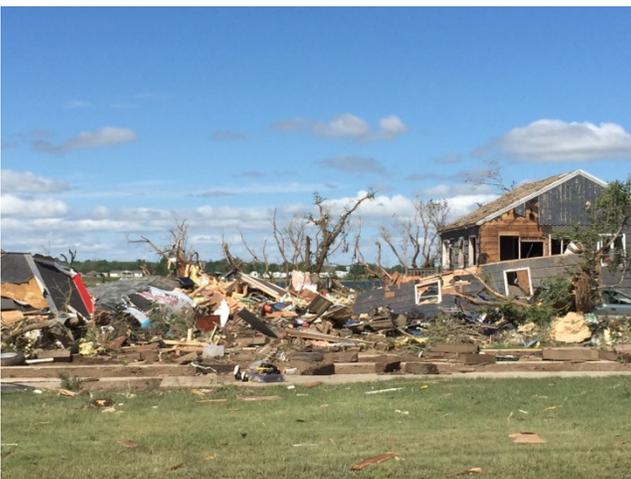
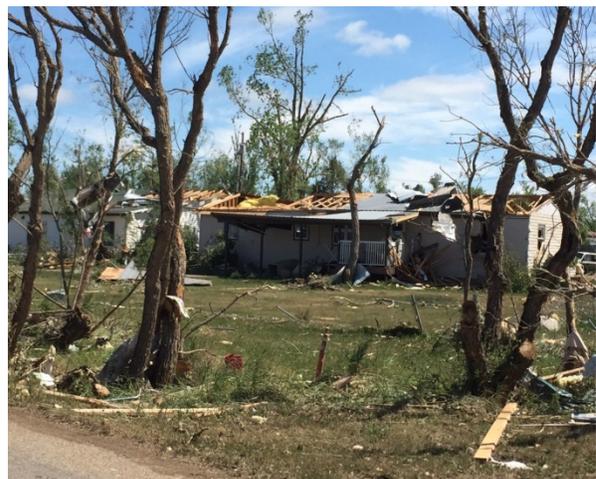
In the most severe portion of the storm in the town of Baker, 10 homes were destroyed along with 4 other structures (garages, shops, outbuildings). An additional 30 homes sustained minor to moderate damage. A half dozen injuries were reported; all non-life threatening. The following pictures (Figures 5-8) were taken in the area around Texas Ave to 6<sup>th</sup> and 7<sup>th</sup> Street East.

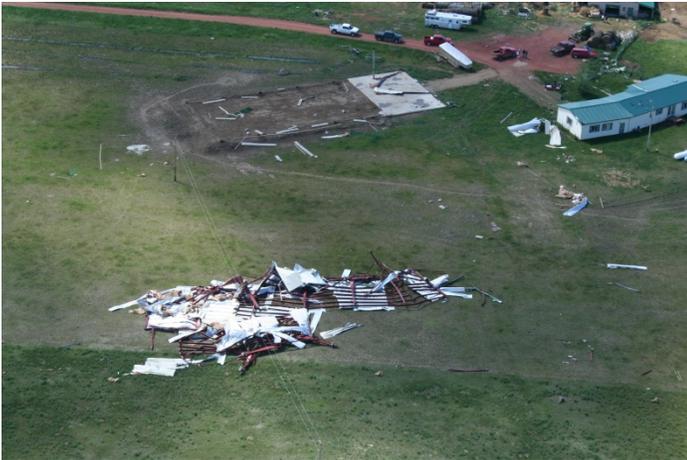
Figure 9: Aerial Photo of Steel Barn Destroyed. 3 Miles South of Baker, MT. Courtesy Roger Meggers

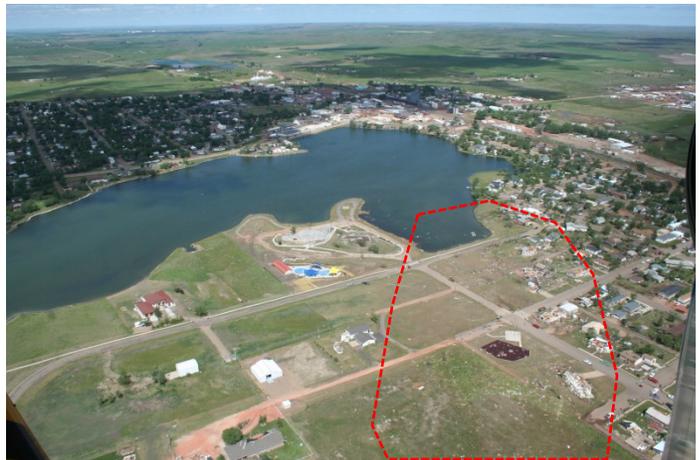
Figure 10: Aerial Photo of EF-3 Damage in Baker, MT Courtesy Roger Meggers
