# **Trip Report for Weather Forecast Office Tucson, Arizona – Colorado Basin River Forecast Center Hydrology Trip for the Week of December 4<sup>th</sup>, 2006**

**Mike Schaffner, Service Hydrologist, NOAA's National Weather Service, WFO Tucson**

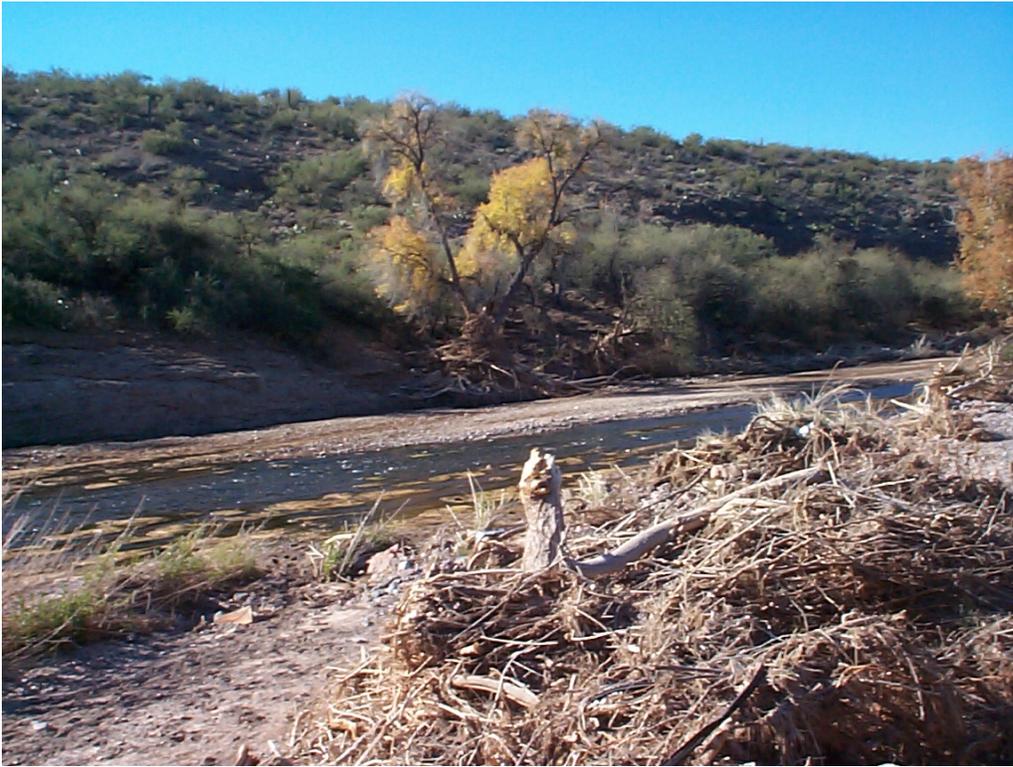
Our tour visited two sections of the Aravaipa Creek Road. One section was 1.5 miles upstream of the gage and another was just downstream (about 0.25 miles) of the gage. The upstream section is impacted at lower flows (as on July 29<sup>th</sup>) while the lower section is impacted at higher flows (as on August 1<sup>st</sup>). The lower road section is exacerbated by a fish dam located 0.25 miles downstream. It was proposed to set minor flood stage at the flow at which the upper canyon road would be impacted.

Image 1: Aravaipa Creek looking downstream towards to southwest. Photo taken about 0.25 miles downstream of USGS gage. This area is impacted by the fish dam located just a short distance further downstream. The photo was taken on top of the right bank at about the same elevation as the Aravaipa Creek Road that got flooded out at this location on August 1, 2006.

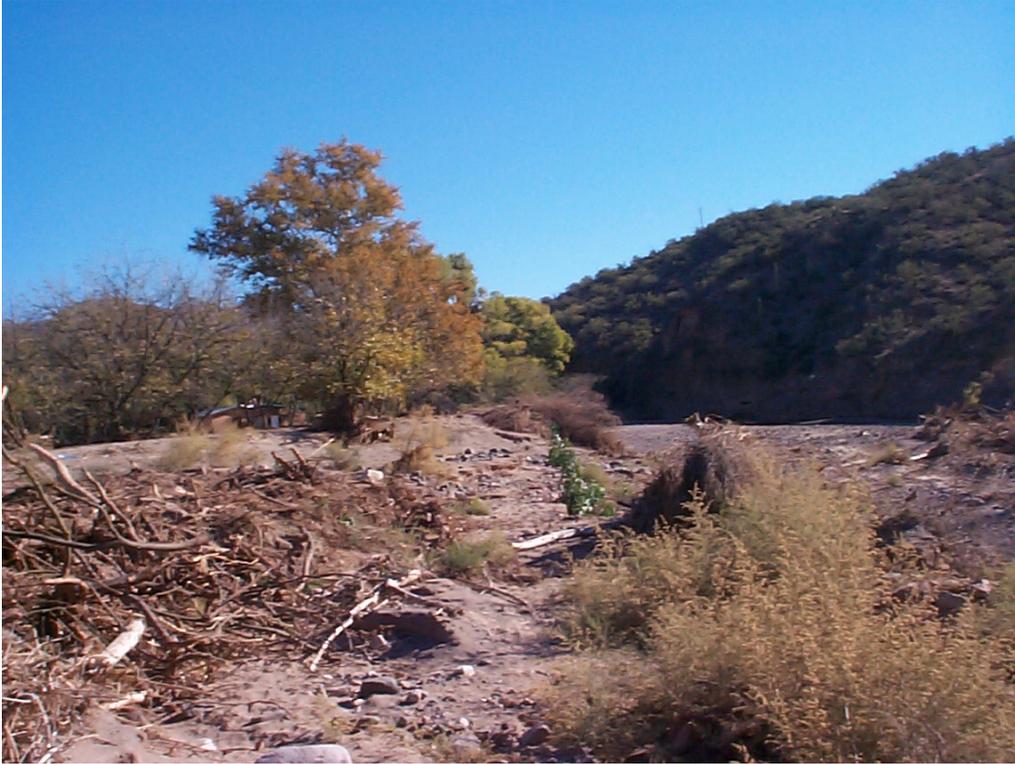
About a dozen structures were destroyed or sustained damage. Several buildings were viewed where foundations or frames only remain. Bank erosion destroyed acres of farmland about 1.0 mile upstream from the gage.

Image 2: Aravaipa Creek. Taken from same location as image 1 – just looking upstream. Notice Aravaipa Creek Road and home on left-side of image that were impacted on flood waters on August 1, 2006.

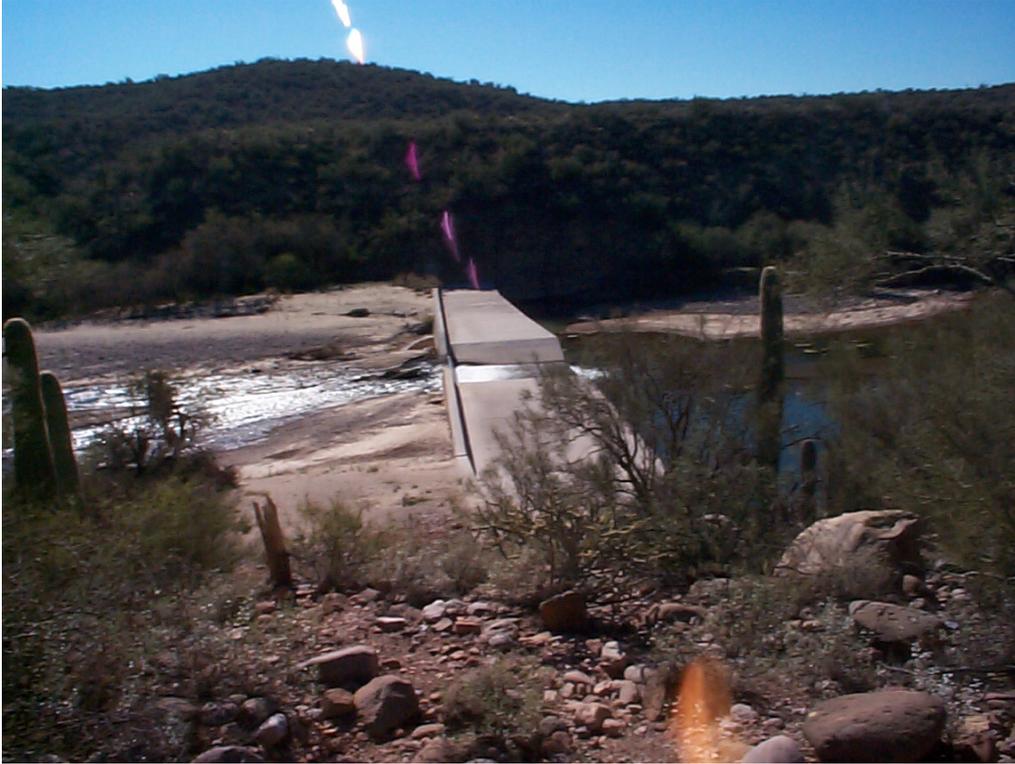
Image 3: Fish dam located about 0.50 miles downstream from USGS gage. One of two fish barriers / dams constructed to keep non-native fish out of upper Aravaipa Creek.

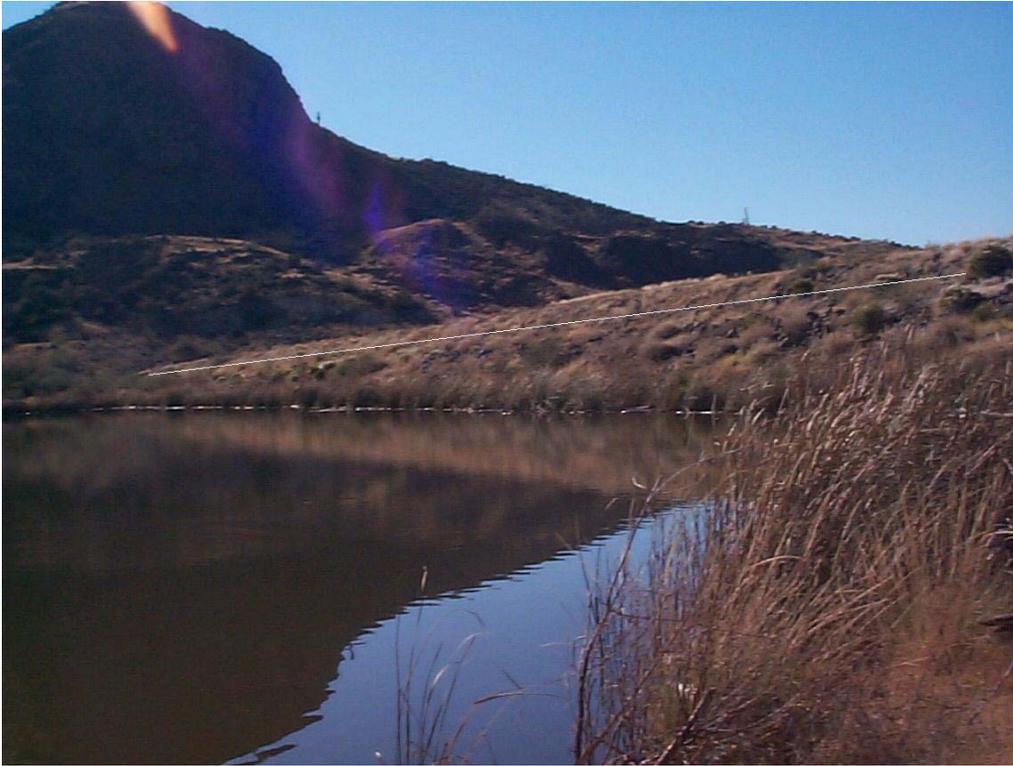
On August 1<sup>st</sup>, water was reported one-half to two-thirds of the way to spillway capacity. Crews were stationed at the dam to monitor the situation. Of particular concern was the build-up of large debris including logs just upstream of the spillway. There was concern that these would block the spillway. Luckily, the large debris passed the spillway with no problem.

Image 4: Elgo Dam. White line inserted in image above shows approximate level of high water mark on August 1, 2006. Elgo Dam is an earthen high hazard dam situated 3 miles upstream of the city of San Carlos along the San Carlos River.

Due to the high hazard nature of the dam and the fact that an event would give little lead time to the town of San Carlos, it was proposed to make the major flood stage equal to the flow corresponding to the maximum spillway capacity. The Elgo and Tufa Stone Dams EAP (2003) and the Tufa Stone and Elgo Dam Inundation Study (1995) assume 30,000 cfs as the maximum spillway capacity and also the approximate 100-year inflow at Elgo Dam).

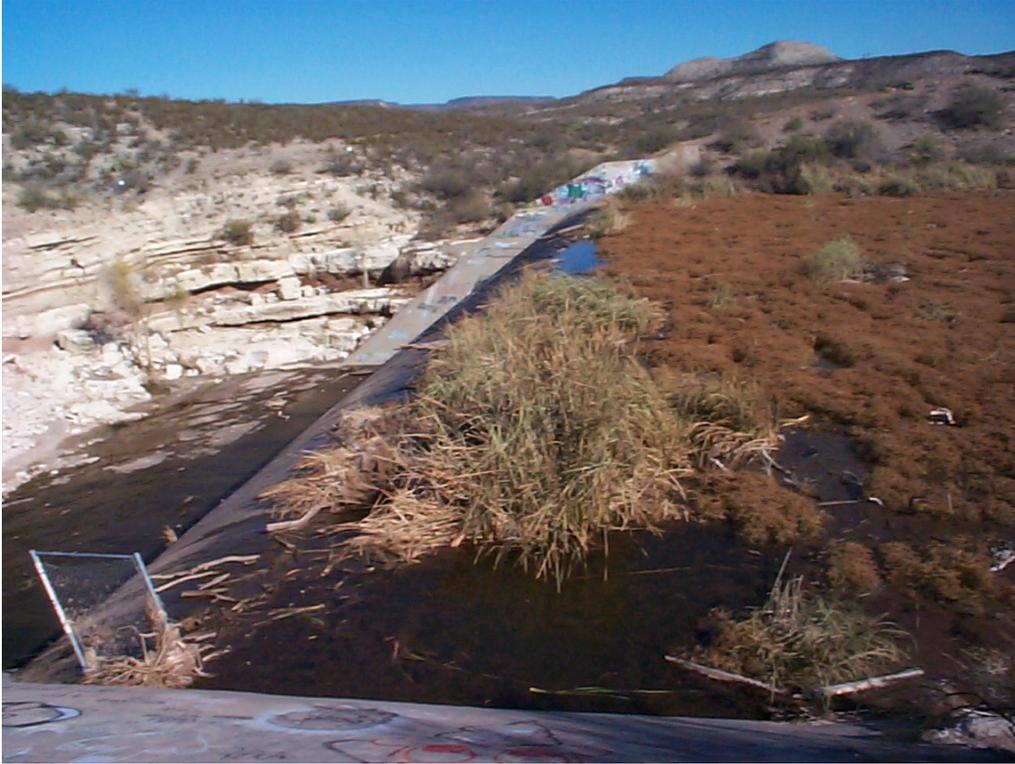
previous visits to the dam, the author noticed that there is a fair amount of debris and vegetation at the outlet of the dam. At low flows, this does not impede flow through the spillway.

Image 5: Elgo Dam spillway. Concrete spillway appeared to be in good condition. A mat of vegetation was however covering the outlet of the dam. Water at low flows was not impeded by vegetative mat.

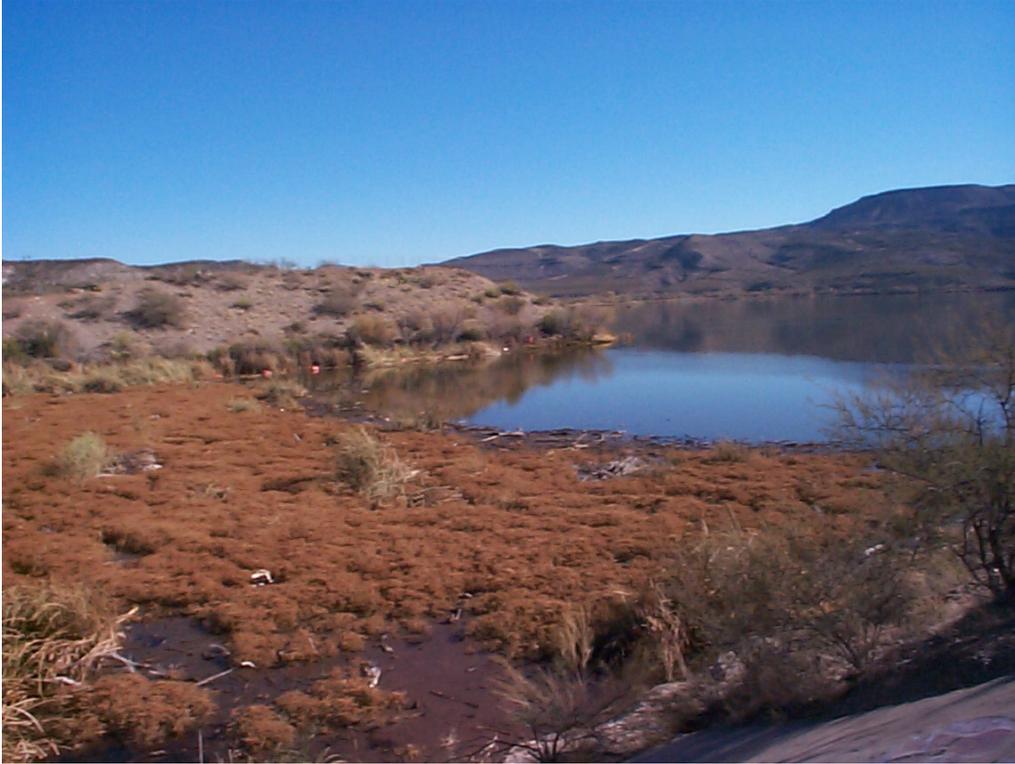
Image 6: Vegetative mat located near outlet for Elgo Dam Spillway. Image taken near spillway looking eastward / upstream.

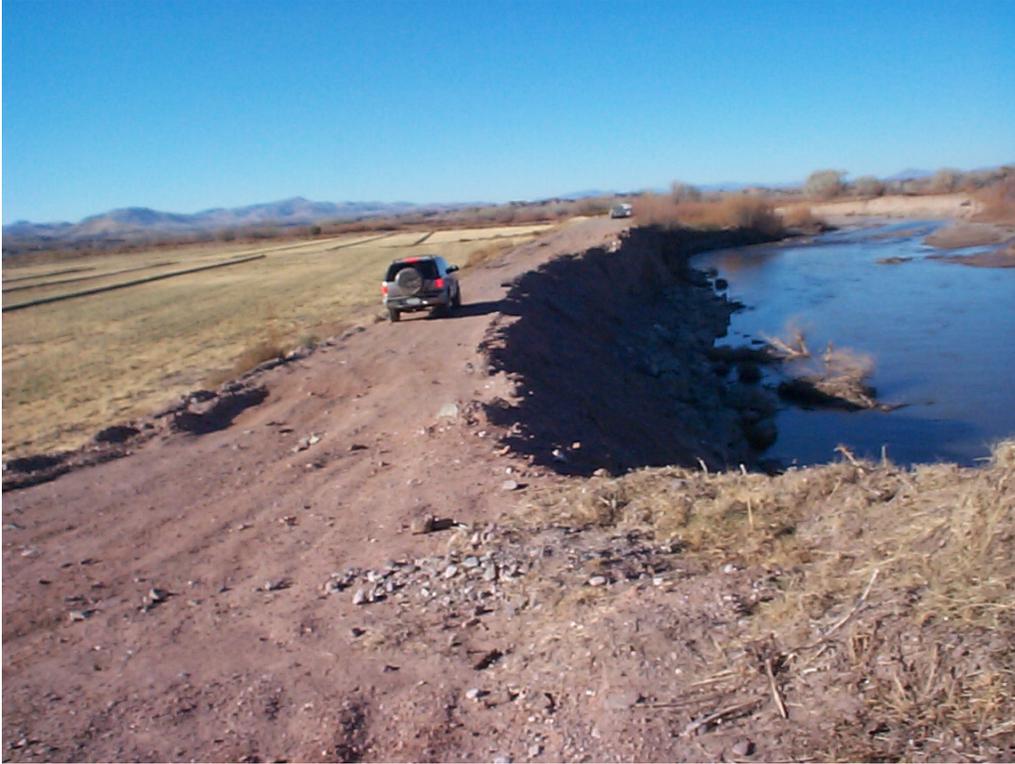
- Levee section is located on an outside bend of the Gila River where the highest velocities and erosion rates take place
- Levee dimensions (both height and width) are less than those of levee both down and upstream
- Gila River face of levee has already begun to sluff (i.e. soil slip)

Image 7: Levee structure on left bank of Gila River at Duncan downstream from USGS gage. Picture taken looking downstream. Farm fields begin immediately beyond levee. Section of levee repaired is narrower and lower in elevation than the remainder of the levee structure. NWS Blazer for scale.

Based upon our observations, it is our recommendation that flood stage not be raised till this section of the levee is riprapped.

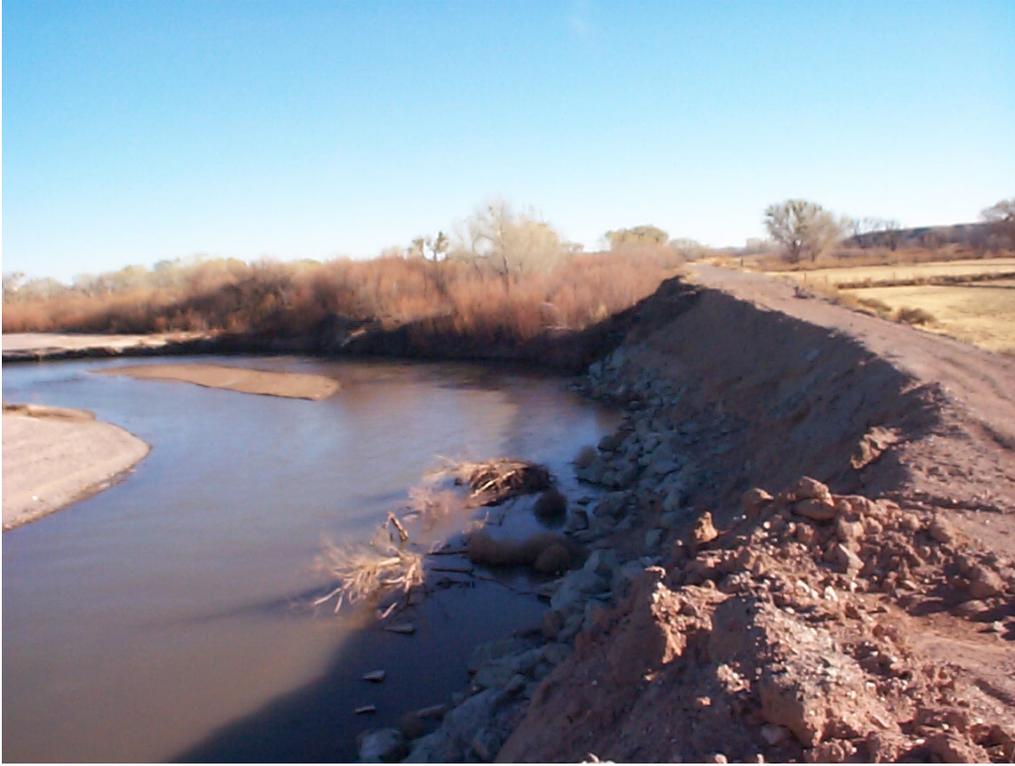
Image 8: Levee structure at Duncan (same section as seen in image 7). Picture taken looking upstream.

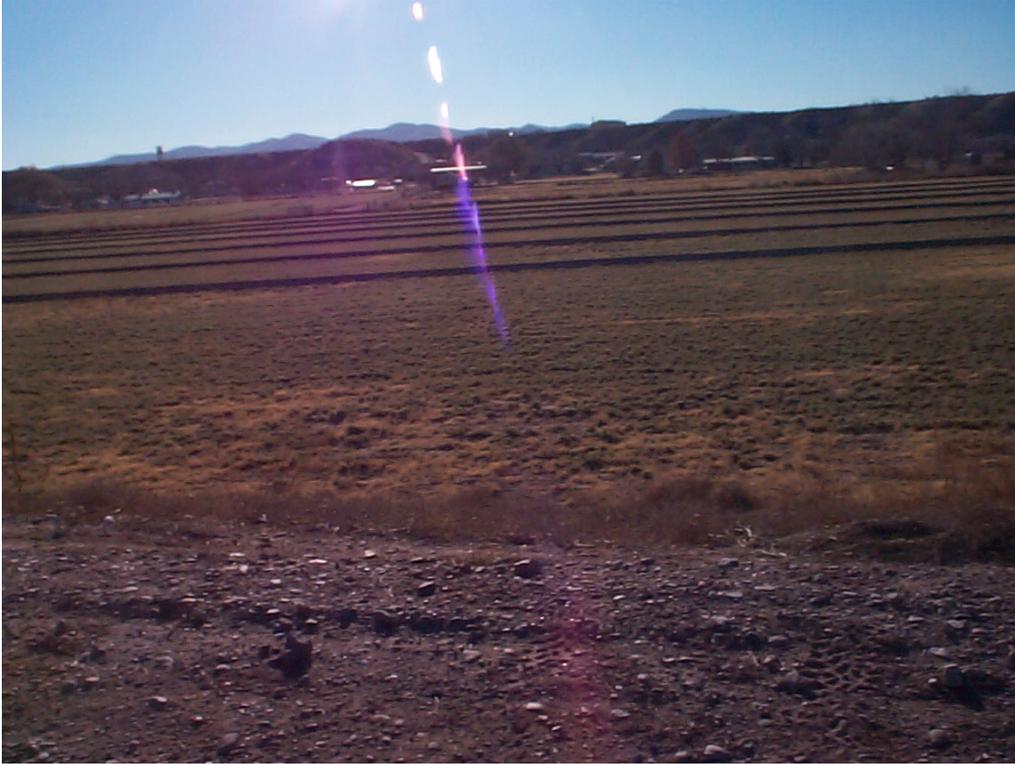
Image 9: Farm fields at Duncan taken from top of levee structure seen in prior images looking southward. Duncan high school can be seen as large building in center of image bisected by sunray. Fields, state highway, and fields below high school would all likely be impacted (as in February 2005 flood) if levee was to breach again at this location.

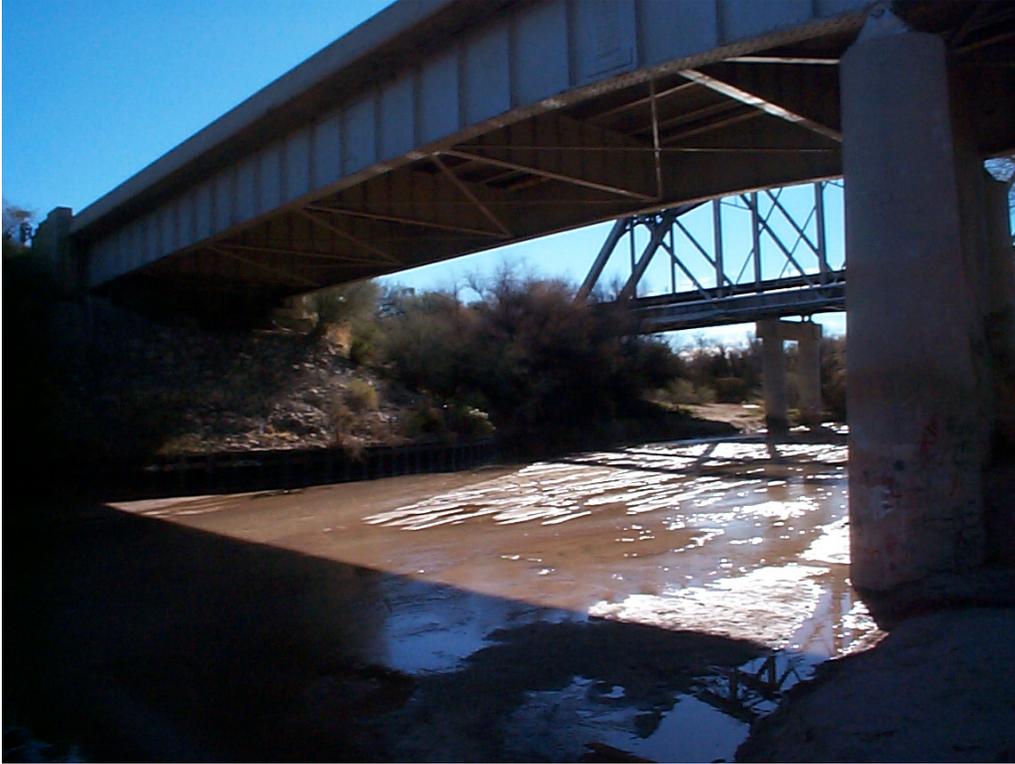
The city of Benson is located half way between the USGS gages near Tombstone (SPTA3) and near Benson (SPBA3). The channel cross-section was evaluated near the Railroad Bridge and RV Park. The Railroad Bridge capacity was estimated at 100,000 cfs. RV Park on left bank would likely require about 50,000 cfs to impact it from flooding (less from bank erosion).

Image 10: San Pedro River at Benson (no gage at site). Flow estimated at 3 to 5 cfs. Channel has significant capacity at both road and railroad bridges seen above. Image taken looking upstream from left bank.
