NOAA/NWS Glasgow Damage Survey

June 26, 2012 Highway 201 Storm Damage

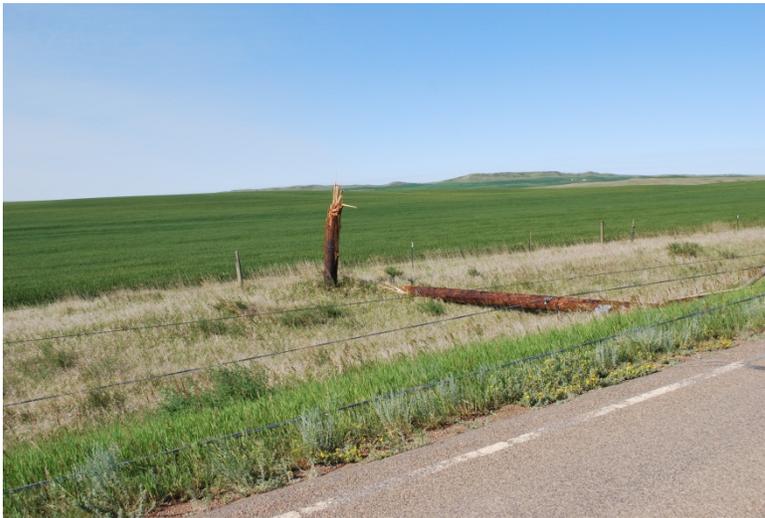
a. Snapped power pole on the south side of Highway 201.

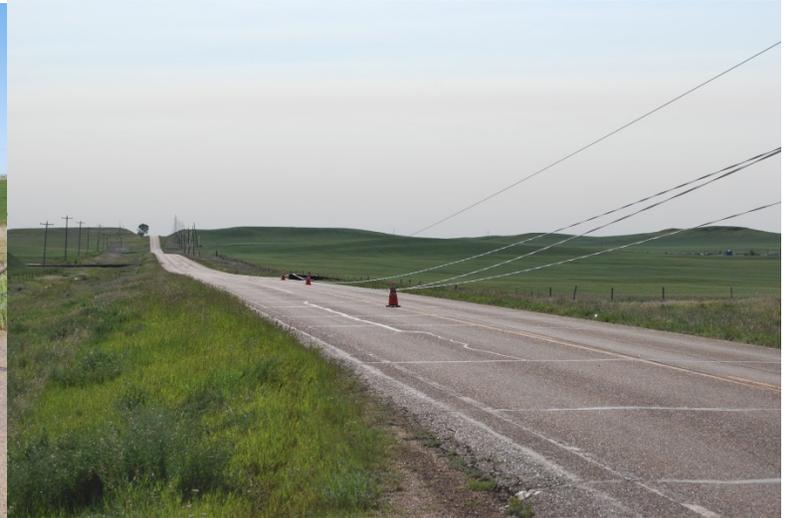
b. Poles down with power lines over the eastbound lane.

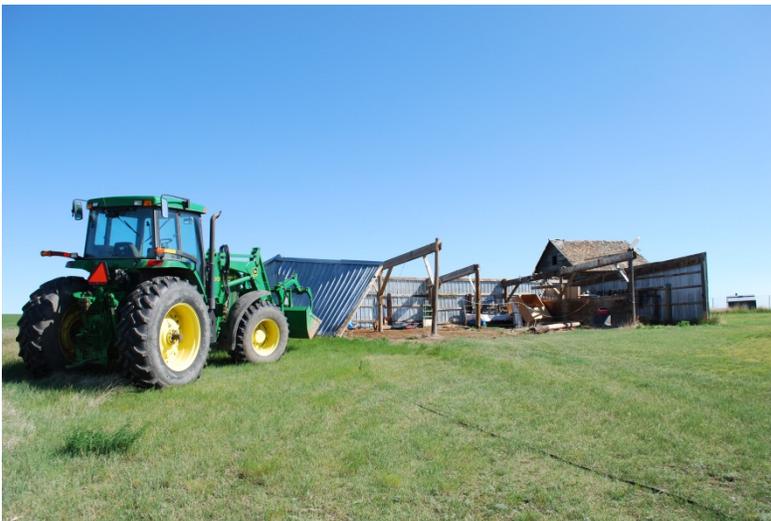
c. Tin shed damage on the north side of Highway 201.

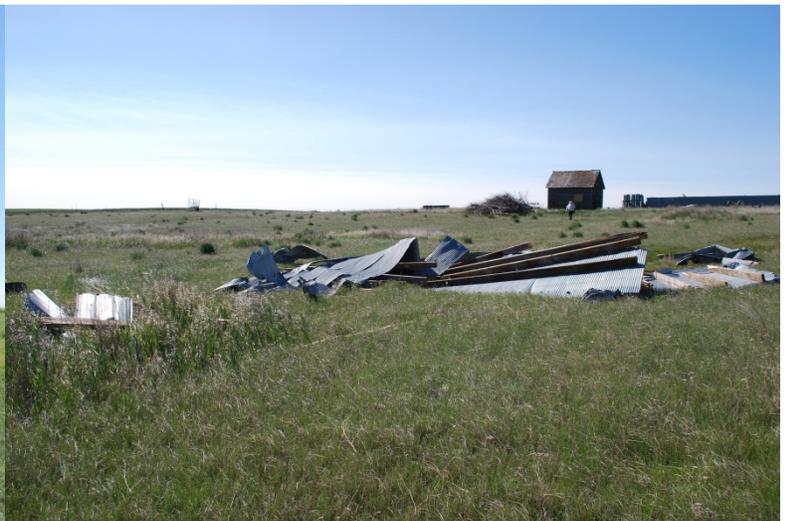
d. Roof of the tin shed blown 100-150 yards north of the shed.

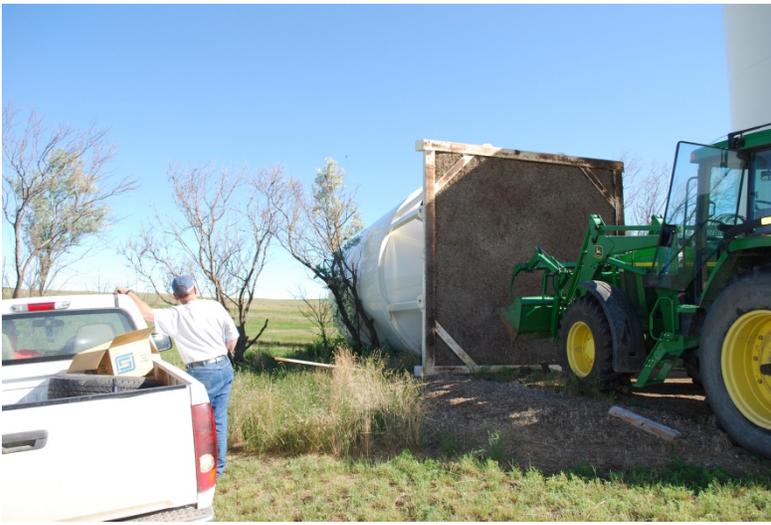
e. 4000 bushel grain bin blown over south of Highway 201.

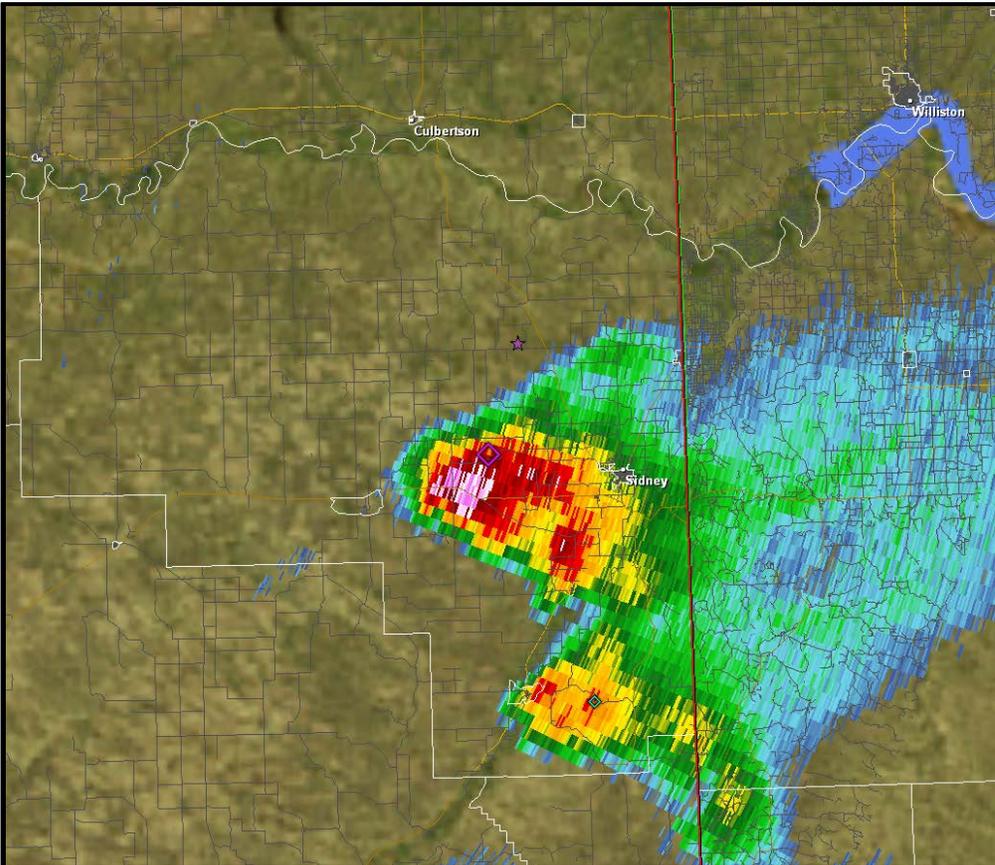
f. Glasgow radar image from 4:58 pm. The purple star on the image is the approximate location of the tin roof damage.

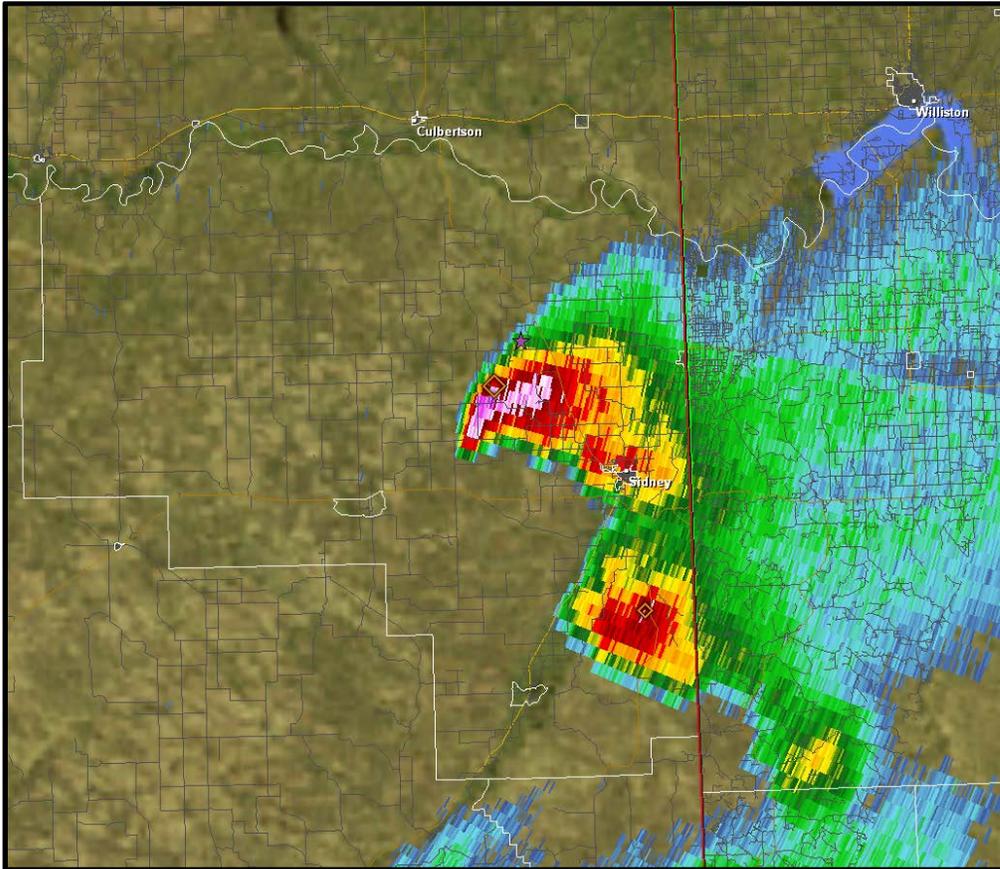
g. Glasgow radar image from 5:09 pm. The purple star on the image is the approximate location of the tin roof damage.

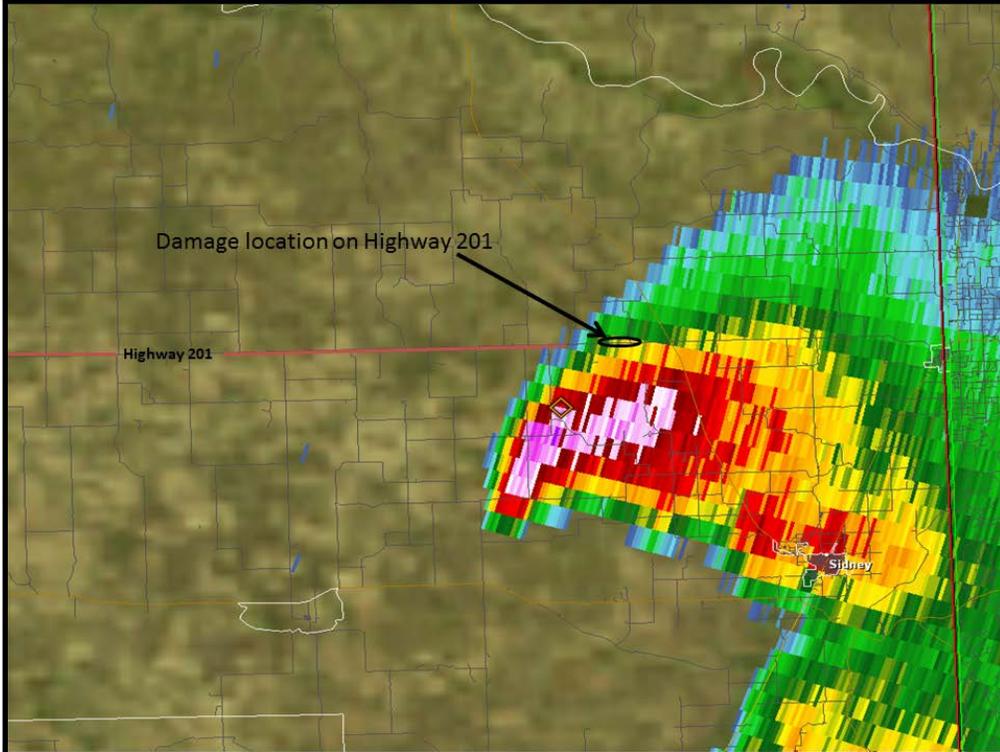
h. Glasgow radar image from 4:58 pm zoomed in closer with Highway 201 and the damage location indicated.

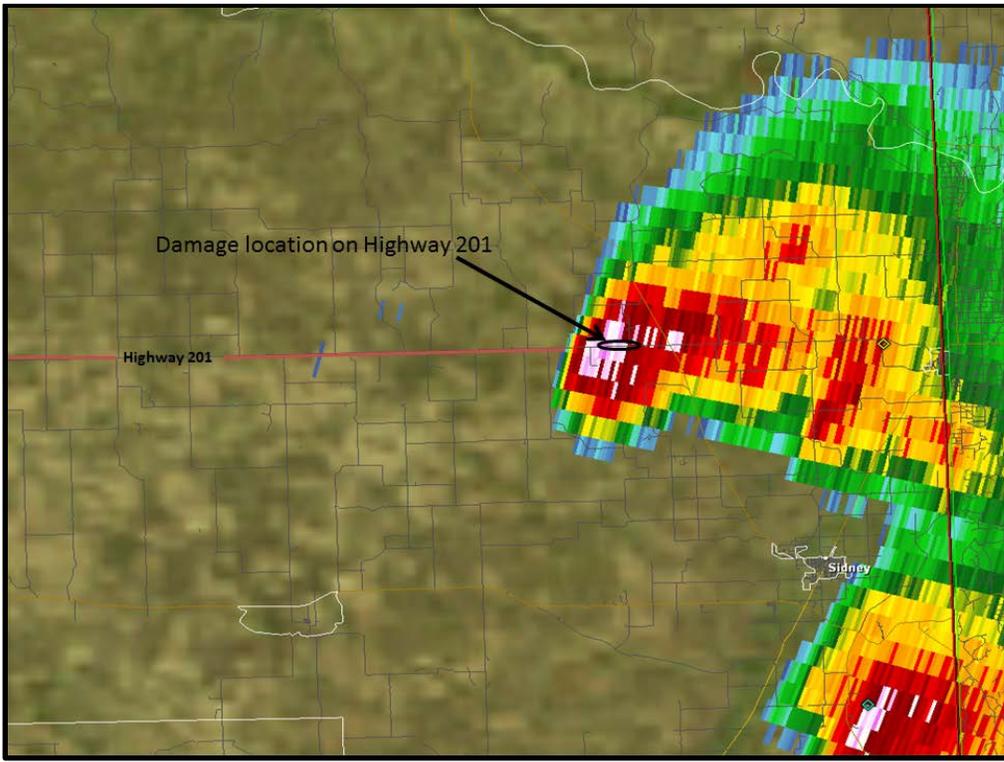
i. Glasgow radar image from 5:16 pm.
