**Roosevelt County/Fort Peck Reservation  
Tornado Event July 15, 2013  
National Weather Service Glasgow  
Storm Survey Summary – Final Update July 30, 2013**

Event Type: Tornado

Tornado Rating: EF-2

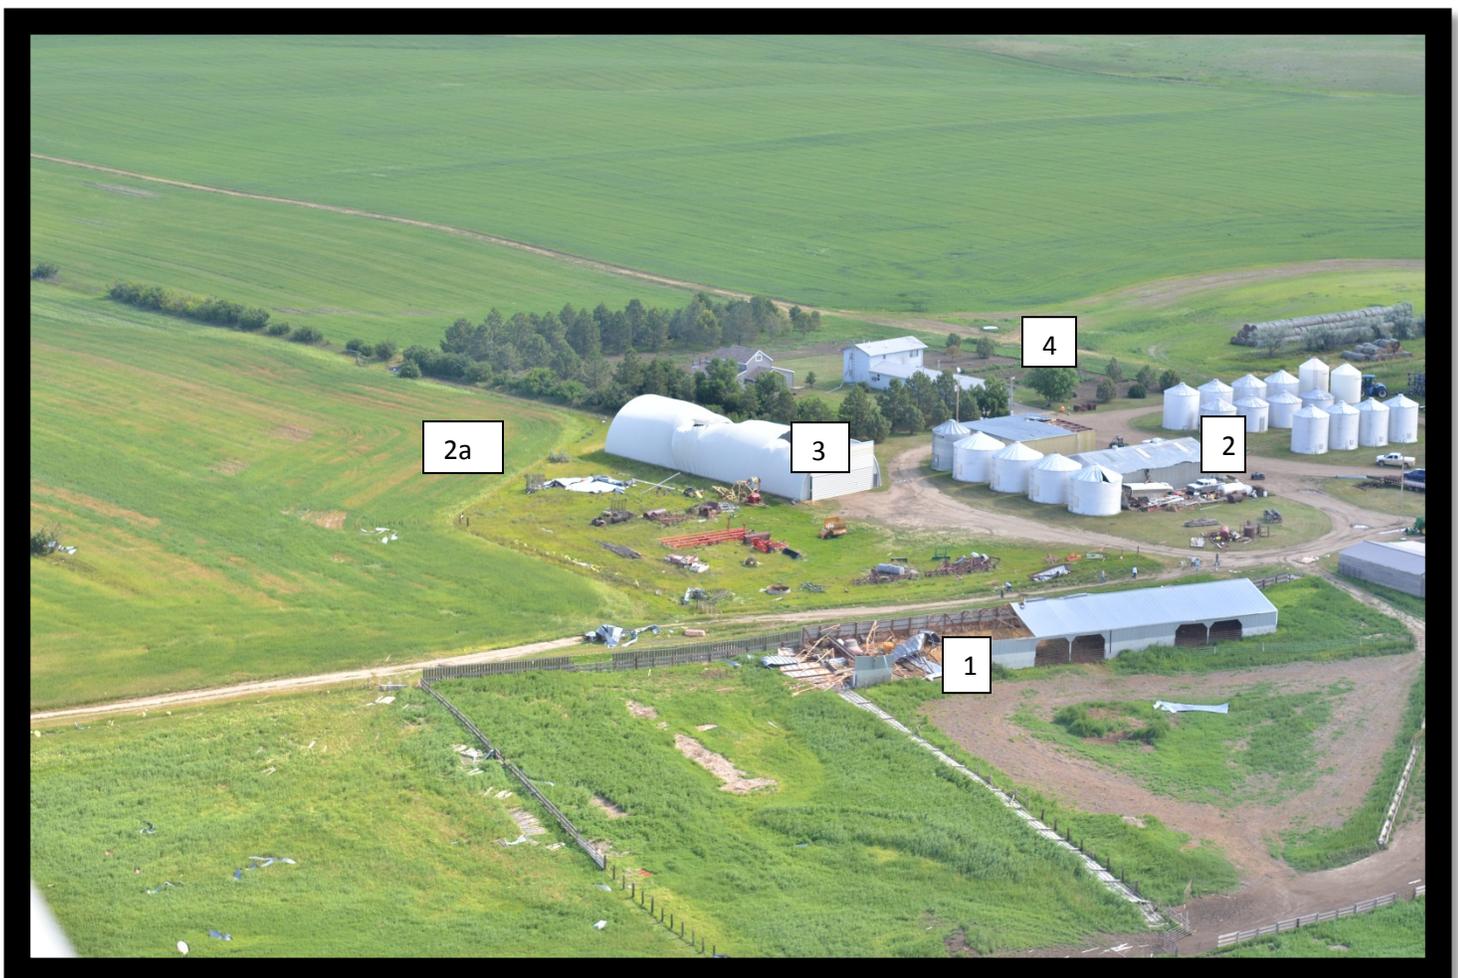
*Farm located 10 miles east of Montana Highway 13 off of the County Road 2042. This photo is looking from SW to NE.  
Photos courtesy of Bill Martin and Dallas Aero.*

The farm with the most damage was 10 miles east of Highway 13 and would have hit around 439 pm. At this location we observed a calving barn (1) that had the west side of the roof blown off, and the walls caved in. The structural supports were still in the ground, but the 4x4's holding up the walls had been sheared about 4 feet off of the ground. A storage building (2) next to a larger Quonset (3), totaling it out. The materials landed west of the large Quonset (2a). A third Quonset that also had metal roofing that was peeled off of the building. (4) The storage building had heavy, long concrete foundation pieces that were pulled out of the ground and tossed onto equipment. Winds at this location are estimated to have been 115 to 120 mph. There were some power poles southeast of this farm that were damaged as well, and the wind estimates for that are 120 mph.

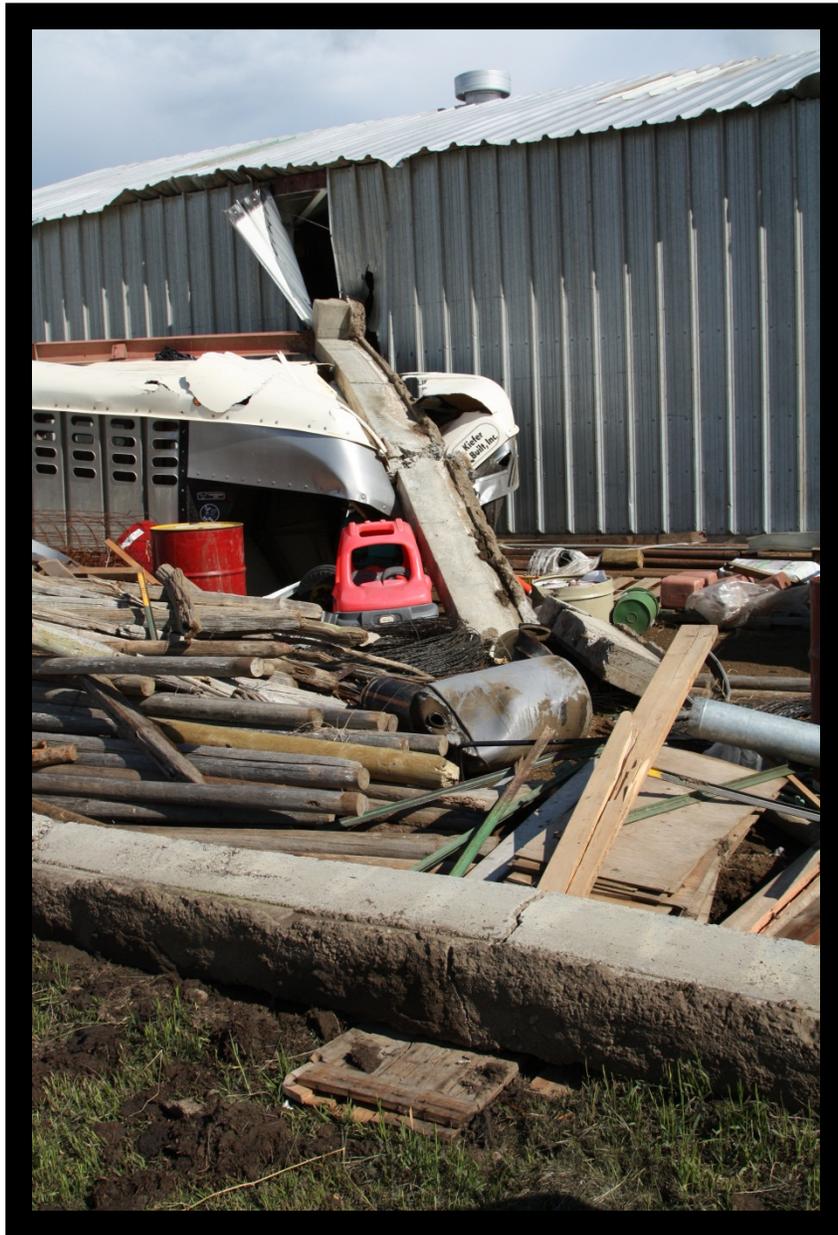
*Photo showing concrete footing moved 6 inches to the south, and in one case, thrown up and into the horse trailer. Photo NWS Glasgow.*

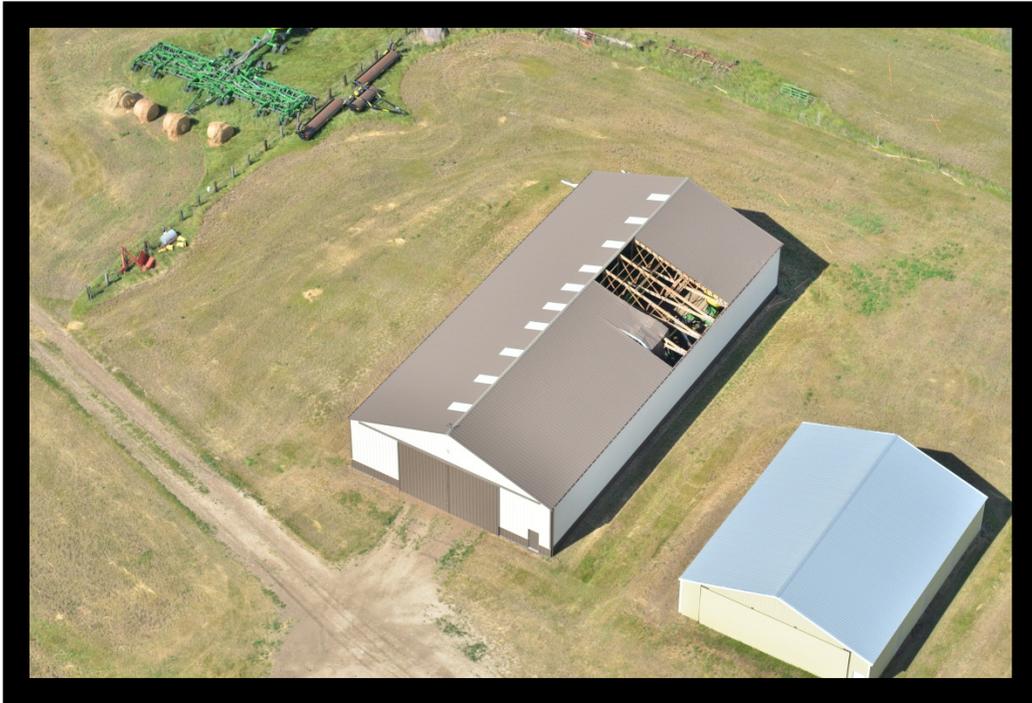
*Aerial Photo showing thunderstorm wind damage to building in above photo on Country Road 2042. Photo Courtesy of Bill Martin and Dallas Aero.*

The tornado then moved across the Poplar River valley. At this point, some photos show it off the ground, but the circulation on the ground may have continued while the visible condensation funnel had to lower itself to the valley bottom. At 447 pm, a farm right on County Road 2042 had the roof peeled off of a well-constructed metal building by rear flank downdraft winds. Wind speeds at this location were estimated at 110 mph. From that farm, they could see the tornado two miles south of them and 13.5 miles east of Montana Highway 13. At this location, 9 power poles were snapped, and irrigation pipes were lifted and moved westward. A large cottonwood tree was also uprooted. Wind speeds were estimated at 100 mph.

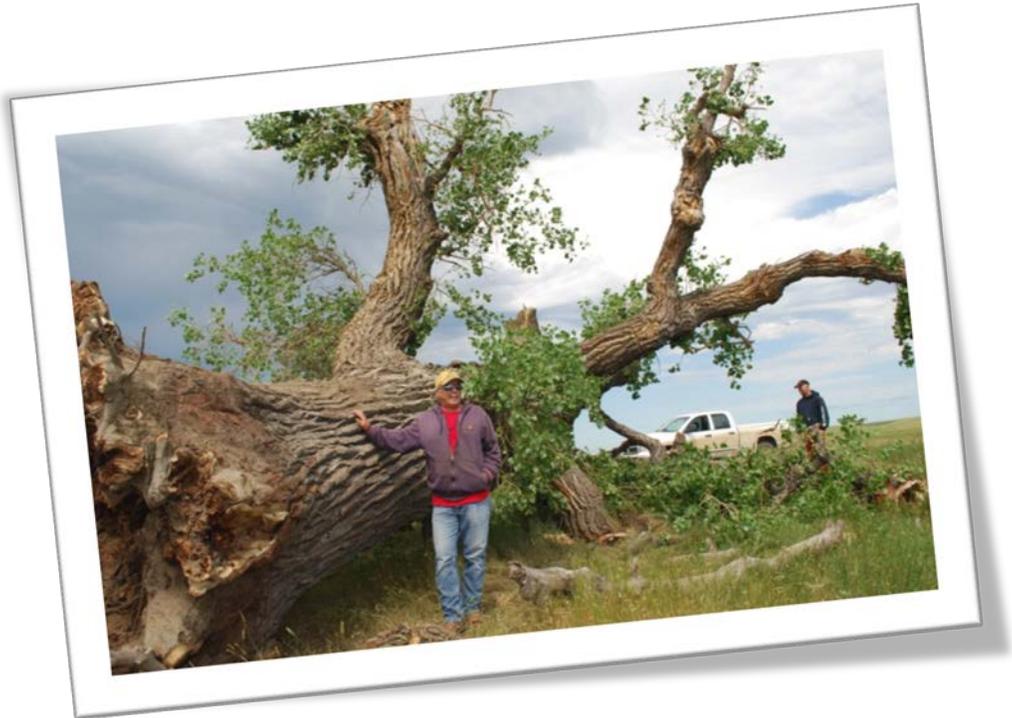
*Mark Swank with the well-known cottonwood tree just off the Poplar River that was the picnic site for generations of farm families in the area for 4<sup>th</sup> of July celebrations. While the tree had some dead on it, there were many live branches left on this beautiful 4 foot in diameter tree. Photo by NWS Glasgow*

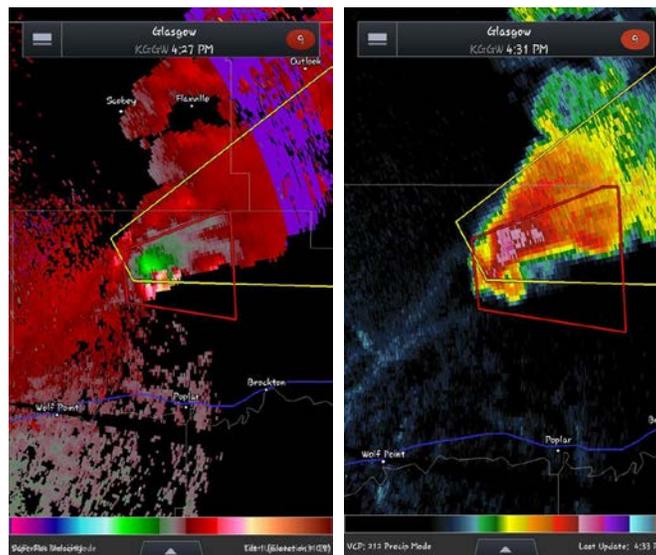
**Storm Relative Velocity and Base Reflectivity at 427 pm and 431 pm on July 15, 2013.**

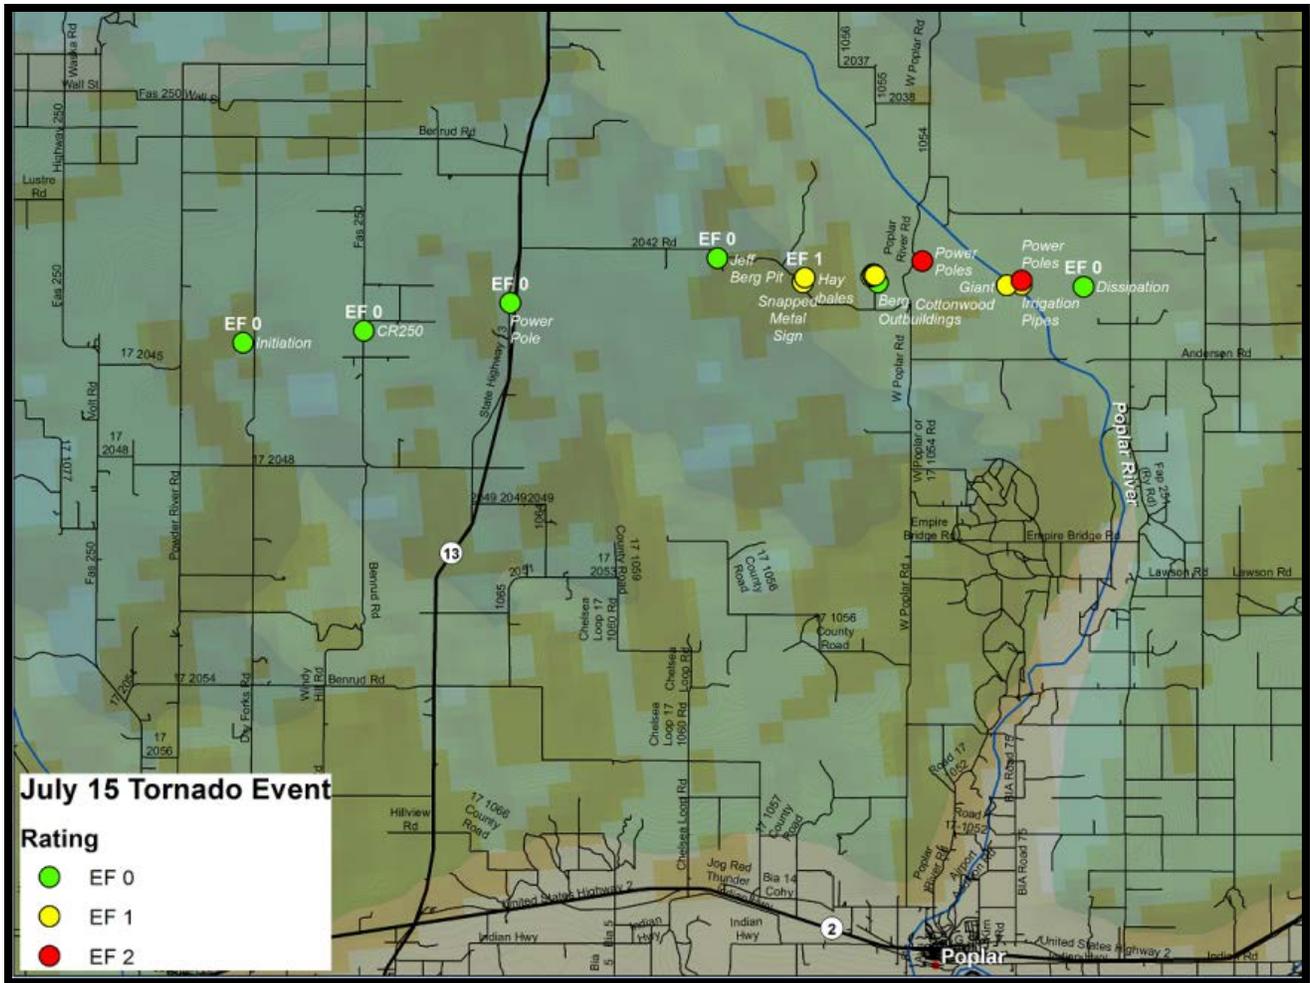
*Path of the tornado and the damage indicators that were found on the survey.*
