REPORT ON RIVER GAGE STATION

LOCATION: Mason
STREAM: Walker River
BASIN: Walker River

LOCATION IDENTIFICATION: MASN2
NWS INDEX NUMBER:
USGS NUMBER: 10300600

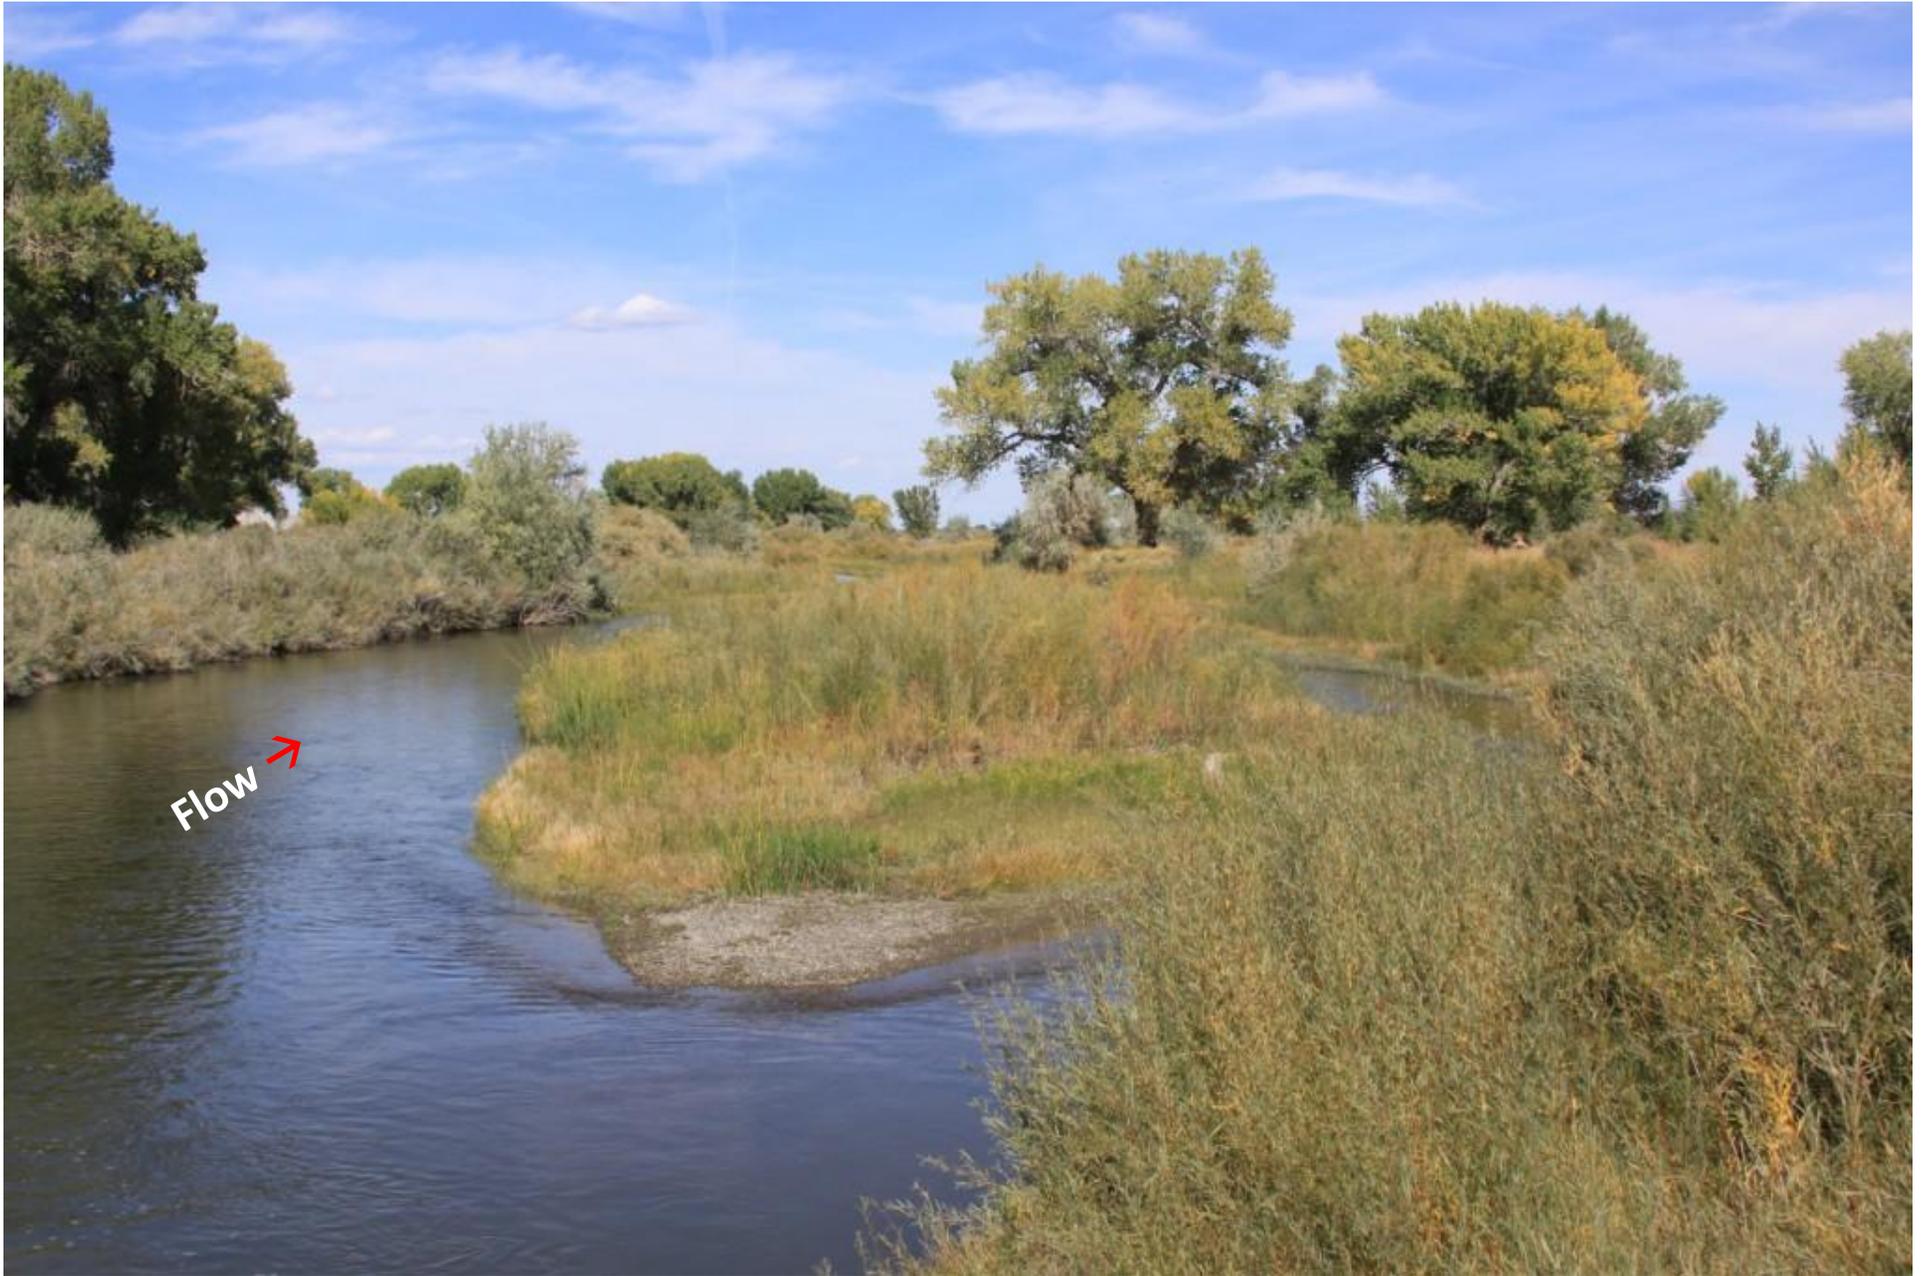
Looking downstream (NW) from Snyder Lane Bridge, 10/15/2010, ~13:45 PDT Stage: 5.80 feet, 141 cfs. Photo by NWS Reno Staff.

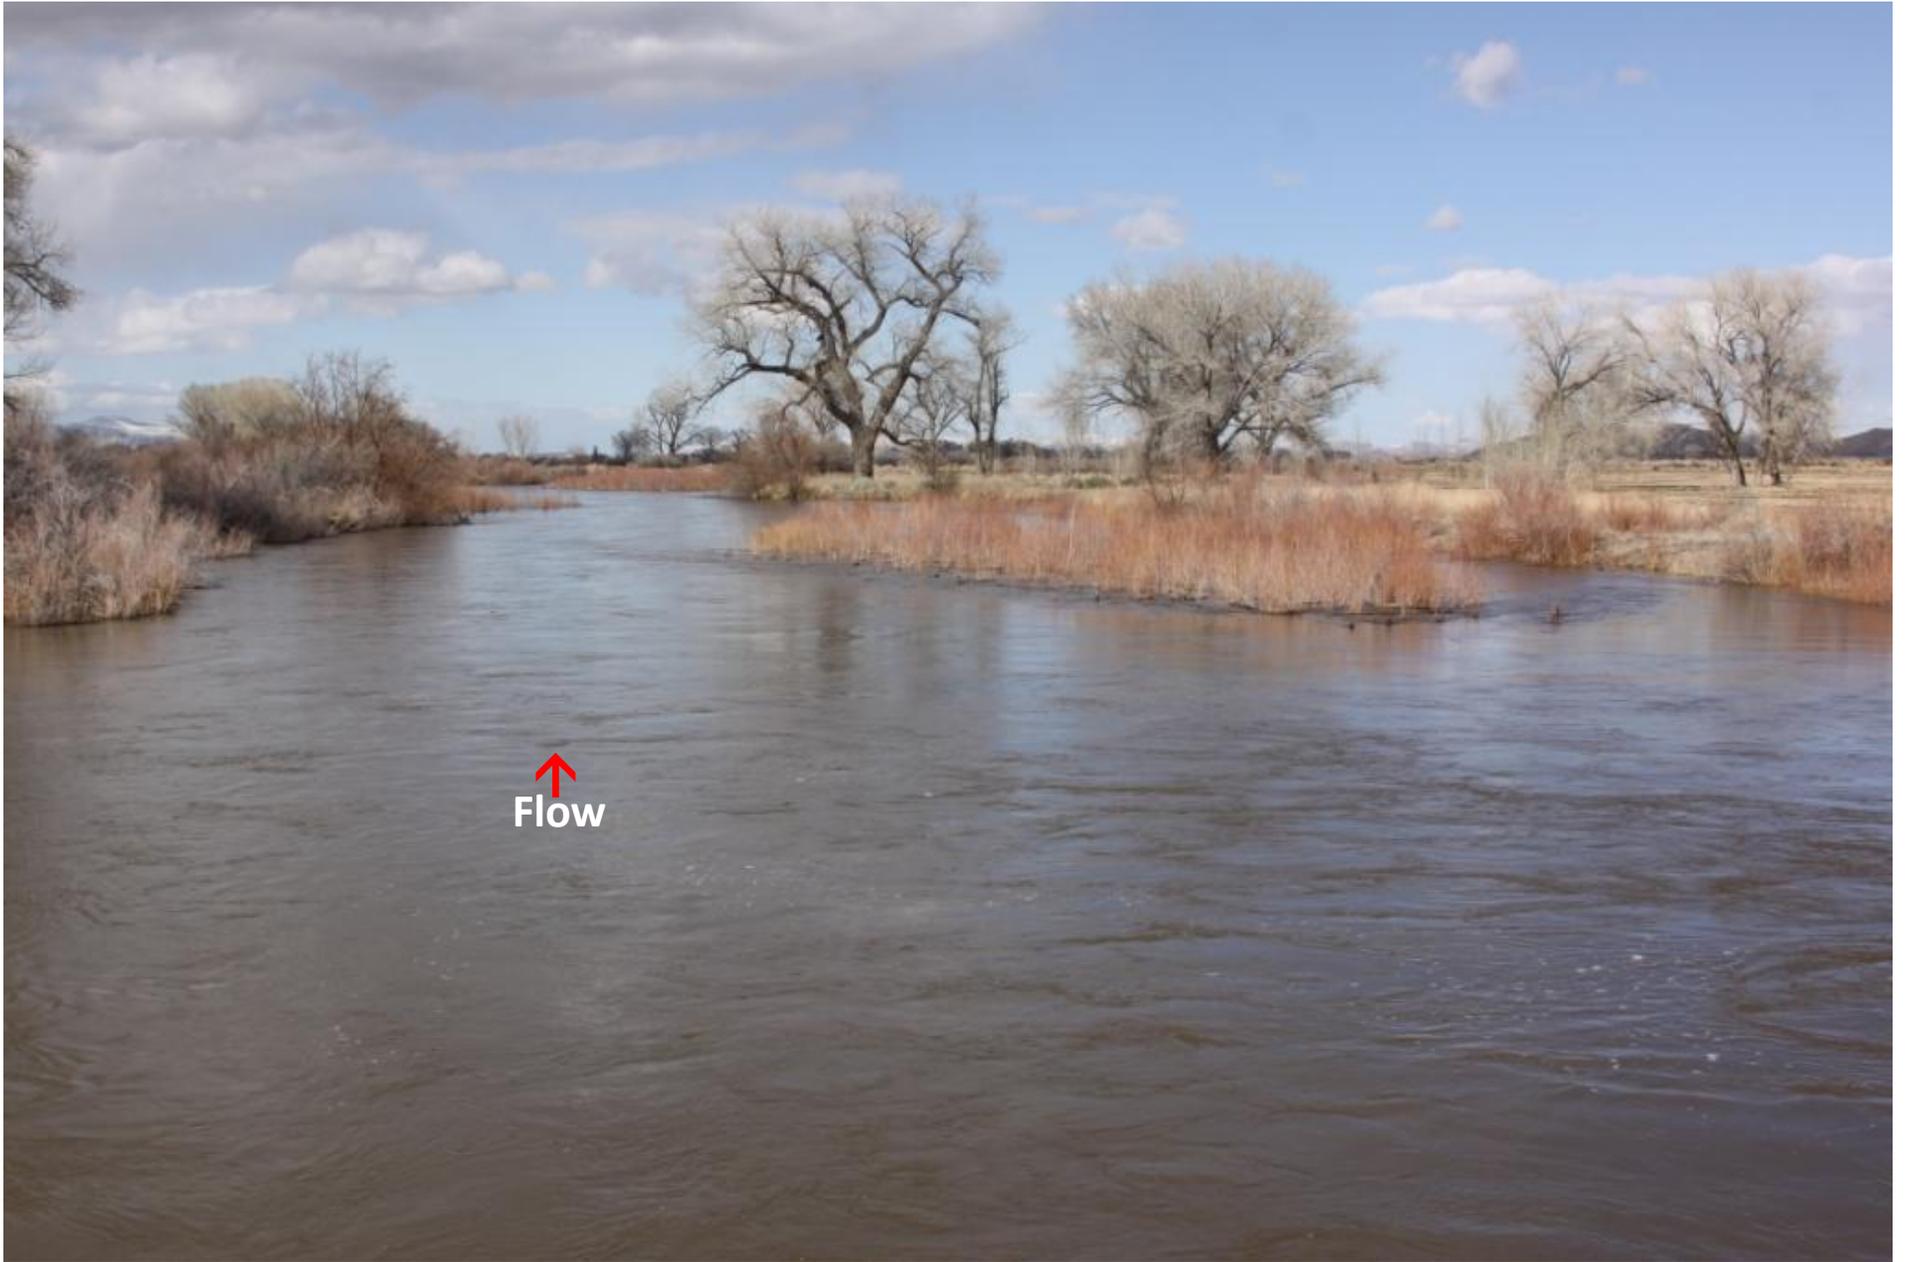
Looking downstream (NNW) from Snyder Lane Bridge, 3/22/2011, ~16:00 PDT. Stage: 8.89 feet, 1240 cfs. Photo by NWS Reno Staff.

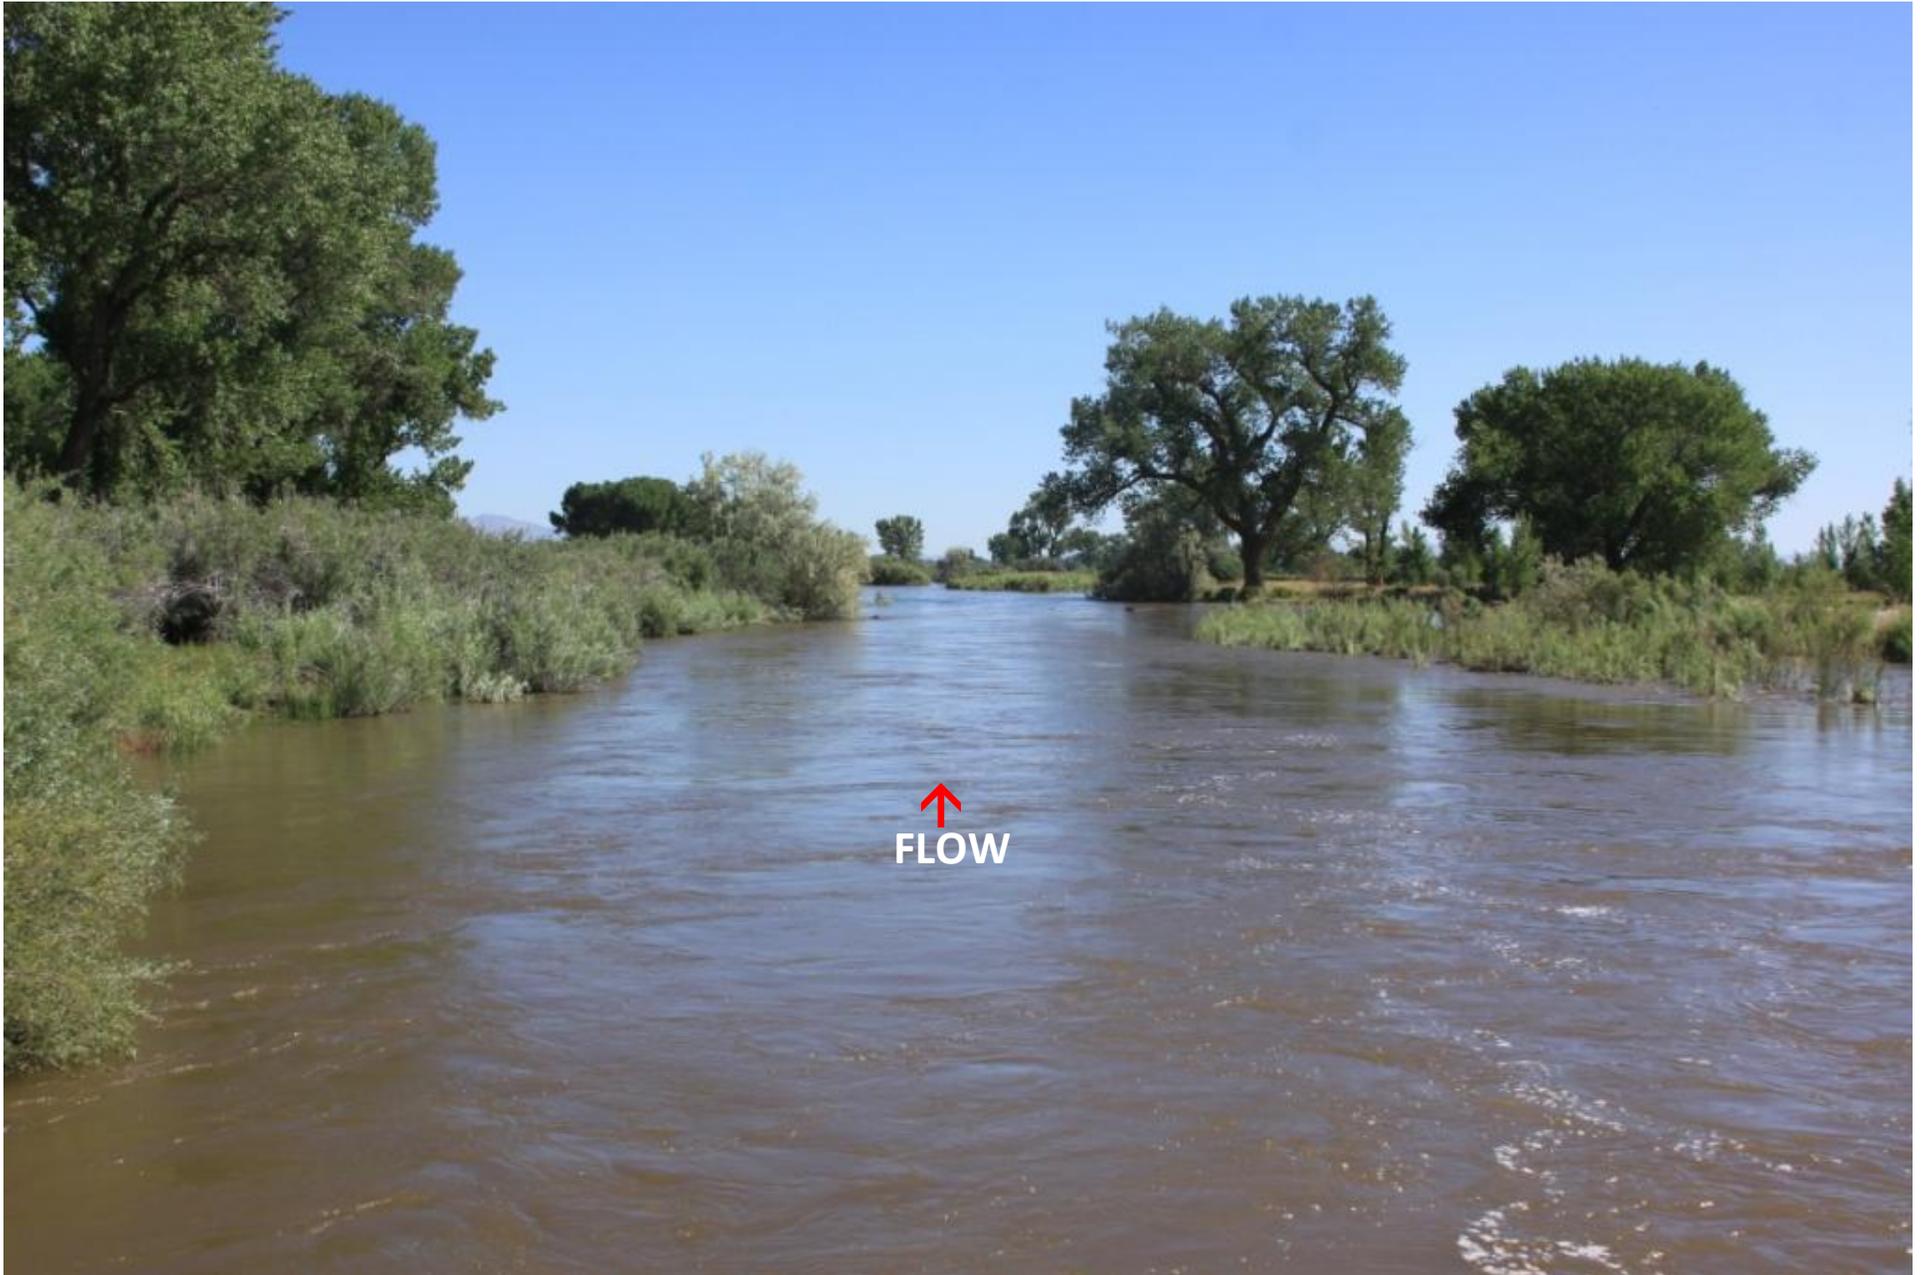
Looking downstream (NW) from Snyder Lane Bridge, 6/23/2011, ~9:15 PDT. Stage: 10.14 feet, 2000 cfs. Photo by NWS Reno Staff.

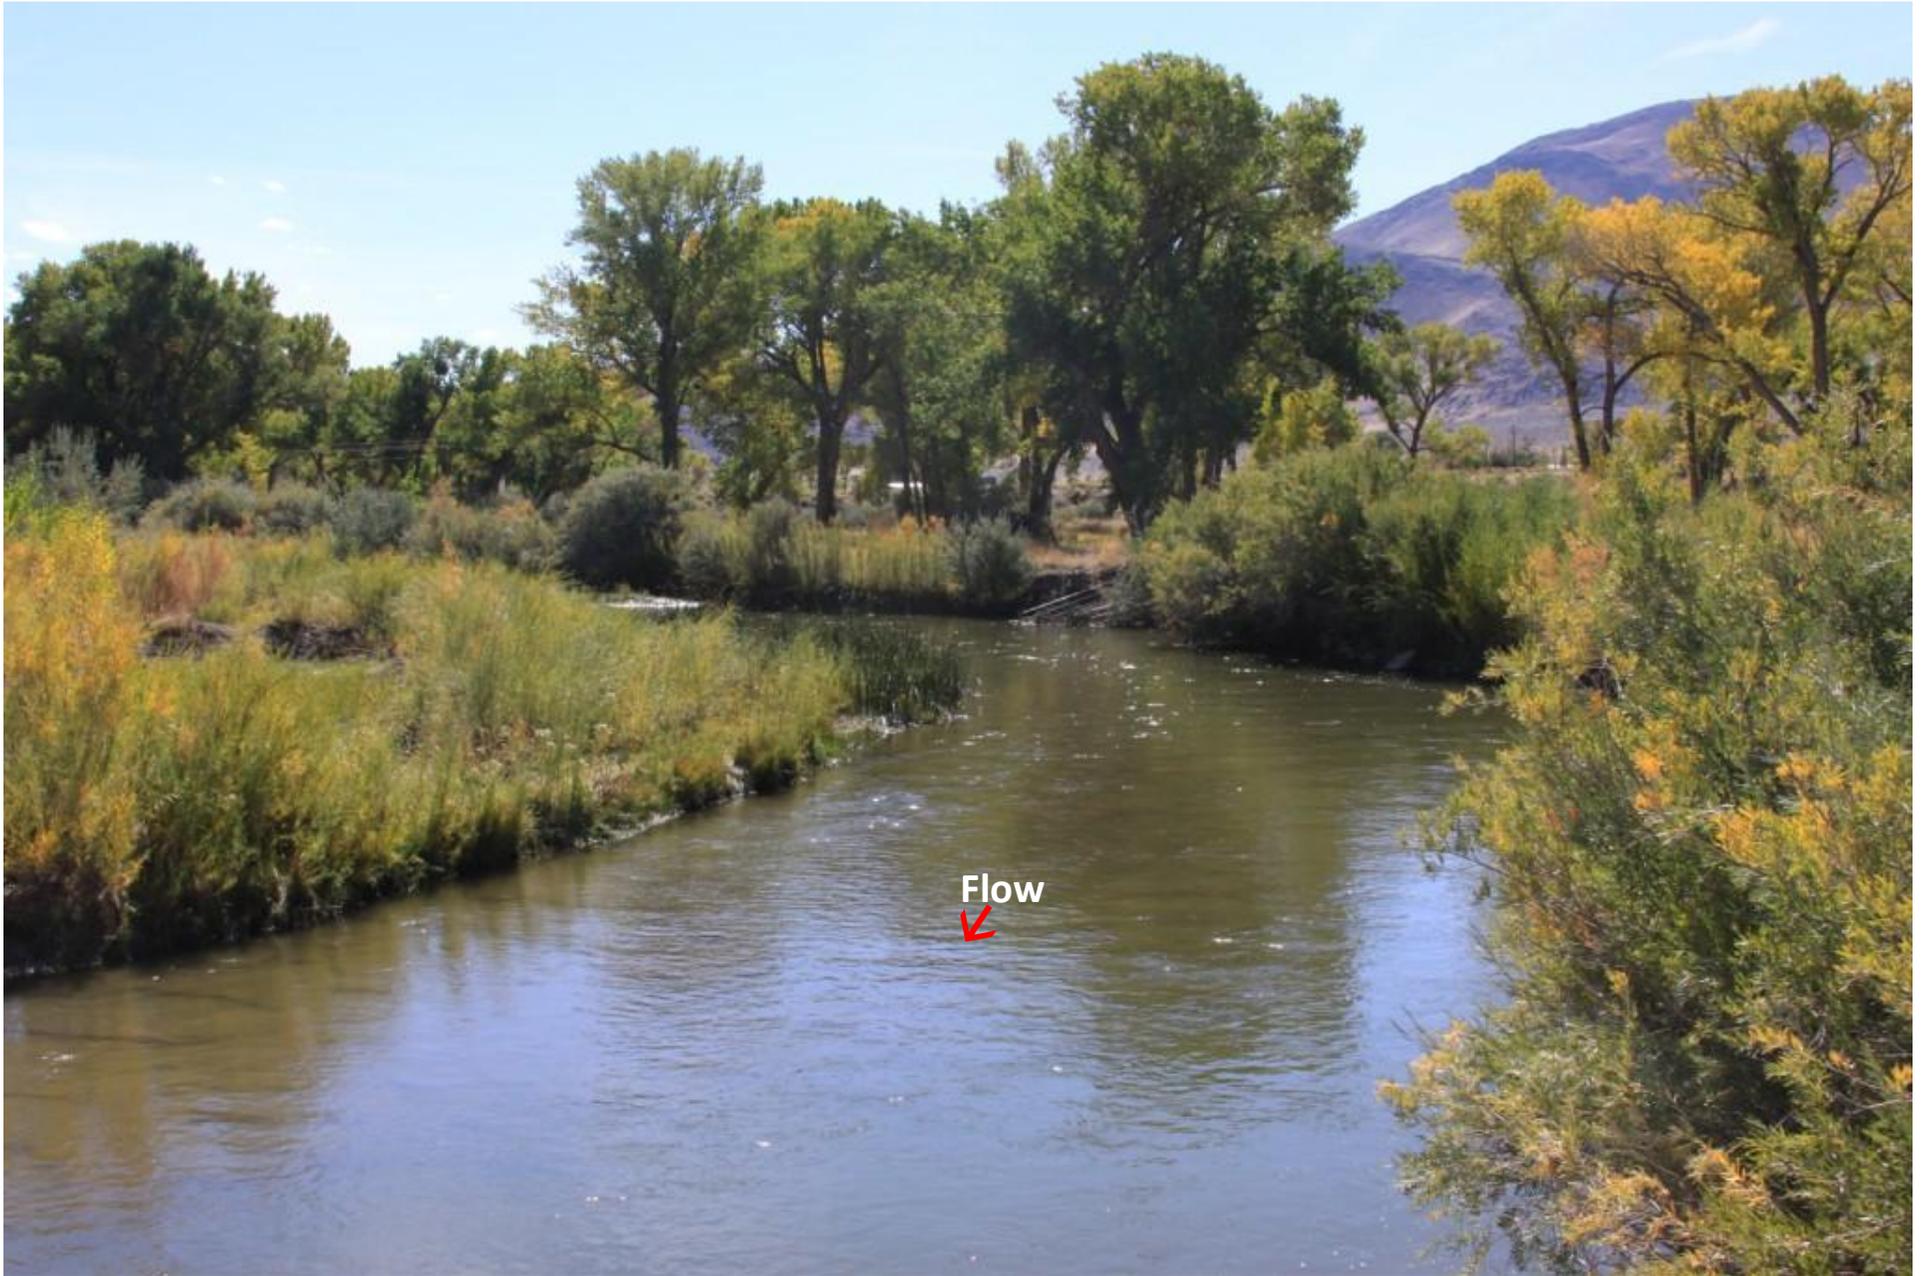
Looking upstream (S) from Snyder Lane Bridge, 10/15/2010, ~13:45 PDT. Stage: 5.80 feet, 141 cfs. Photo by NWS Reno Staff.

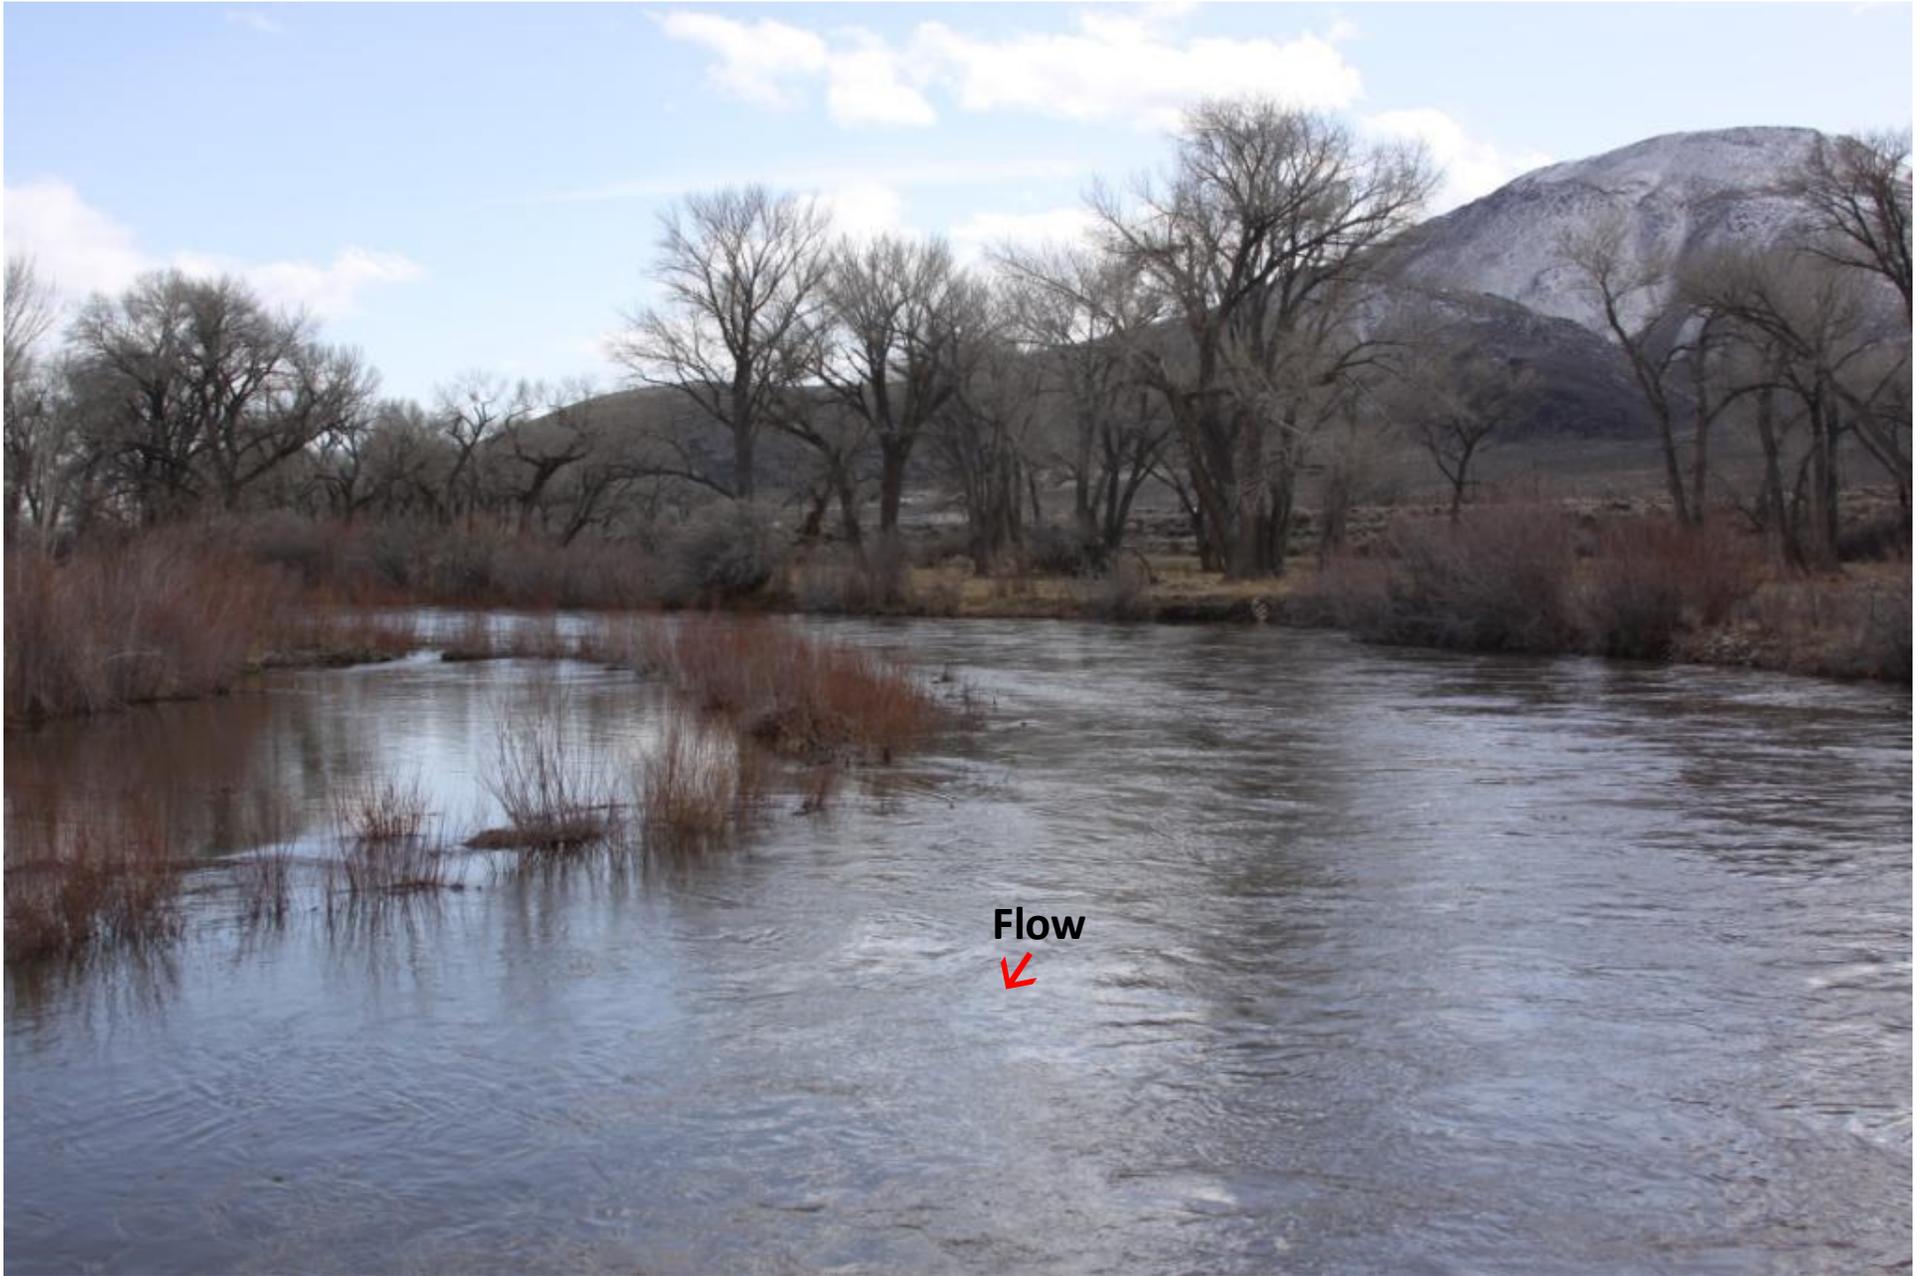
Looking upstream (S) from Snyder Lane Bridge, 3/22/2011, ~16:00 PDT. Stage: 8.89 feet, 1240 cfs. Photo by NWS Reno Staff.

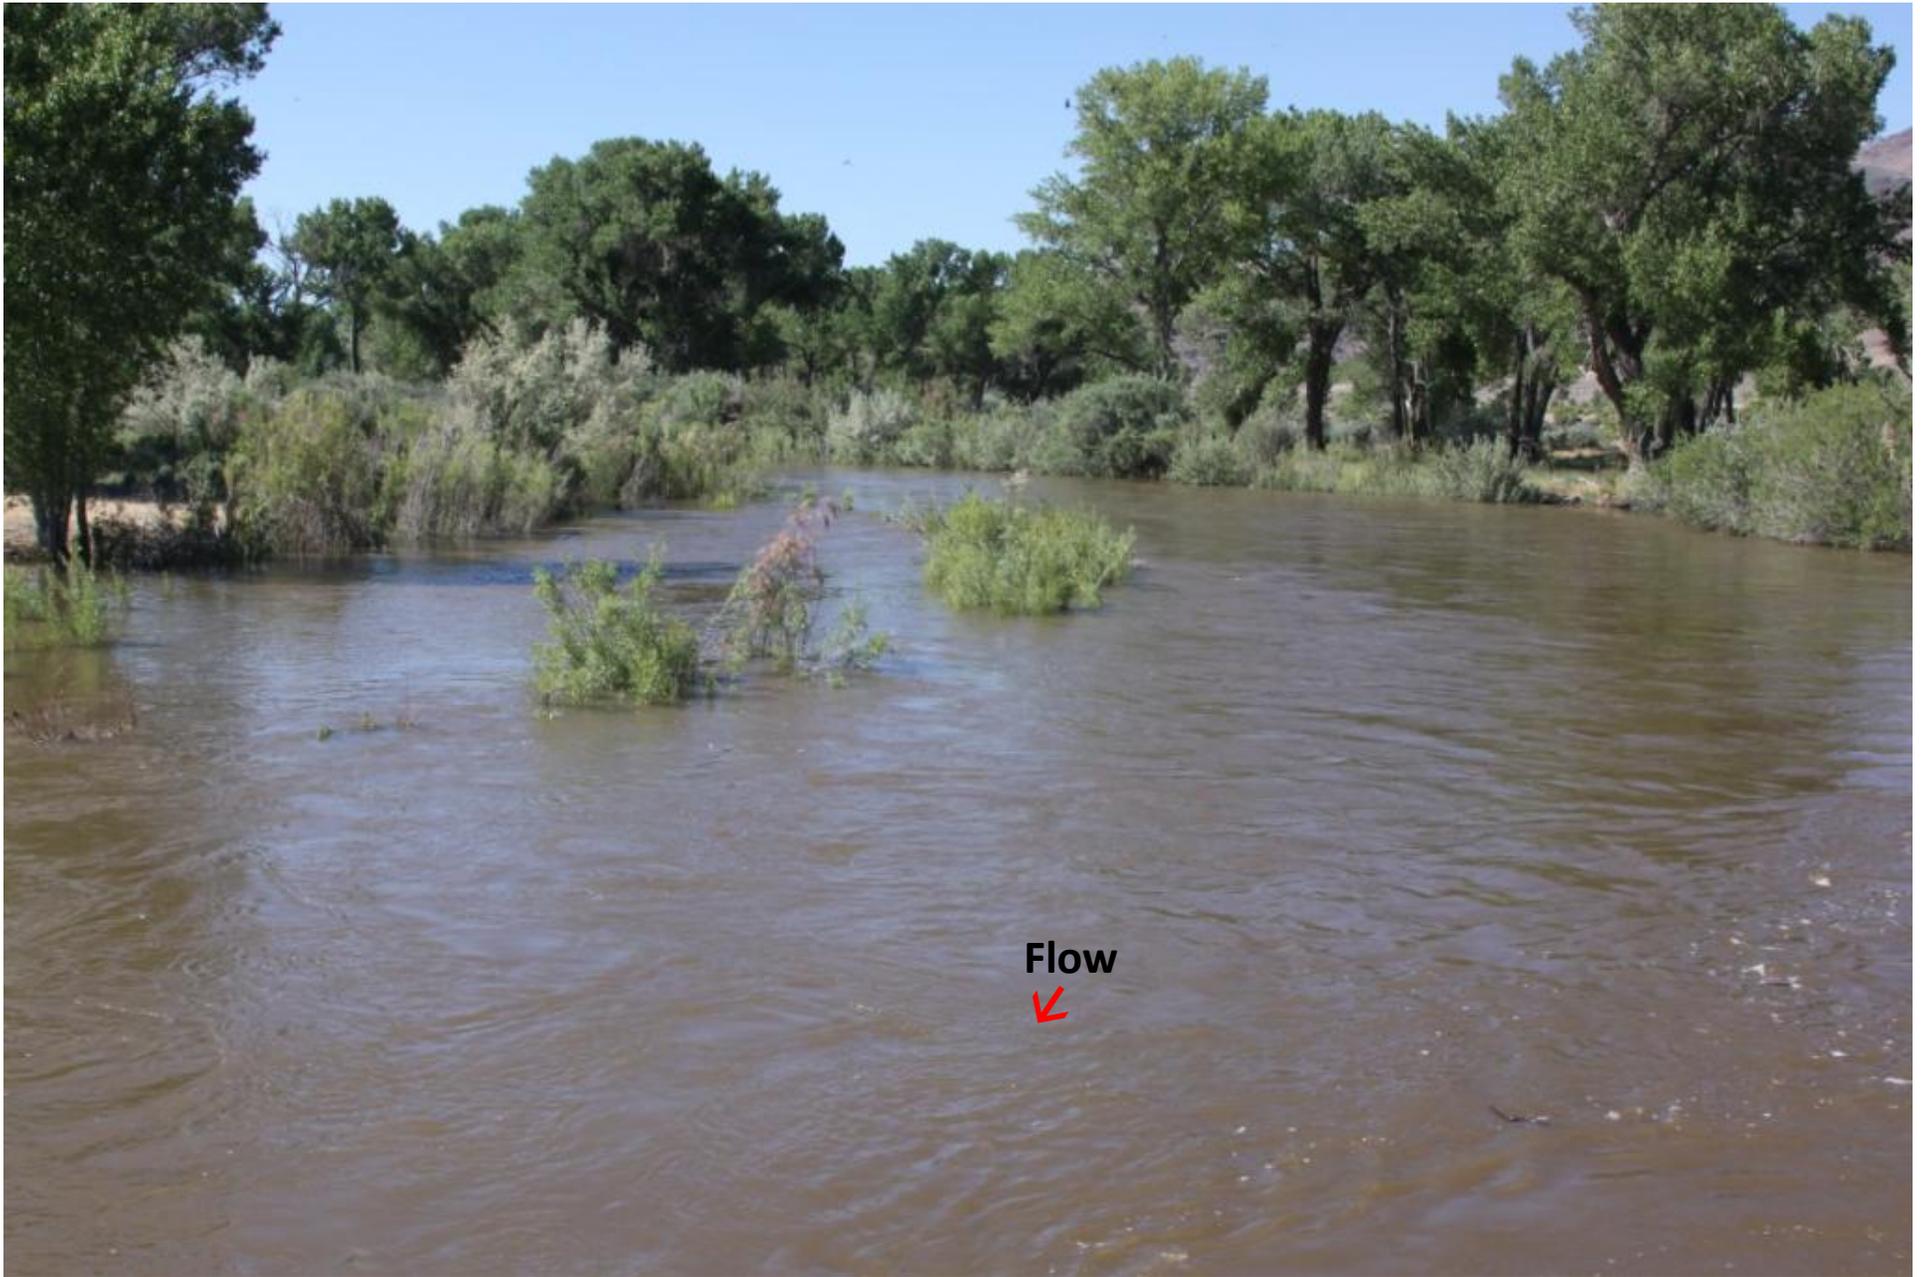
Looking upstream (S) from Snyder Lane Bridge, 6/23/2011, ~09:15 PDT. Stage: 10.14 feet, 2000 cfs. Photo by NWS Reno Staff.

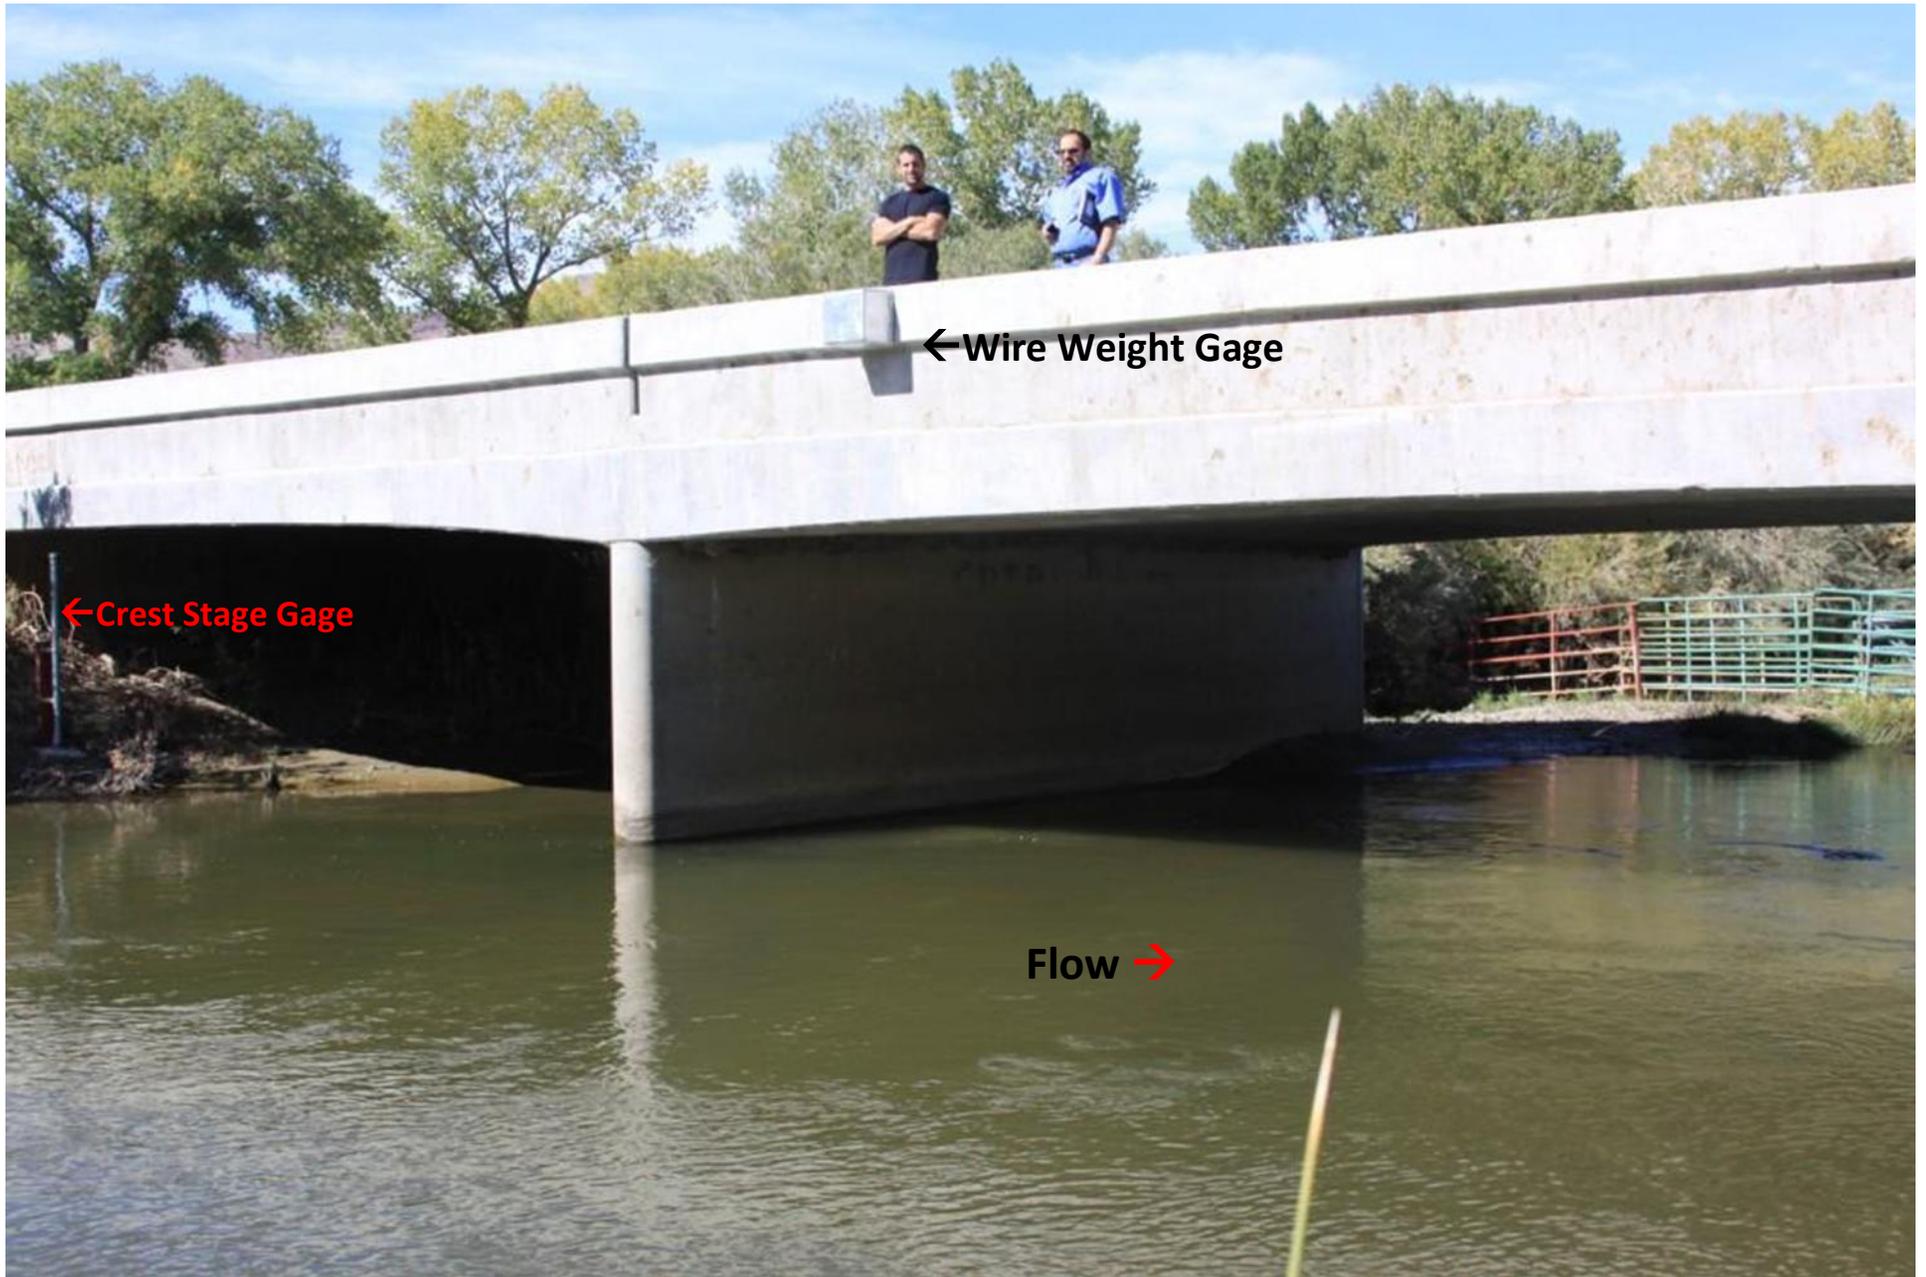
Walker River at Snyder Lane Bridge, from upstream of bridge, 10/15/2010, ~13:45 PDT. Stage 5.80 ft, 141 cfs. Wire weight gage (WWG) in center of bridge; crest stage gage (CSG) visible on left bank. Photo by NWS Reno Staff.

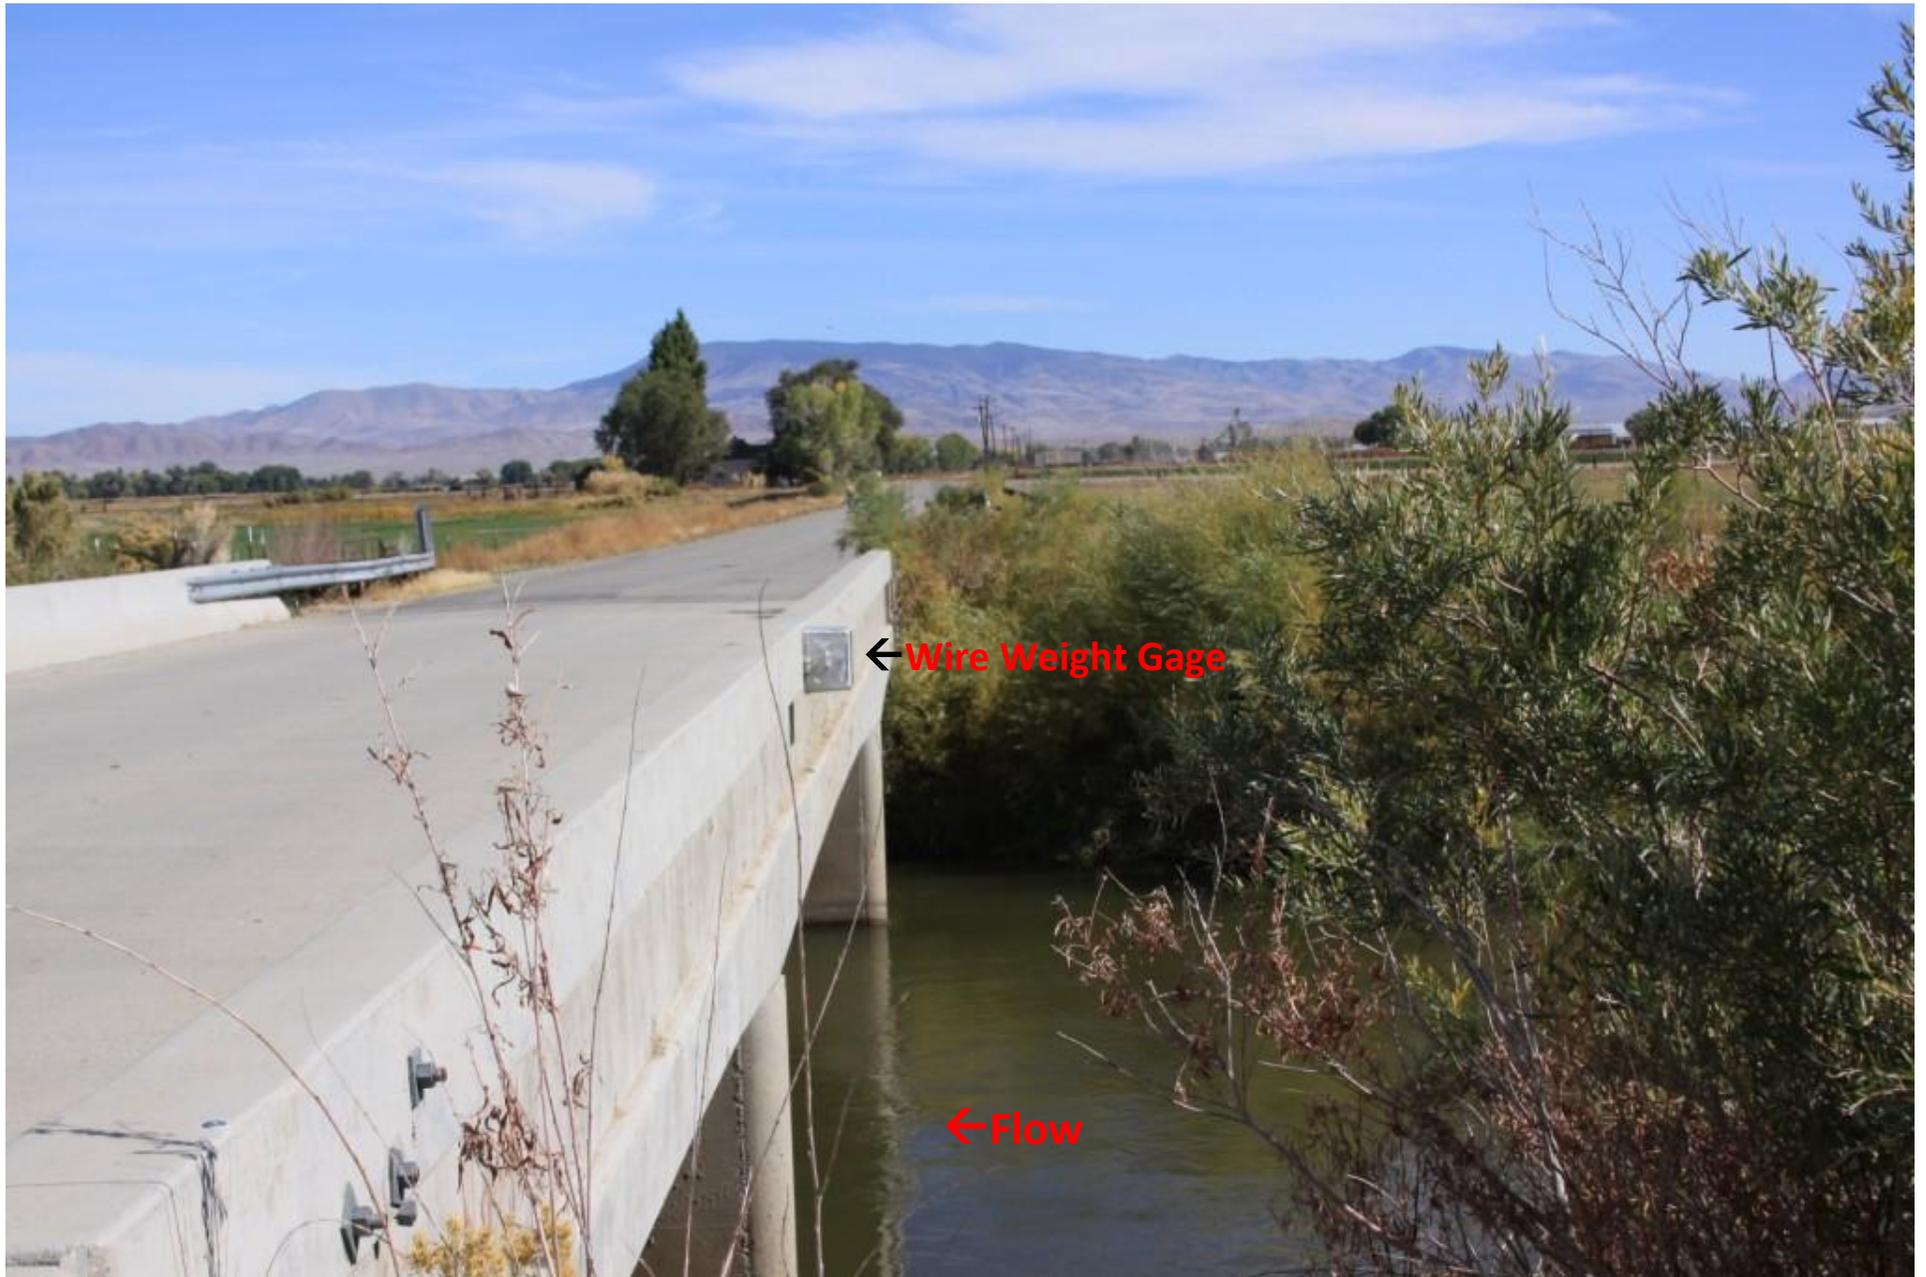
Upstream side of Snyder Lane Bridge and wire weight gage, looking ENE. 10/15/2010, ~13:30 PDT. Stage: 5.80 feet, 141 cfs. Photo by NWS Reno Staff.

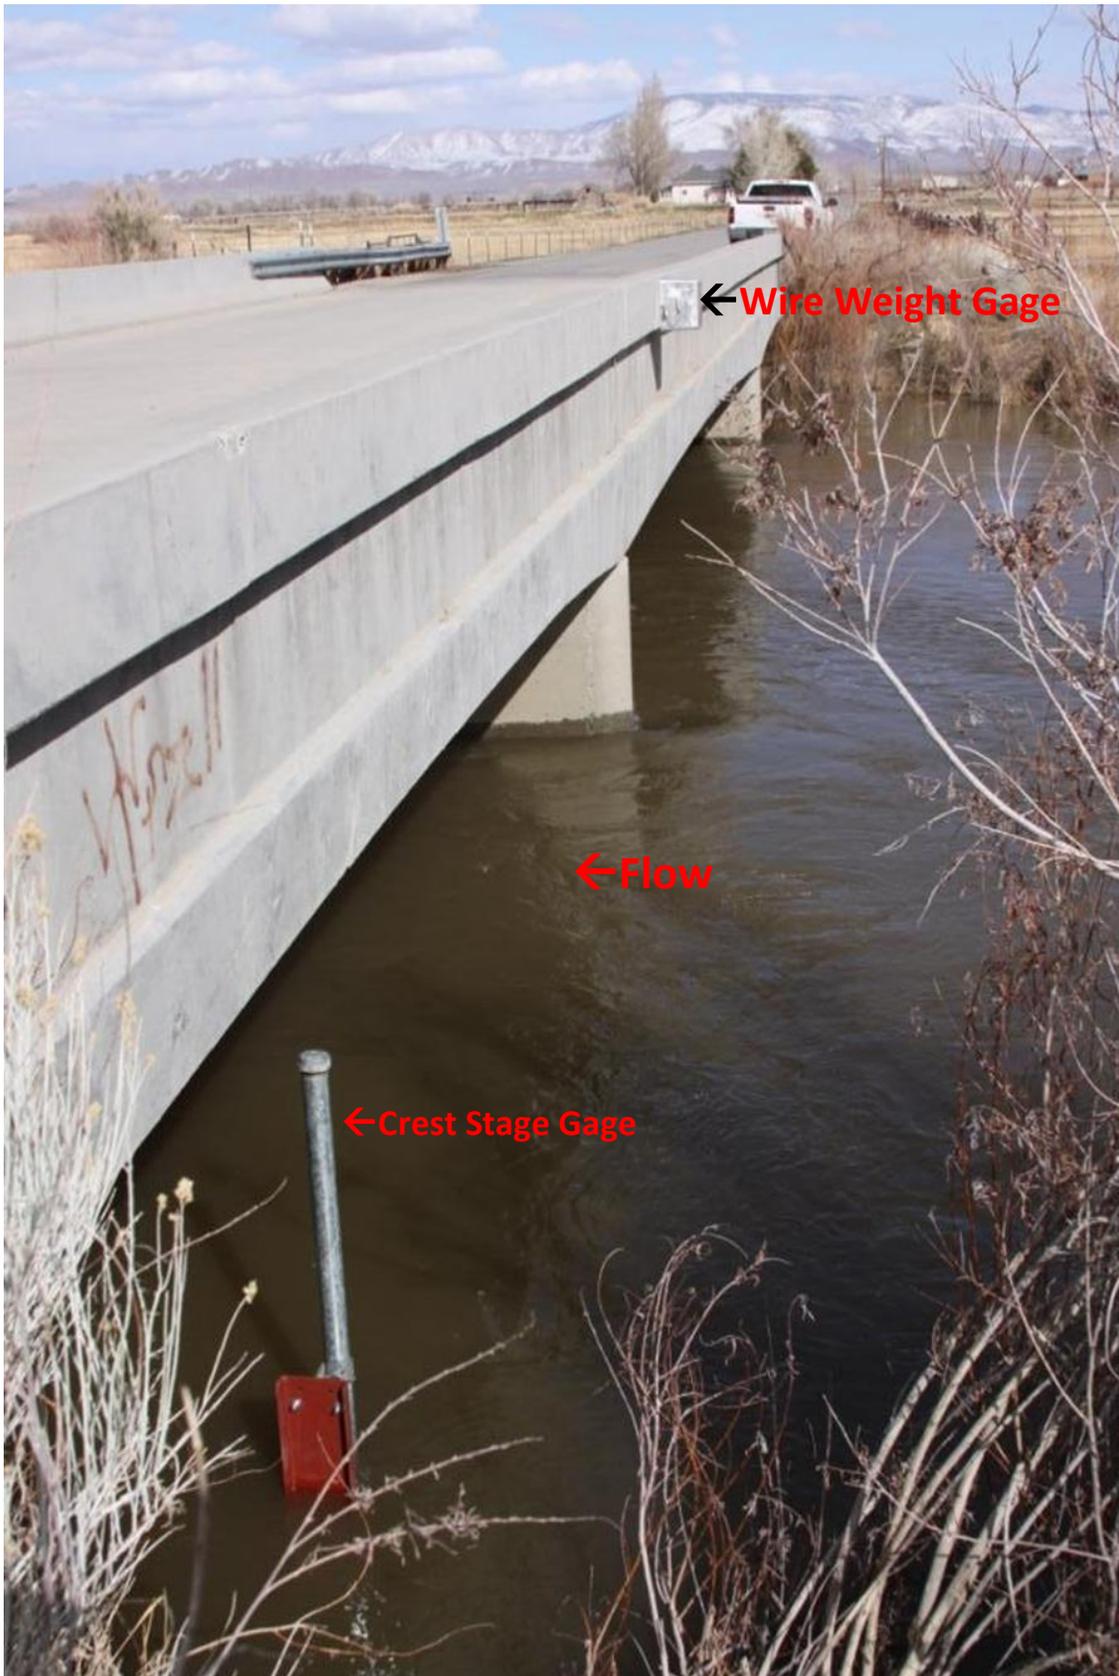
Upstream side of Snyder Lane Bridge, with wire weight gage in center and crest gage on left bank, looking NE. 3/22/2011, ~16:00 PDT. Stage: 8.89 feet, 1240 cfs. Photo by NWS Reno Staff.
