REPORT ON RIVER GAGE STATION

LOCATION: Mason
STREAM: Walker River
BASIN: Walker River

LOCATION IDENTIFICATION: MASN2
NWS INDEX NUMBER:
USGS NUMBER: 10300600

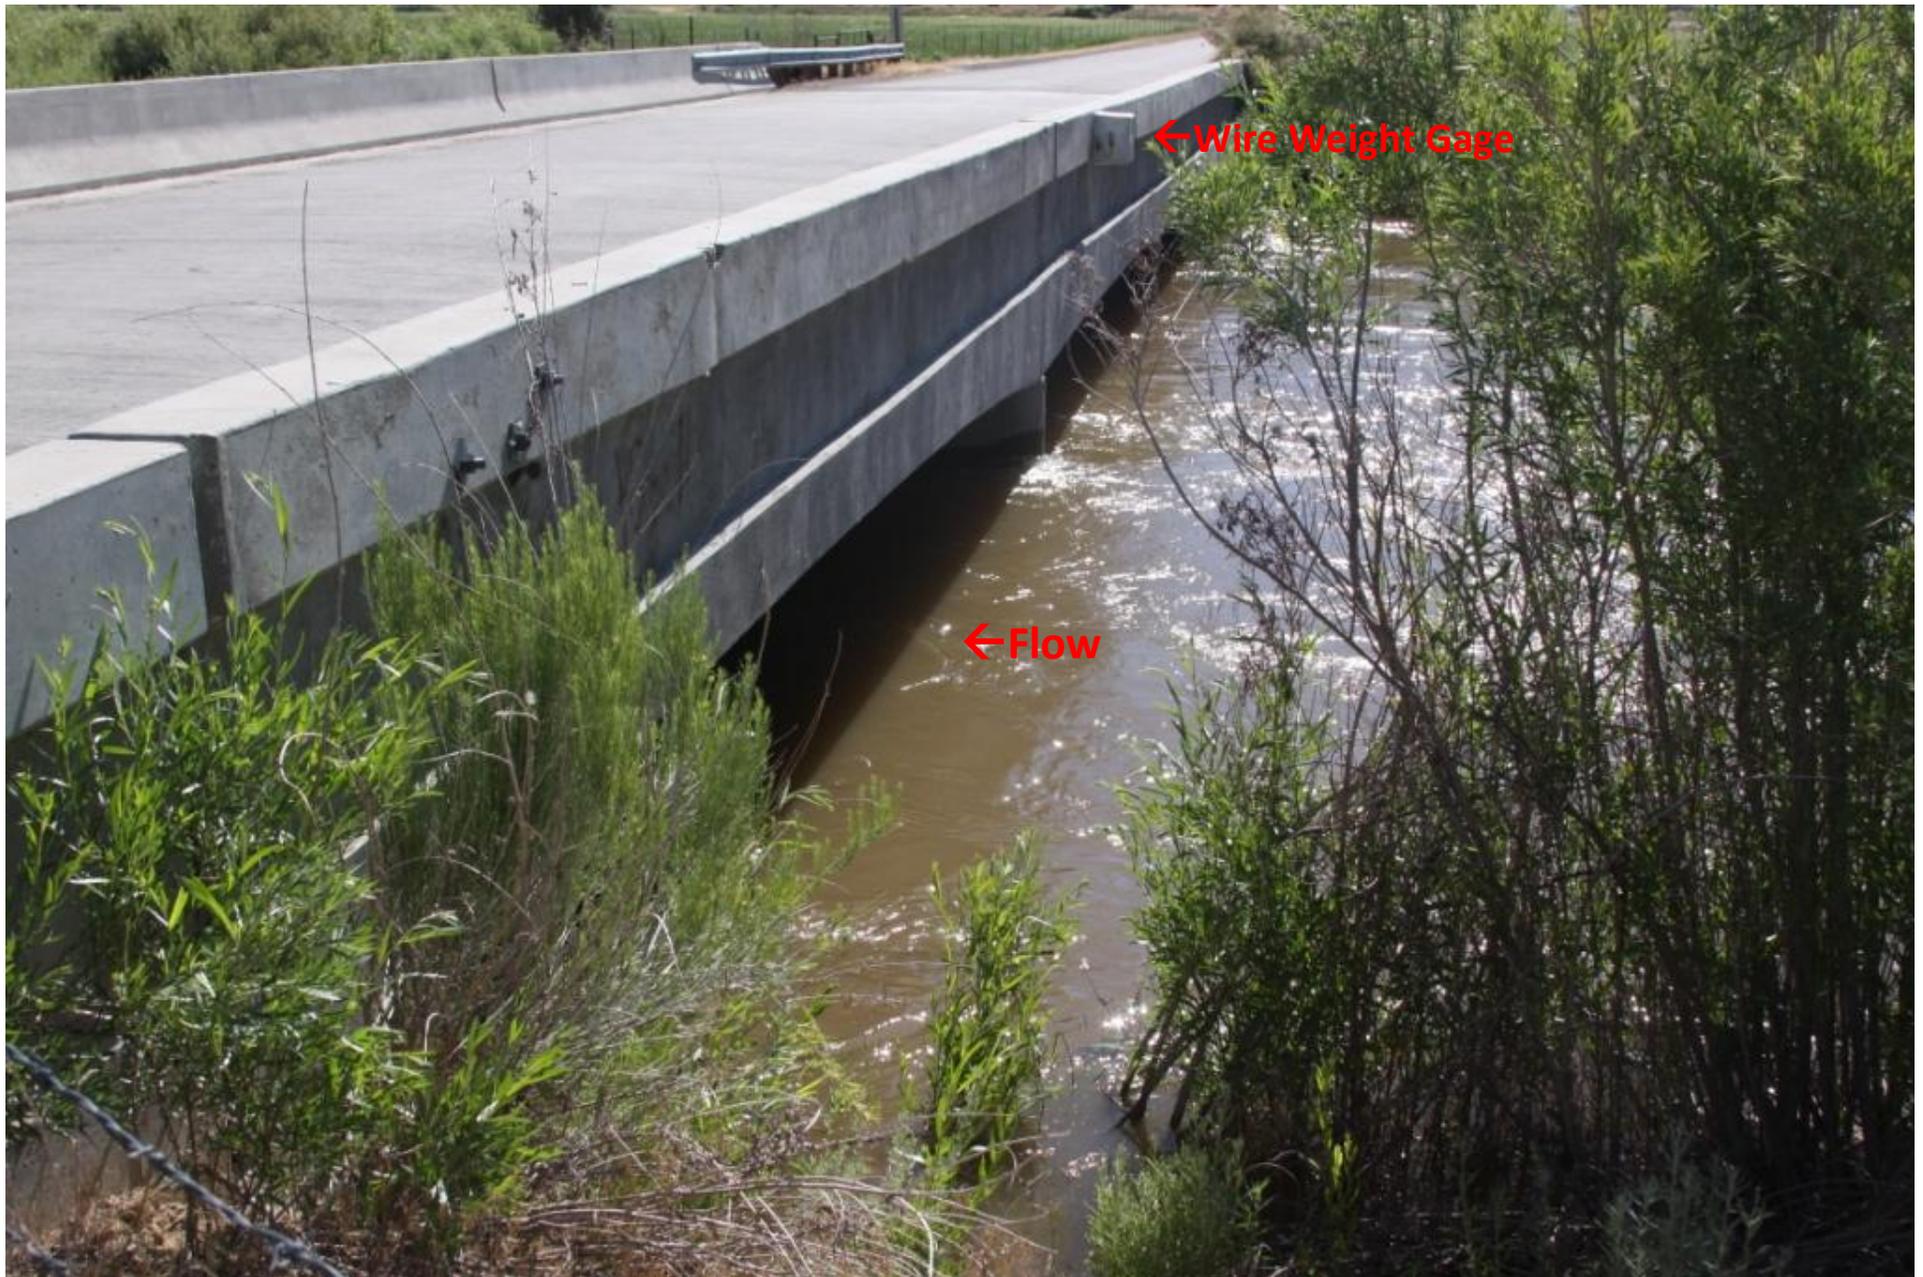
Upstream side of Snyder Lane Bridge, with wire weight gage in center (view of crest gage is blocked by brush in foreground); looking NE.
6/23/2011, ~9:15 PDT. Stage: 10.14 feet, 2000 cfs. Photo by NWS Reno Staff.

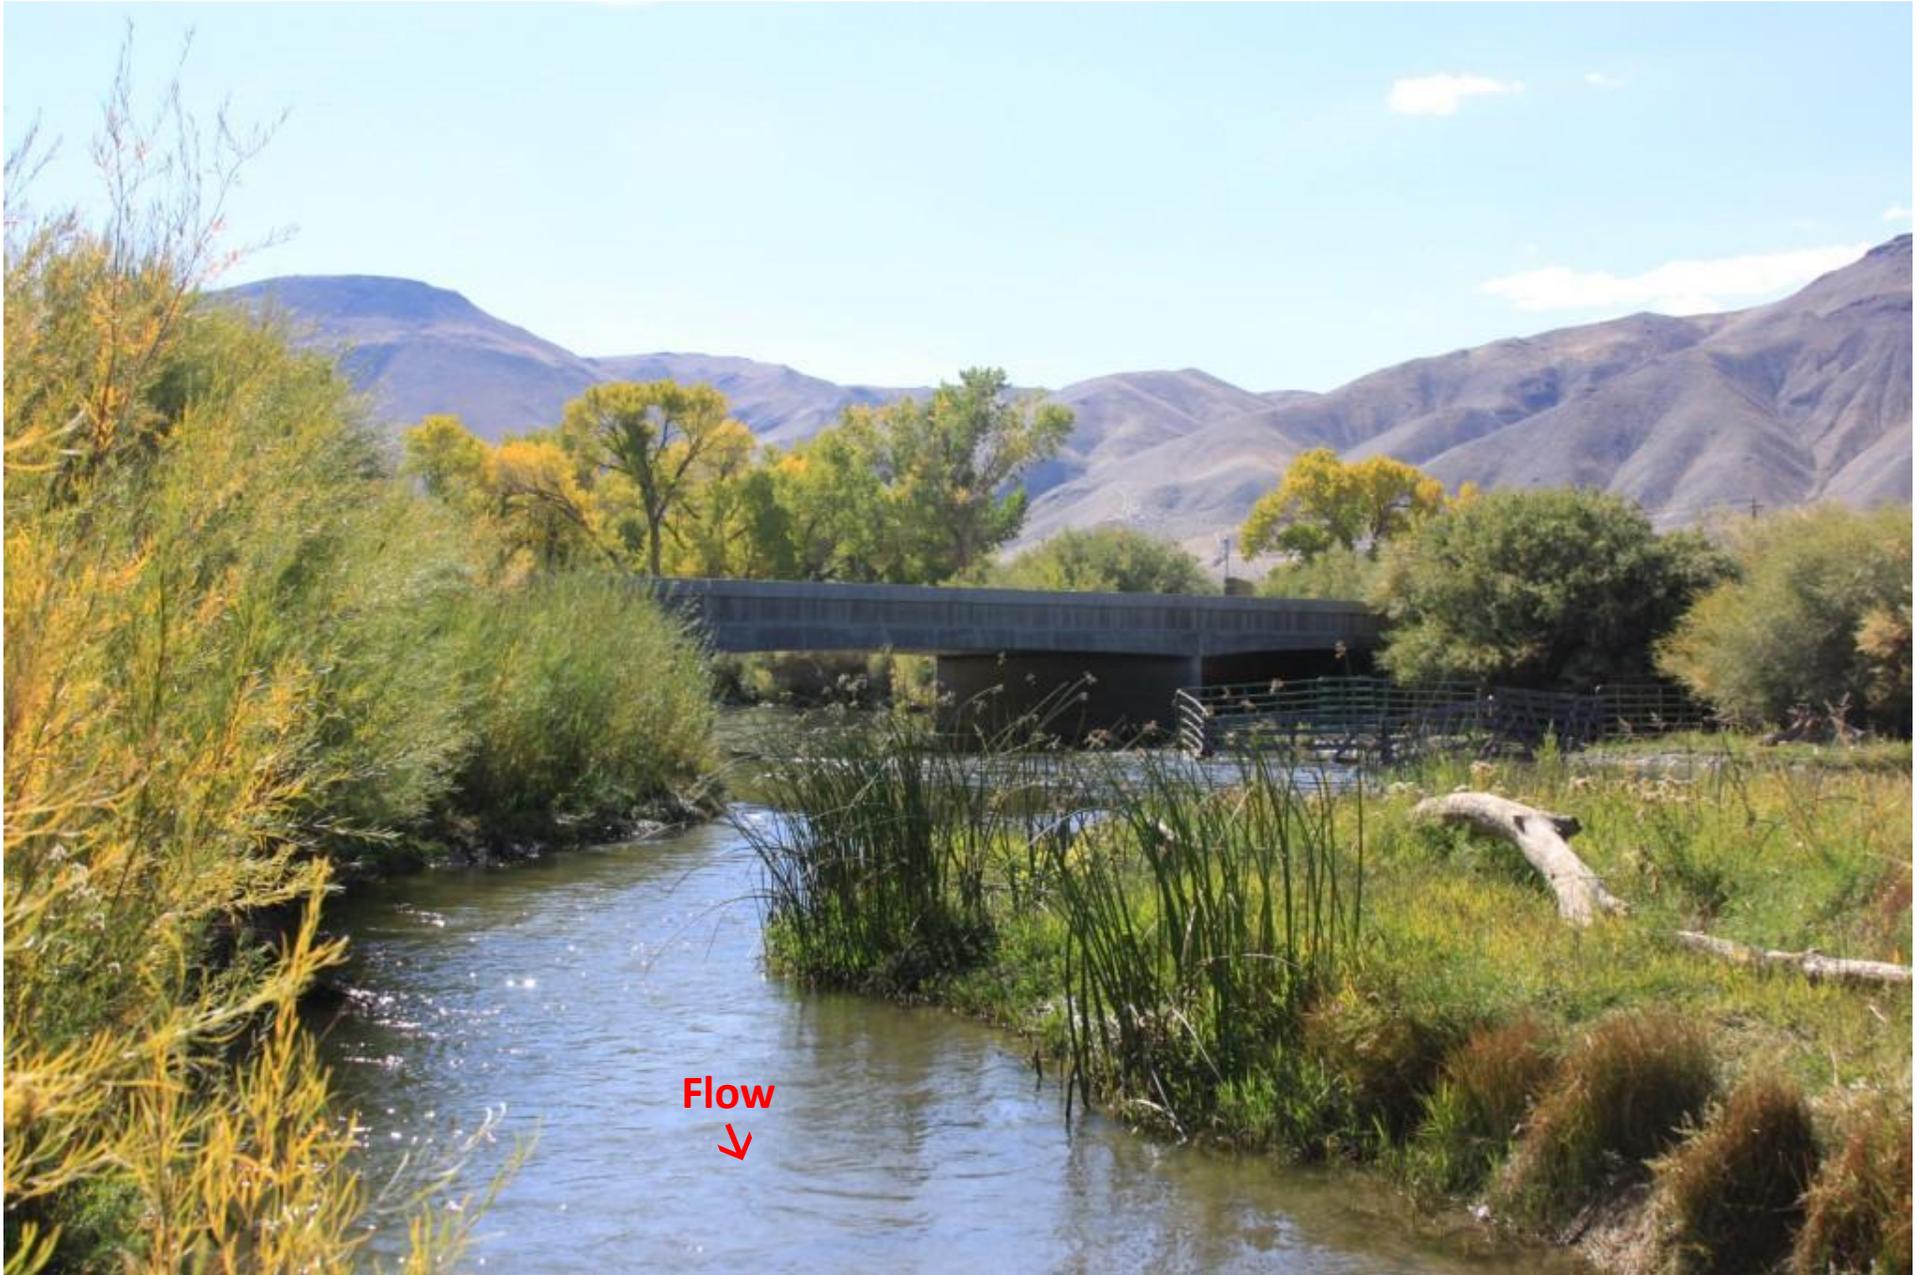
Upstream view (to SSW) from right bank below bridge. 10/15/2010, ~13:45 PDT. Stage 5.80 ft, 141 cfs. Photo by NWS Reno Staff.
Walker River near Mason, NV (MASN2) HSA: REV April 2012 Page 27

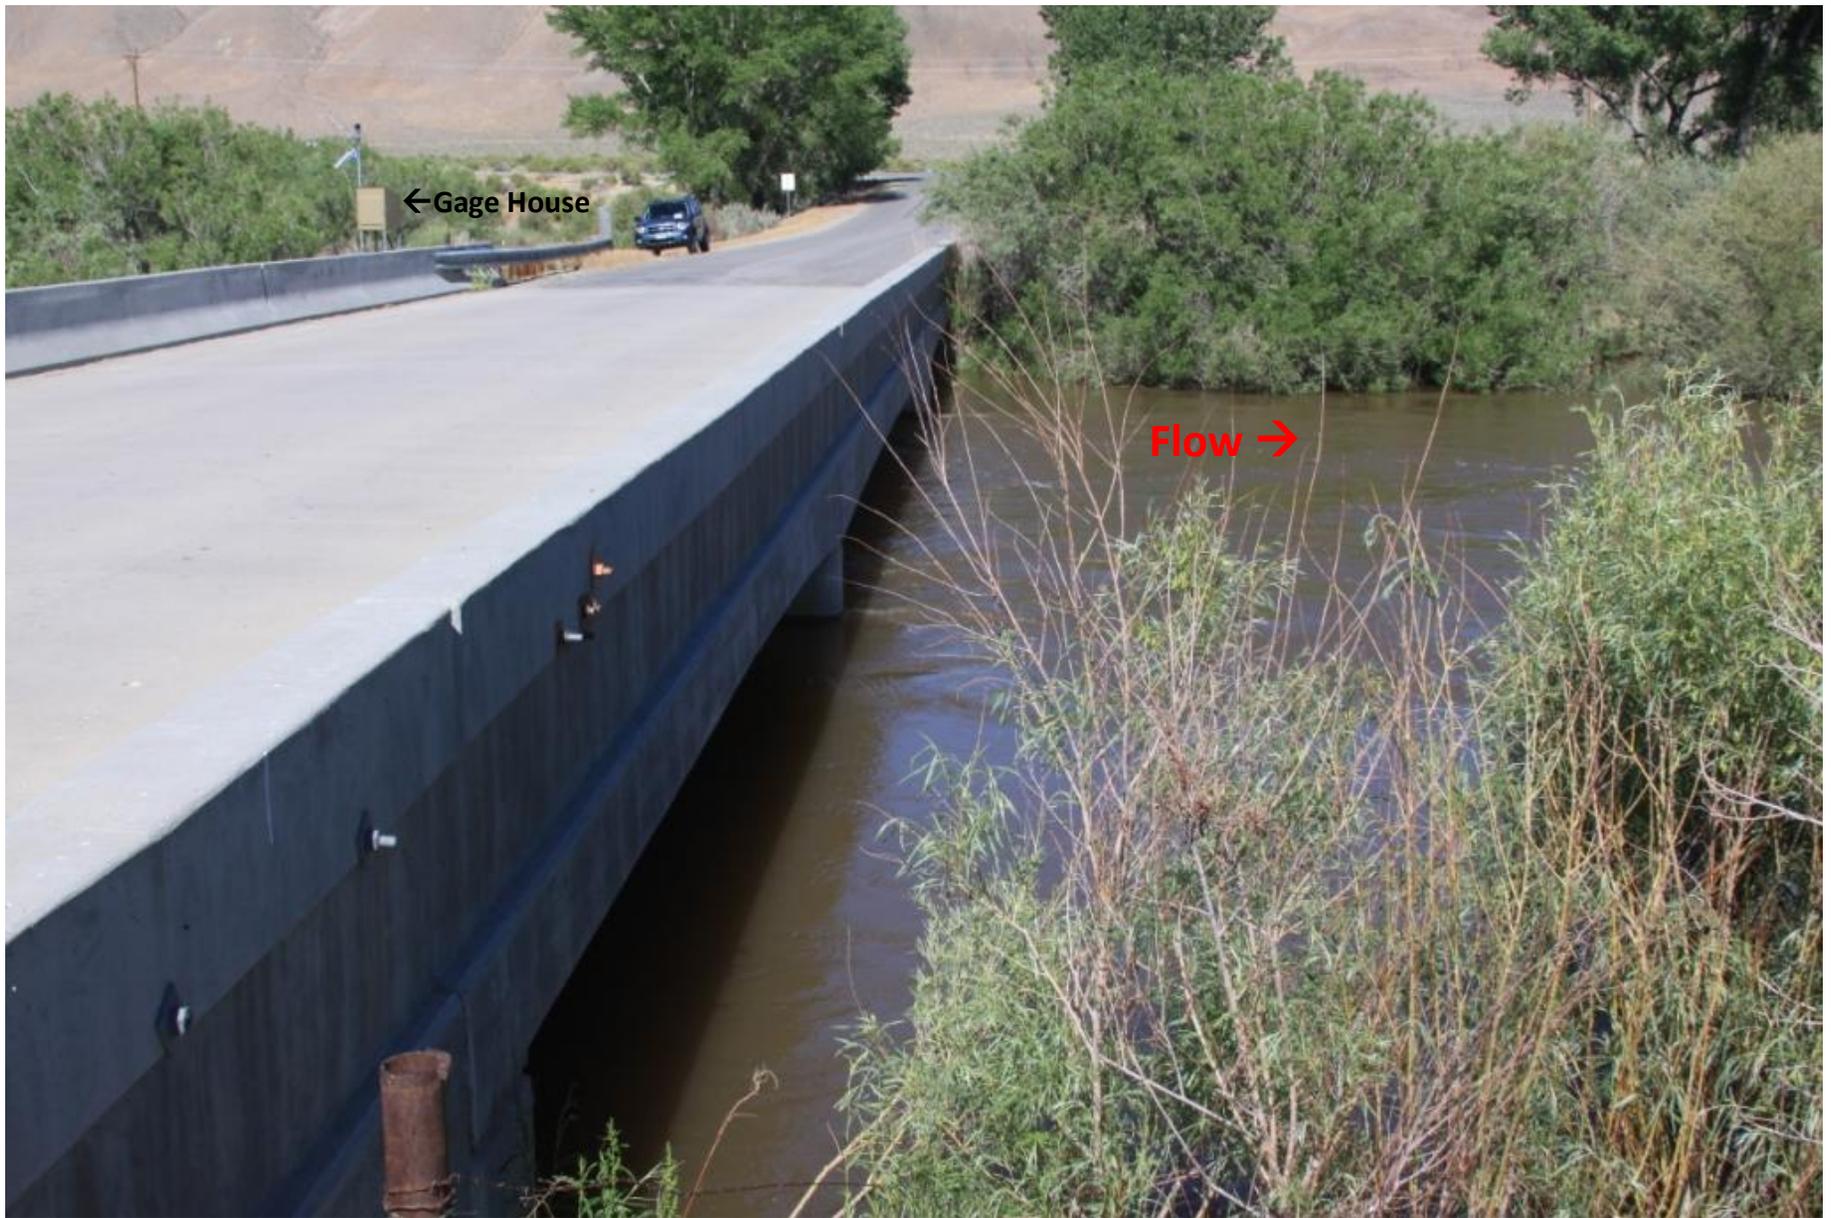
Downstream side of Snyder Lane Bridge, looking W, gage house visible upper left. 6/23/2011, ~9:15 PDT. Stage: 10.14 feet, 2000 cfs. Photo by NWS Reno Staff.

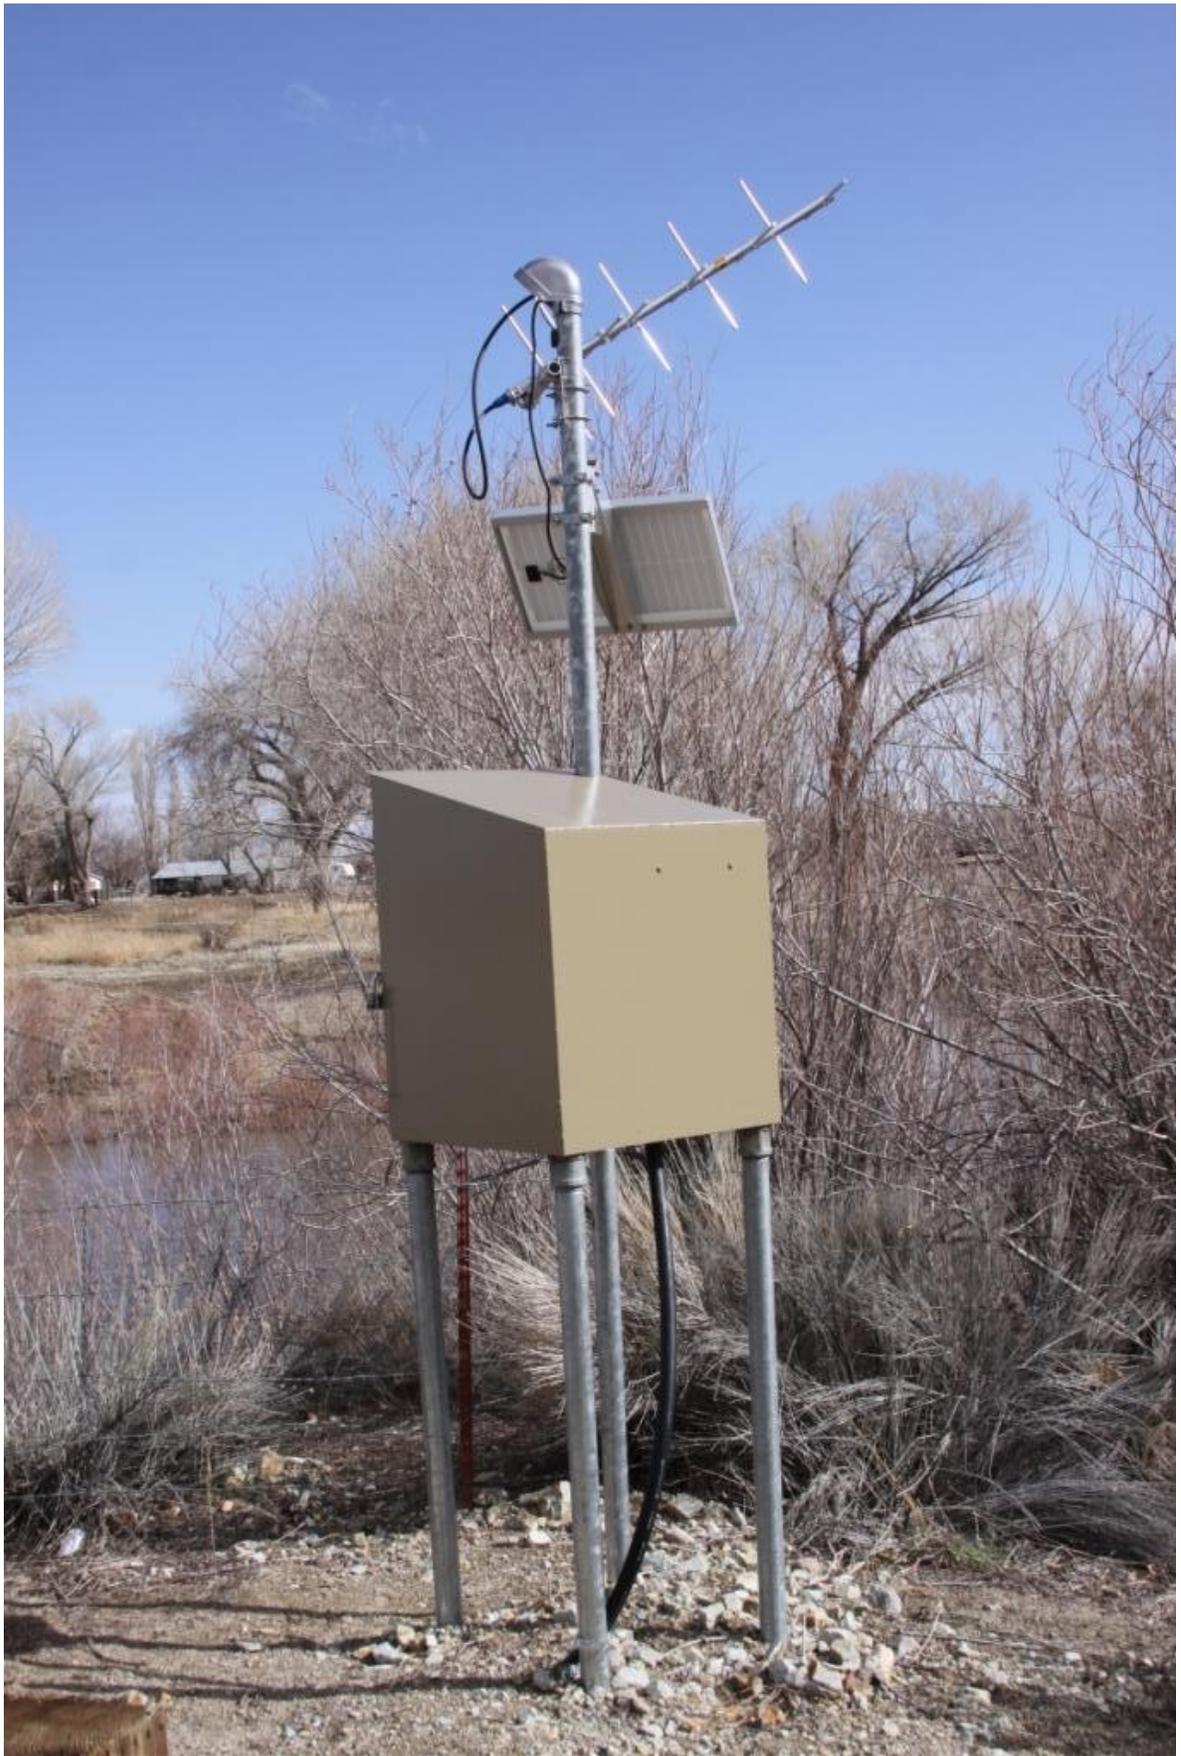
Gage house, Walker River near Mason, 3/22/2011. Photo by NWS Reno Staff.

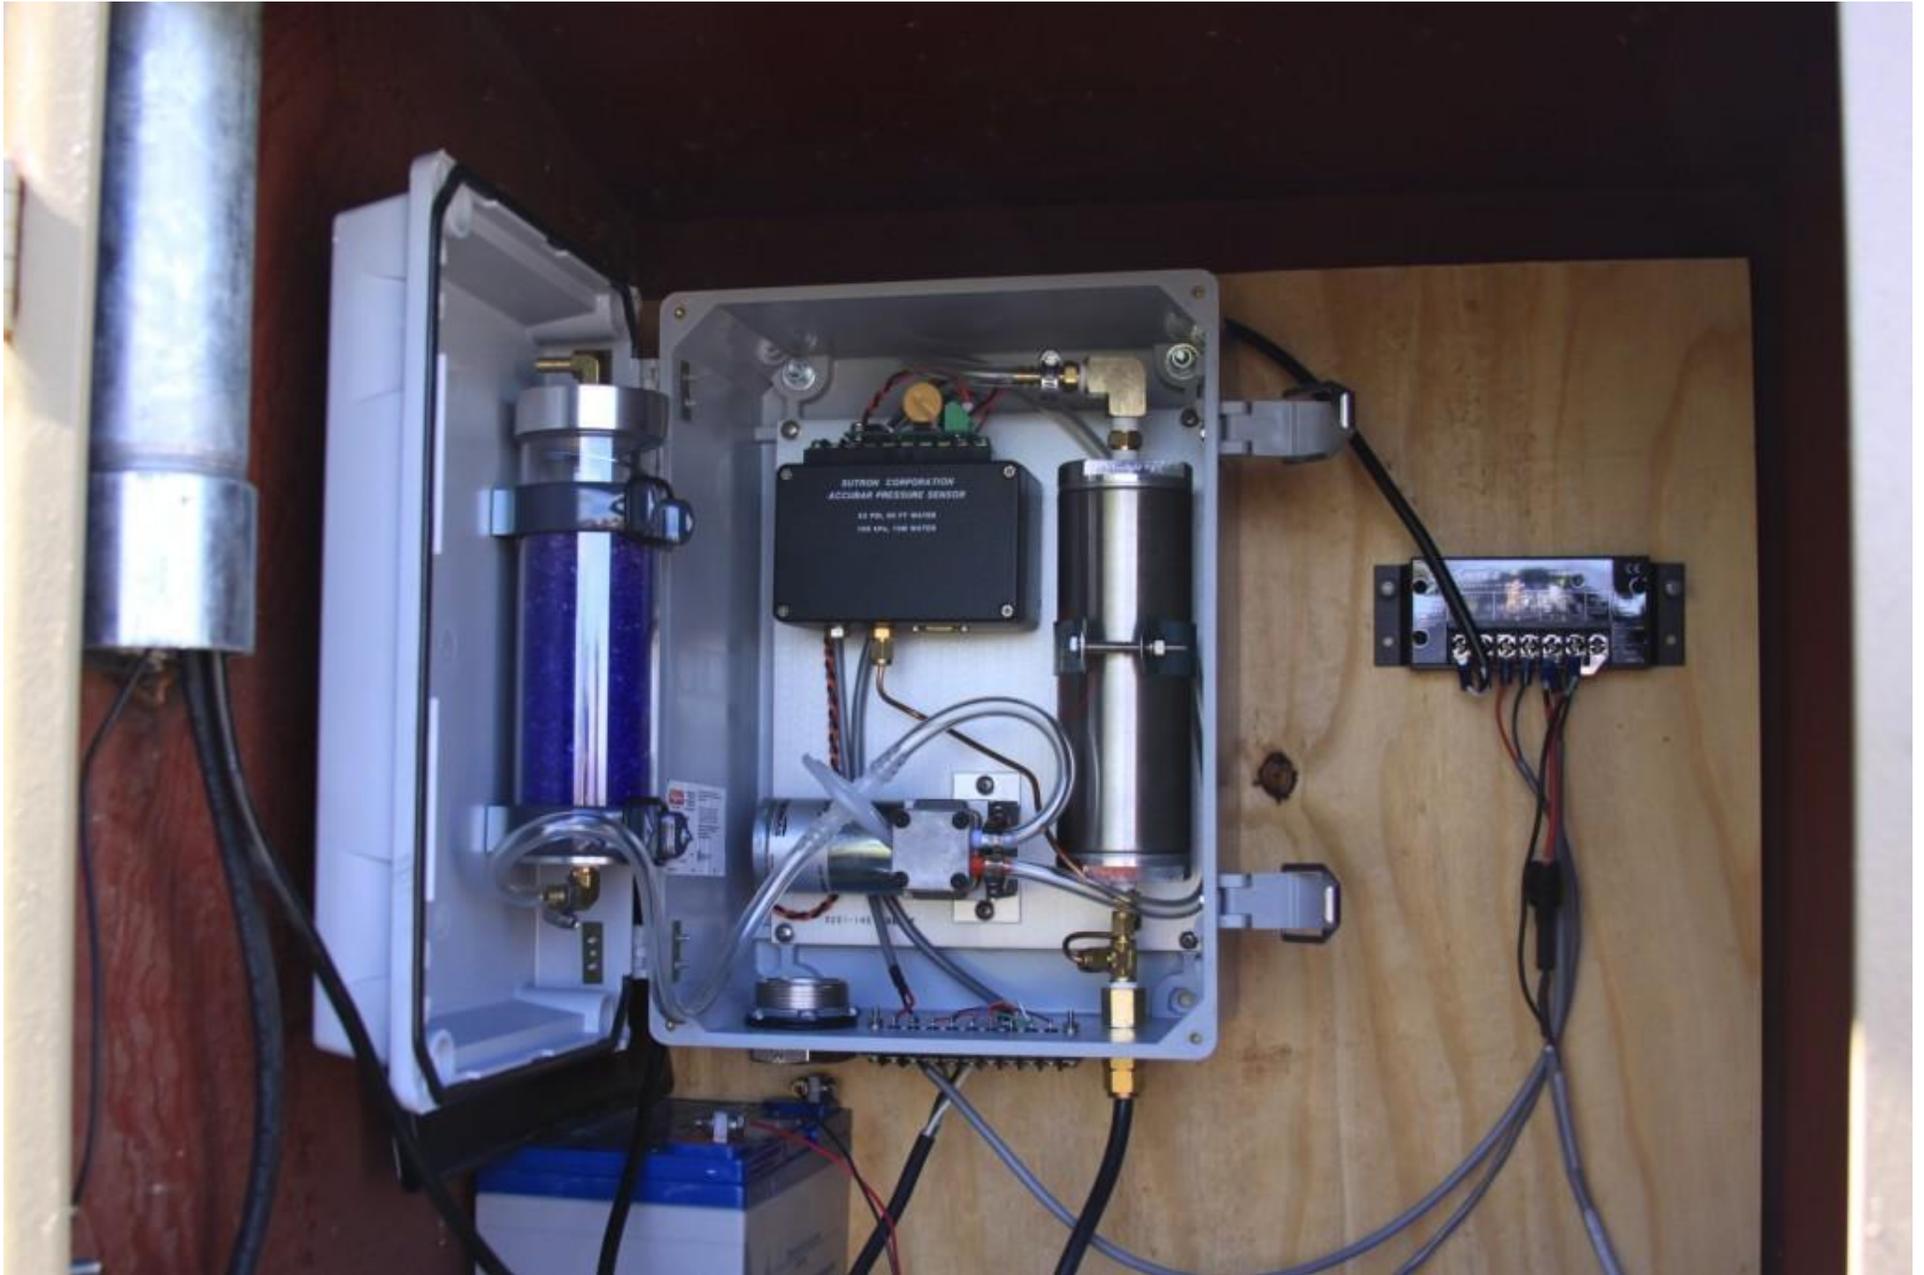
Sutron Accubar bubbler to sense stage in channel via orifice, interfaced w/Sutron Satlink recorder & DCP, 10/15/2010. Photo by NWS Reno Staff.

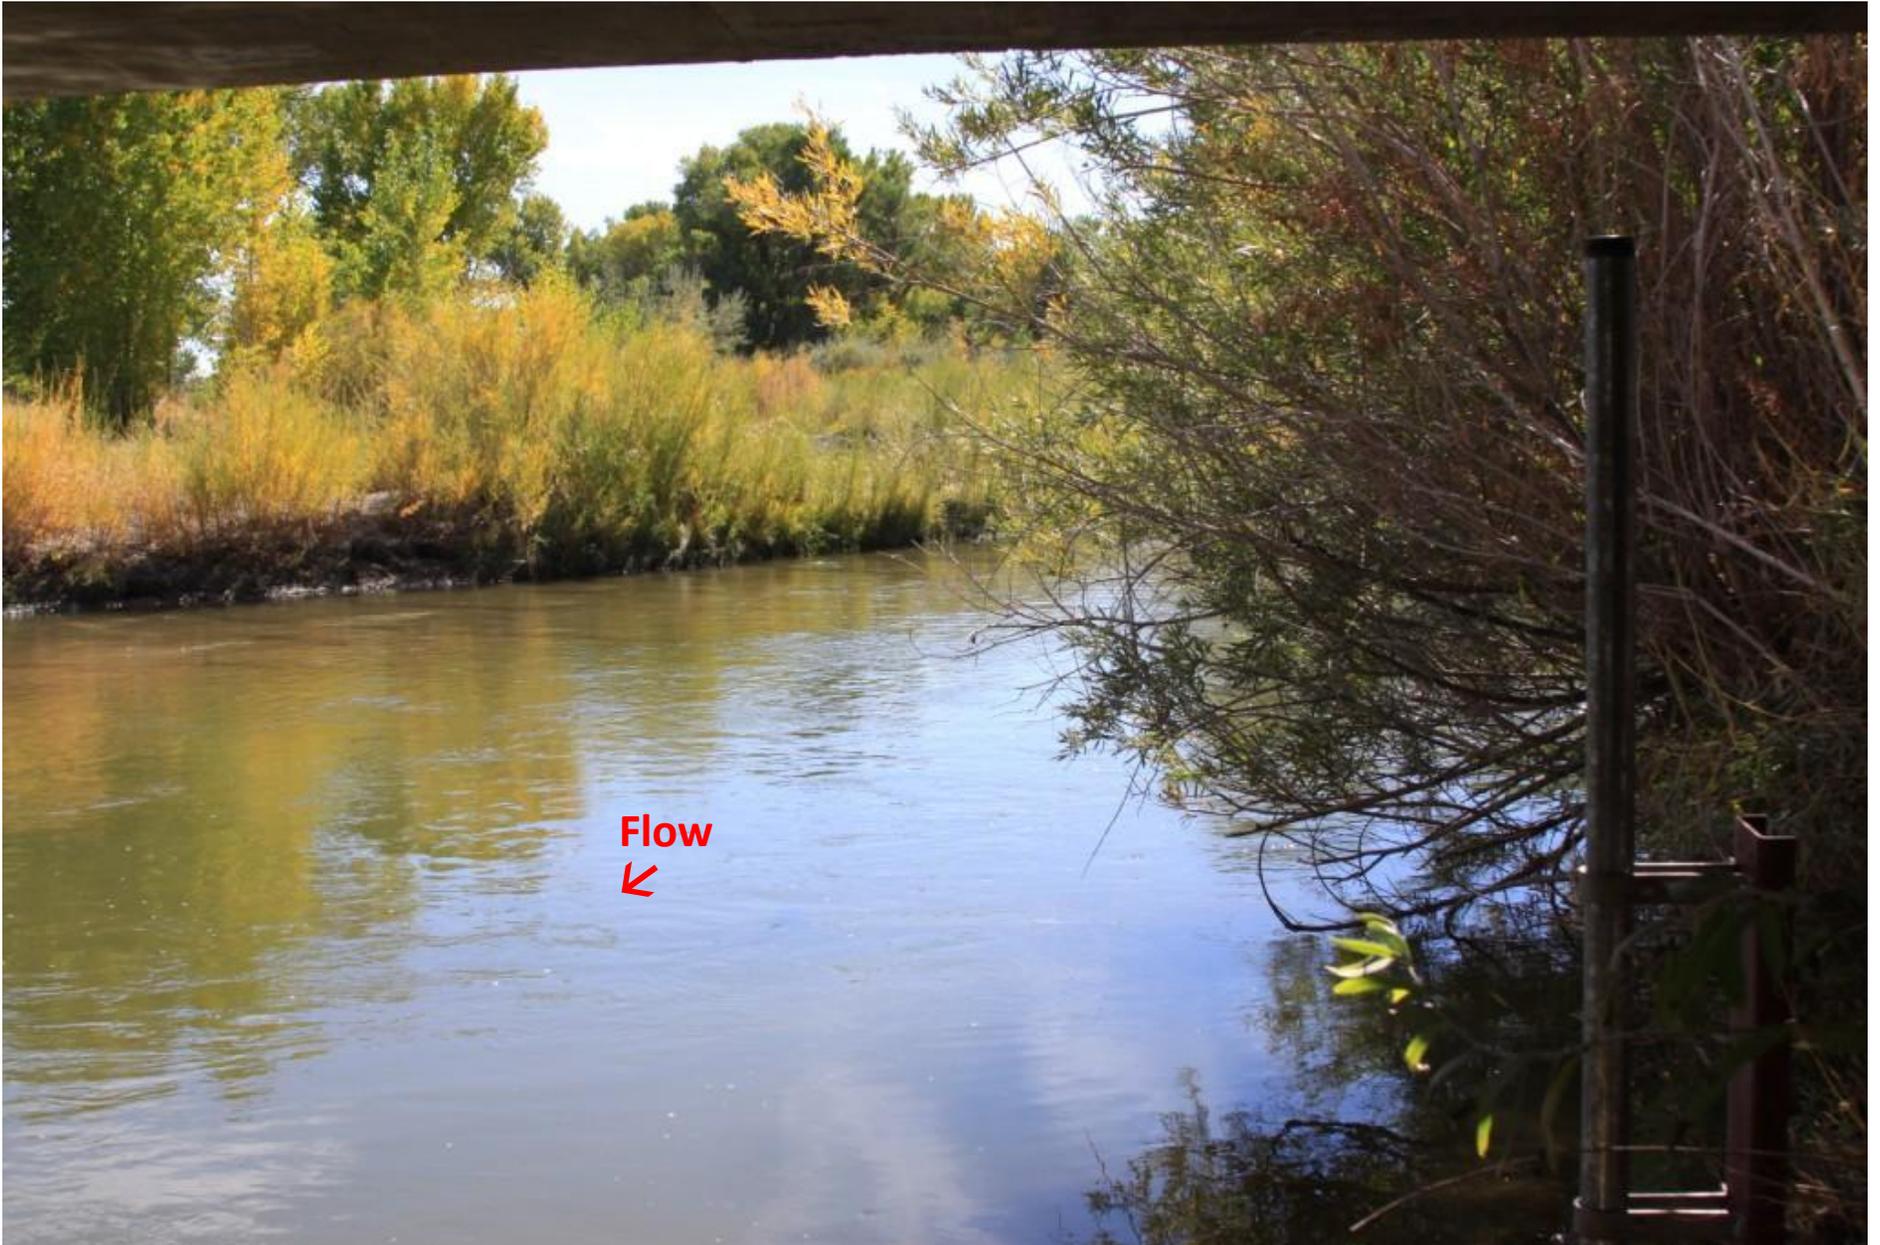
Crest stage gage on left bank, just upstream of Snyder Lane Bridge. View is upstream (SE), Stage 5.80 ft, 141 cfs. 10/15/2010, ~1345 PDT.

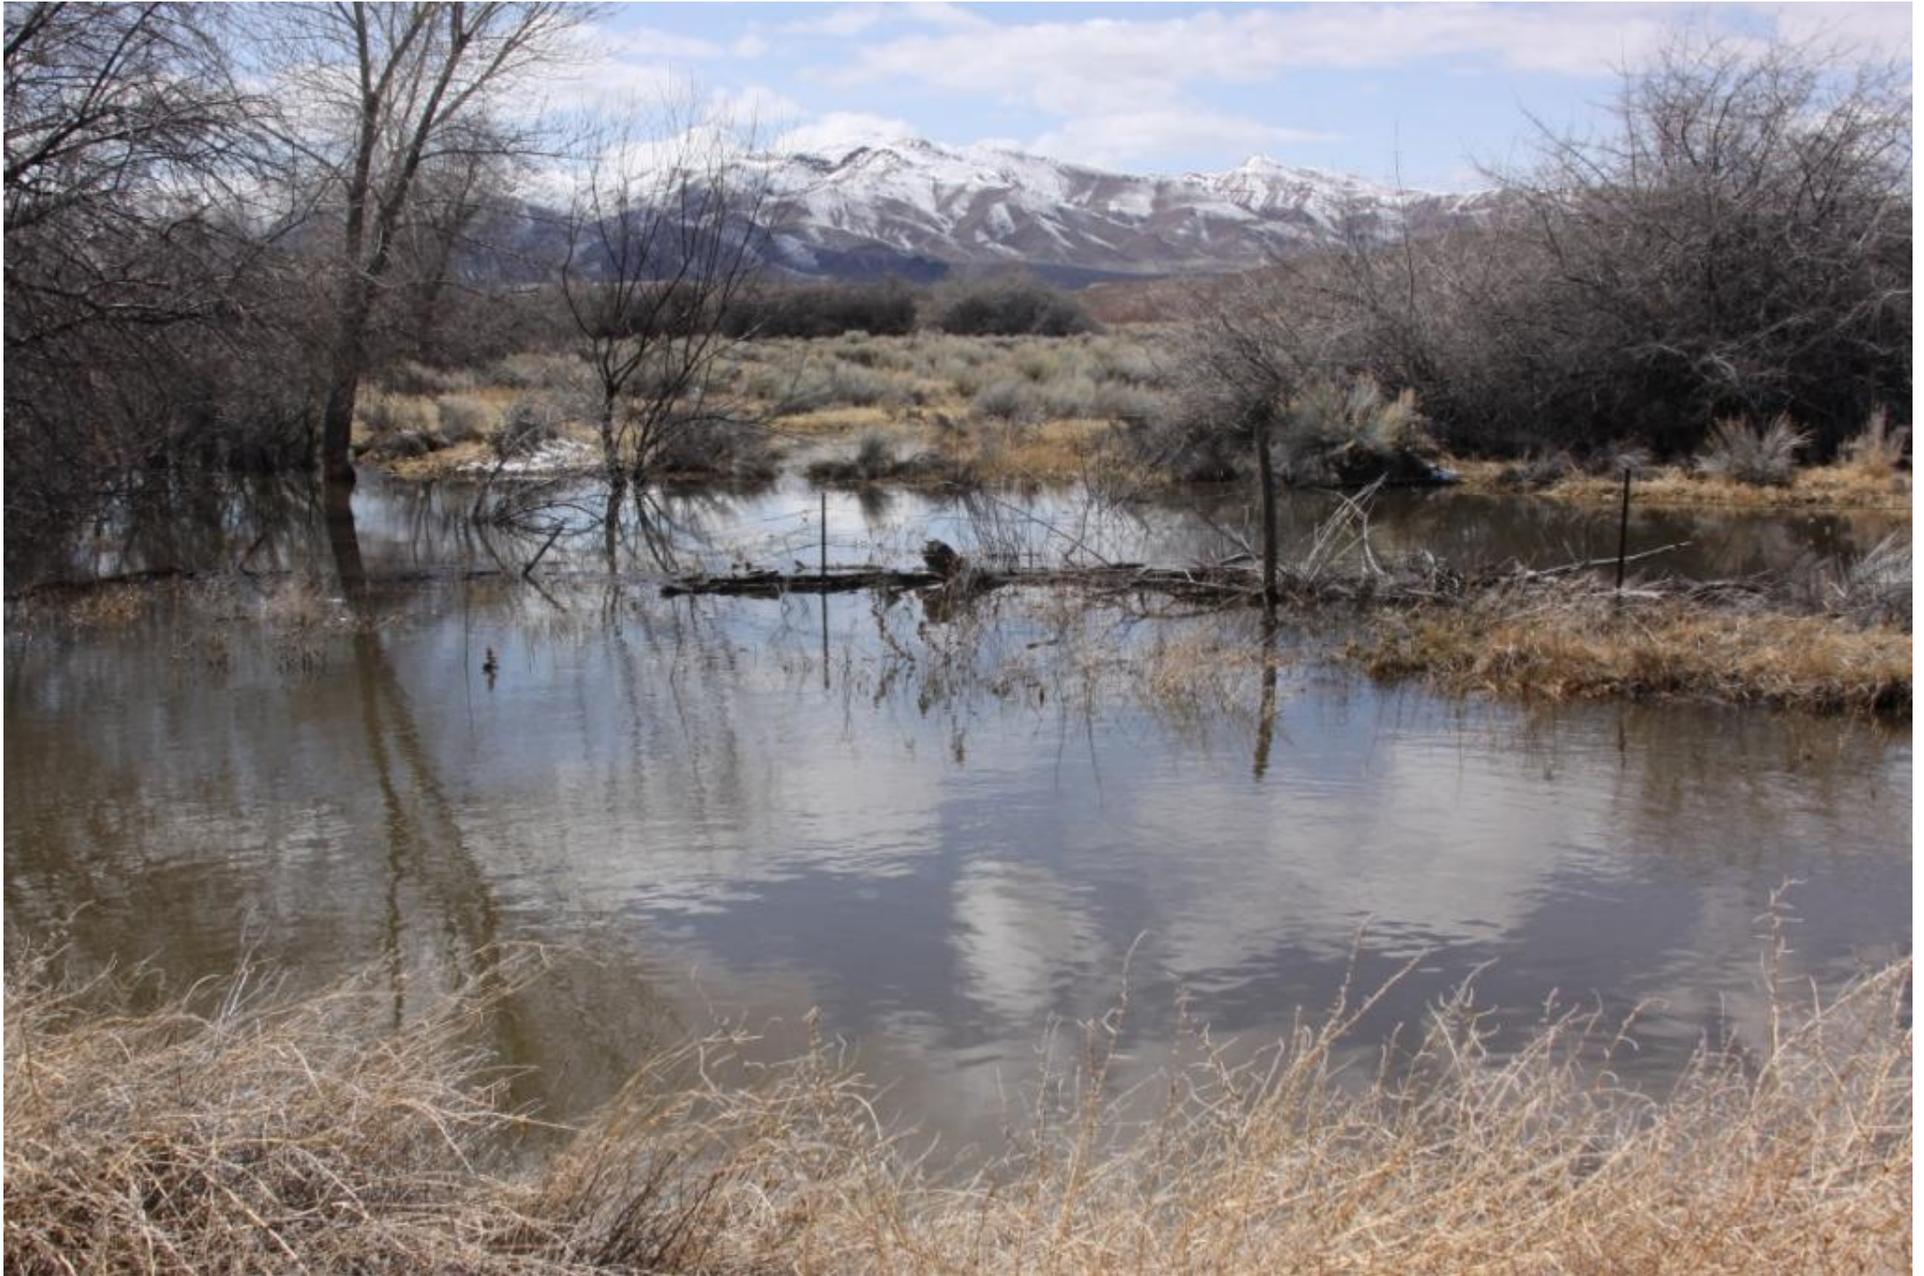
Minor lowland flooding in the vicinity of Walker R nr Mason gage, 3/22/2011, ~1600 PDT. Stage 8.89 feet, 1240 cfs. Photo by NWS Reno Staff.

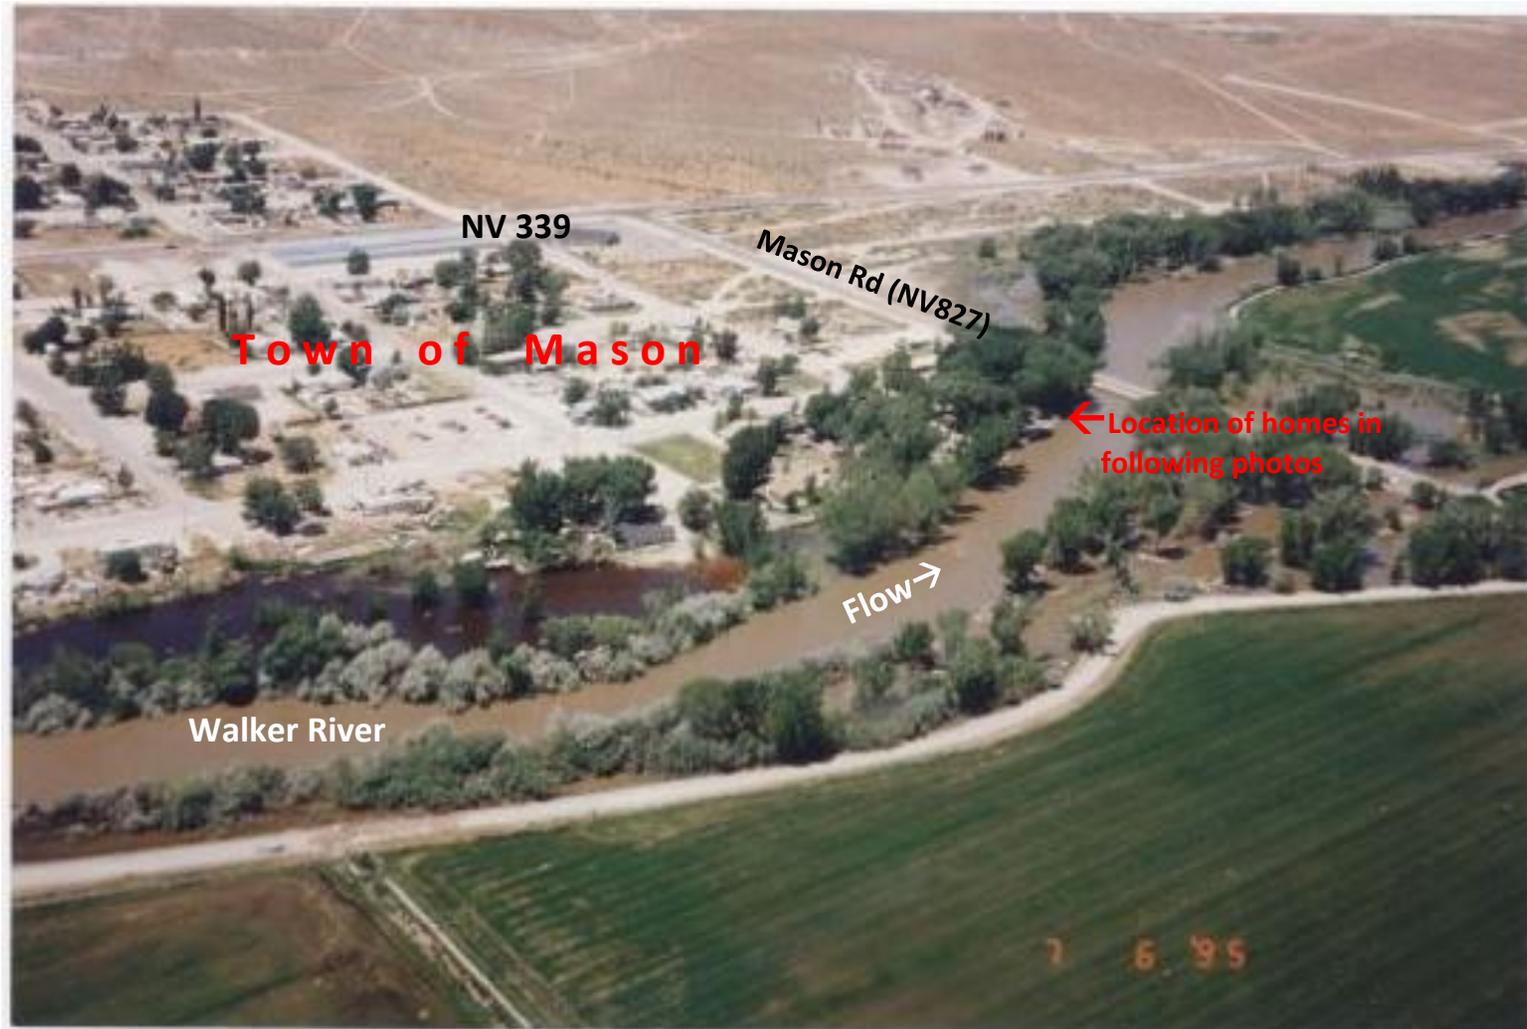
Looking WNW from just E of town of Mason, July 6, 1995. Walker River runs by town of Mason (left to right). Bridge over river (center right) is Mason Road (NV Hwy 827). Flow (estimate) ~2400 cfs, Stage (MASN2 Rtg 2, estimate) ~10.7 feet. Photo by NWS Reno Staff.

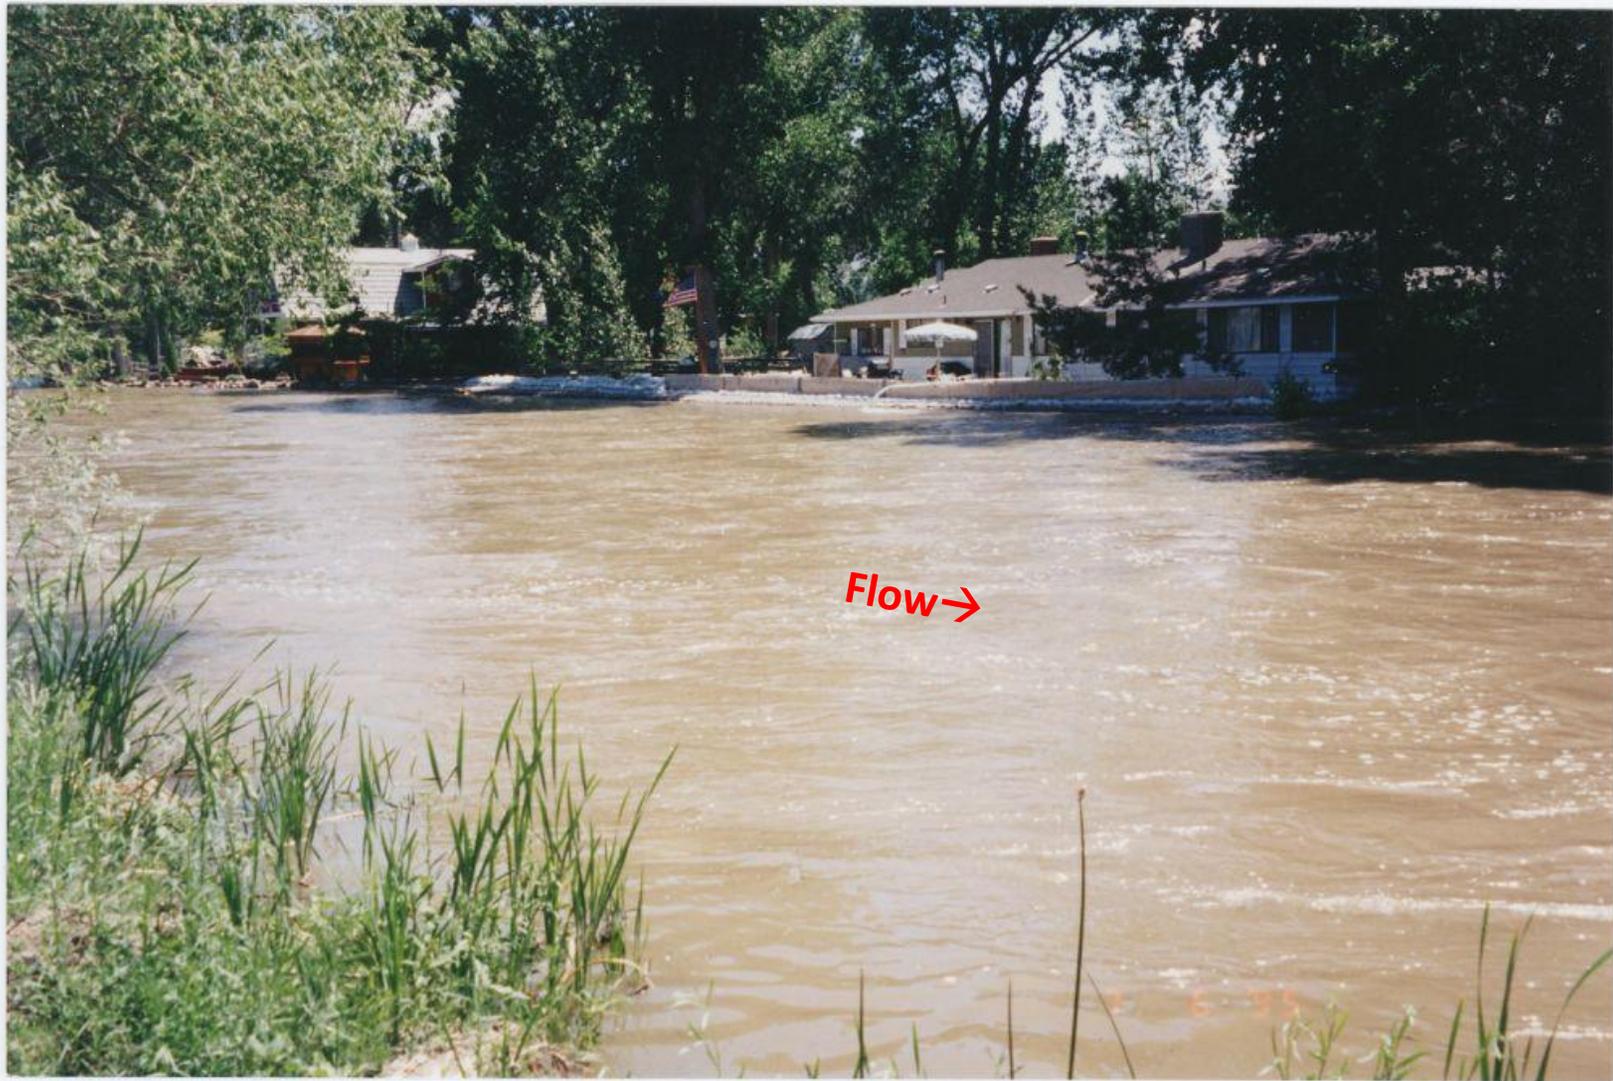
View upstream (S) from E side of Mason Rd. Bridge in Mason, July 6, 1995. Flow (estimate) ~2400 cfs, Stage (MASN2 Rtg 2, estimate) ~10.7 feet. Homes are on left bank of Walker River, on River Ave., between Glasner Ln and Happiness Way. Photo by NWS Reno Staff.

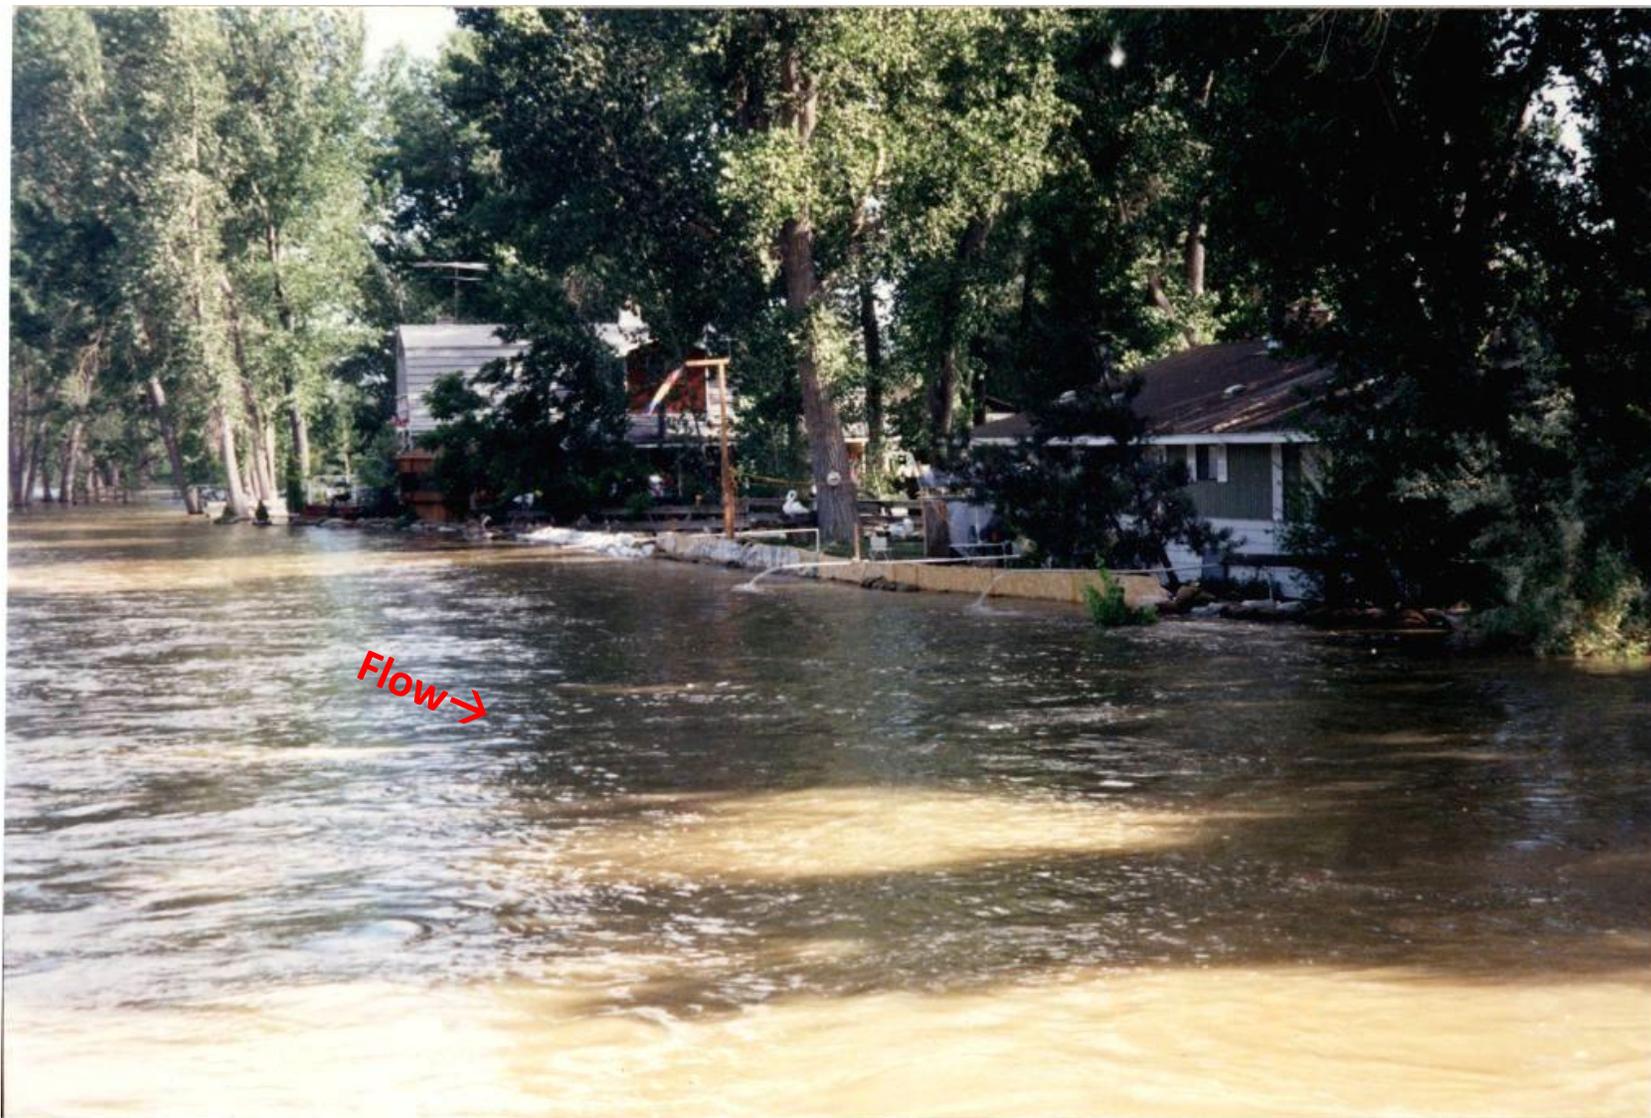
View upstream (S) from E side of Mason Rd. Bridge in Mason, near peak on July 11 or 12, 1995. Flow (estimate) ~2950 cfs, Stage (MASN2 Rtg 2, estimate) ~11.5 feet. Homes are on left bank of Walker River, on River Ave., between Glasner Ln and Happiness Way. Photo by NWS Reno Staff.
