REPORT ON RIVER GAGE STATION

LOCATION: Mason
STREAM: Walker River
BASIN: Walker River

LOCATION IDENTIFICATION: MASN2
NWS INDEX NUMBER:
USGS NUMBER: 10300600

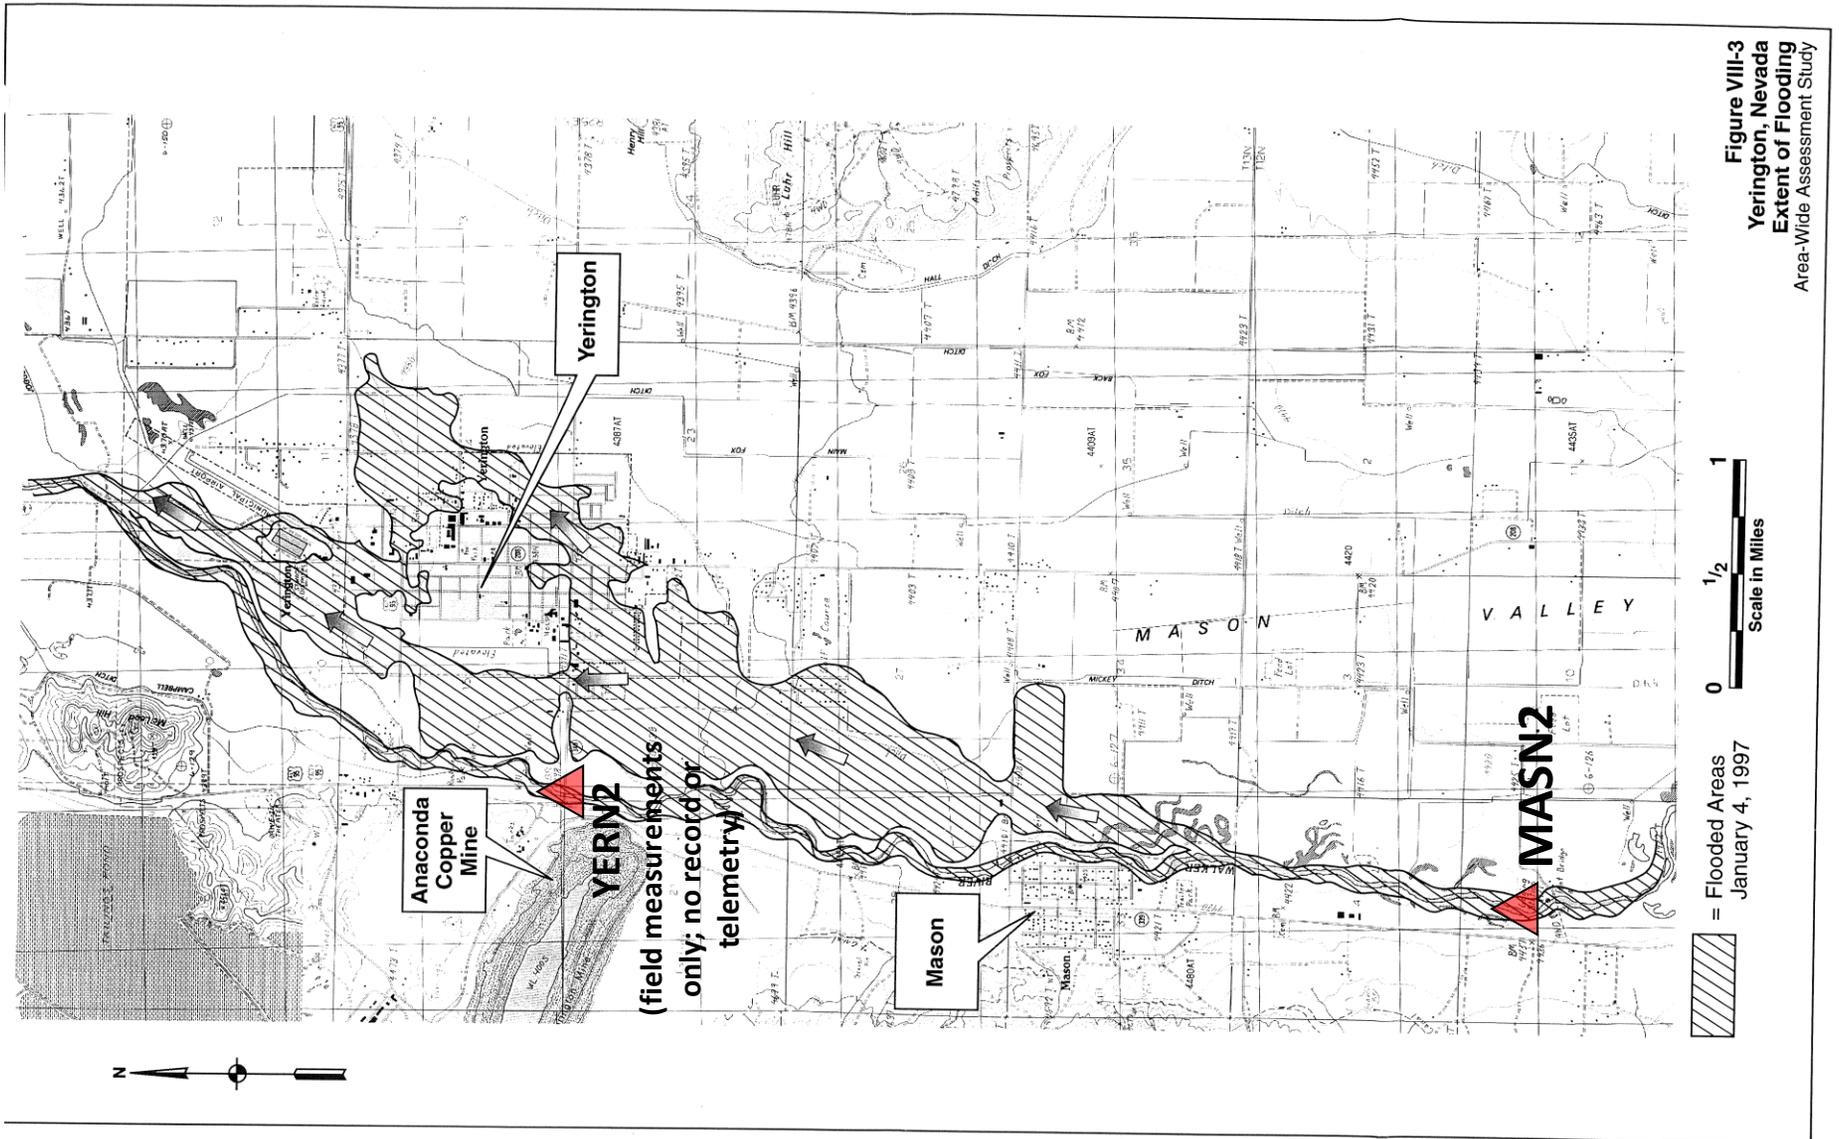
Figure VIII-3
Yerington, Nevada
Extent of Flooding
 Area-Wide Assessment Study

Hatched area denotes extent of flooding in the Mason Valley-Yerington area on January 4th, 1997. MASN2 gage was not in operation at the time, but Walker R nr Yerington gage (YERN2) crested near 3900 cfs on January 4th, 1997 around 1600 PST. (The crest at Yerington was difficult to estimate as the river had left its channel in 2 places, about a mile S of Mason and west of Yerington.) From: USCE 1/97 Flood Assessment, E Sierra/W NV, Lyon Co. & Yerington; Sept. 1997; Fig. VIII-3.

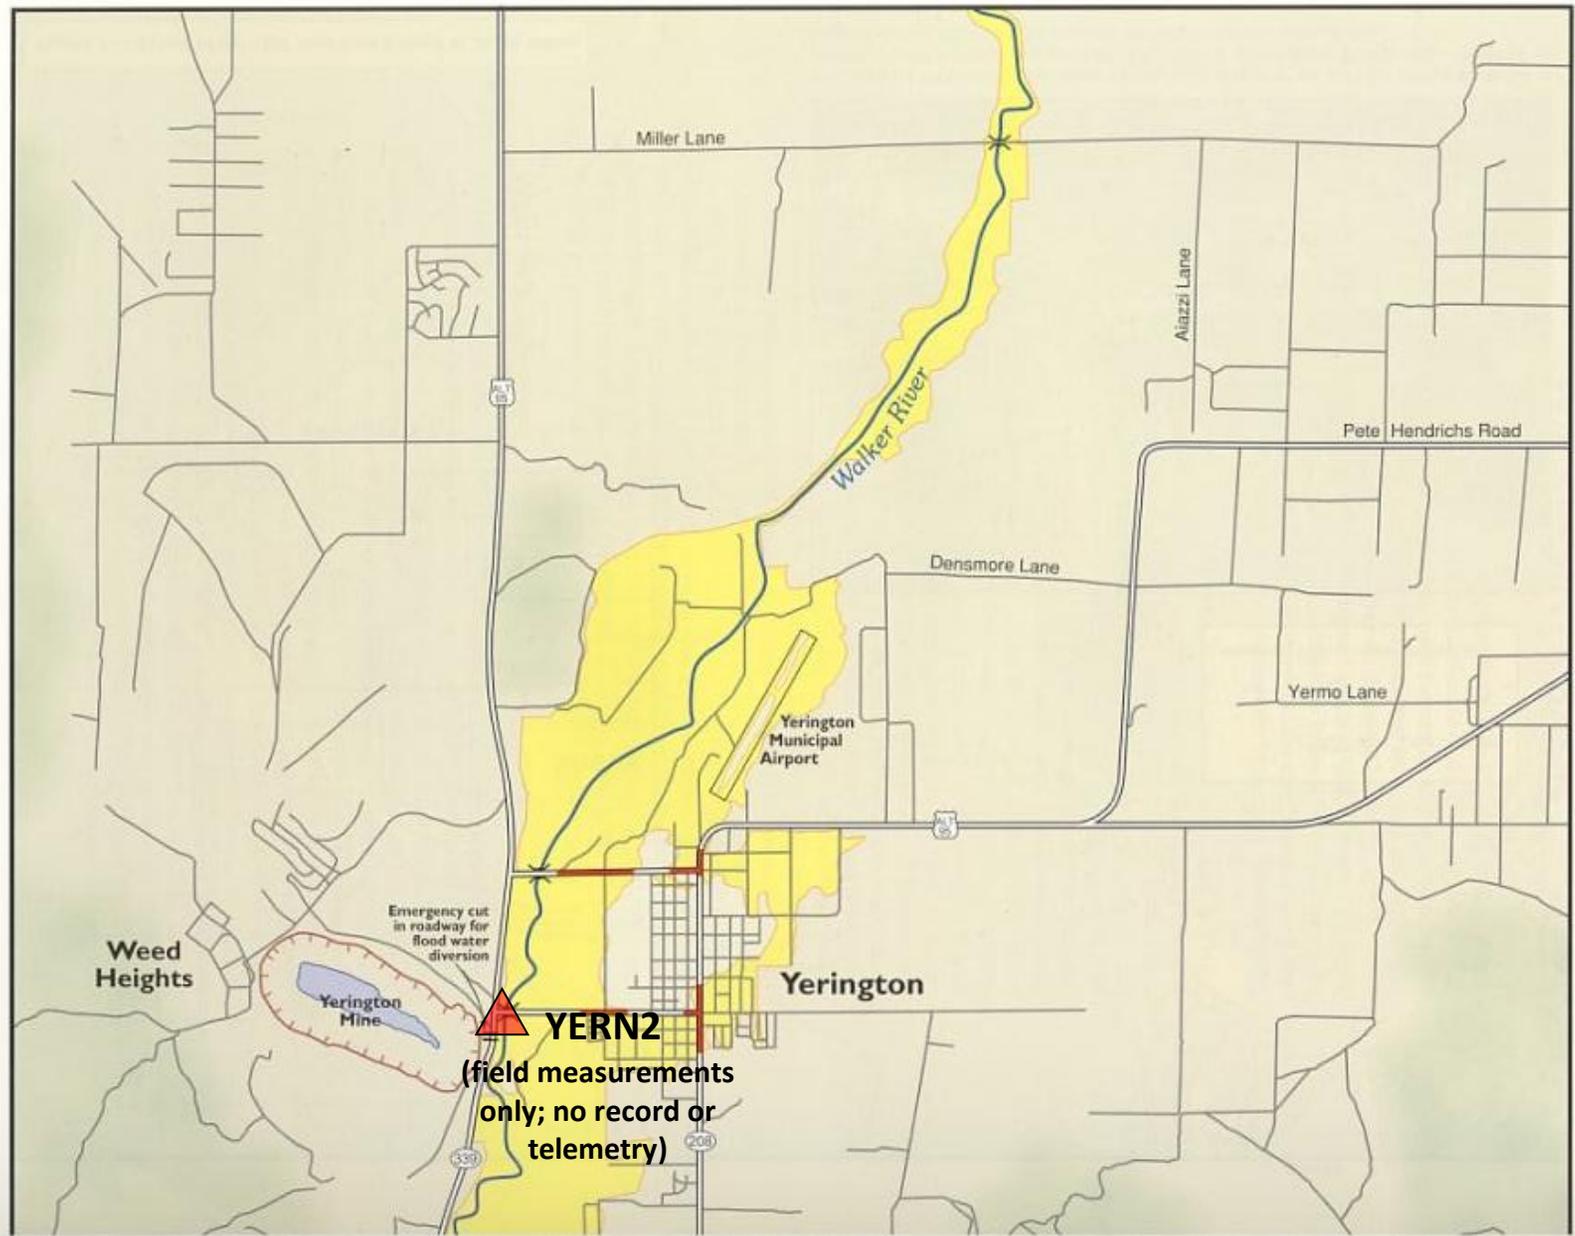
View of the extent of flooding in the Mason Valley-Yerington area on January 4th, 1997, from south of Yerington to Miller Lane; approx. 3900 cfs. From "1997 New Year's Flood in Western NV"; NV Bureau of Mines & Geology; 1998, Figure 8, pg. 58.

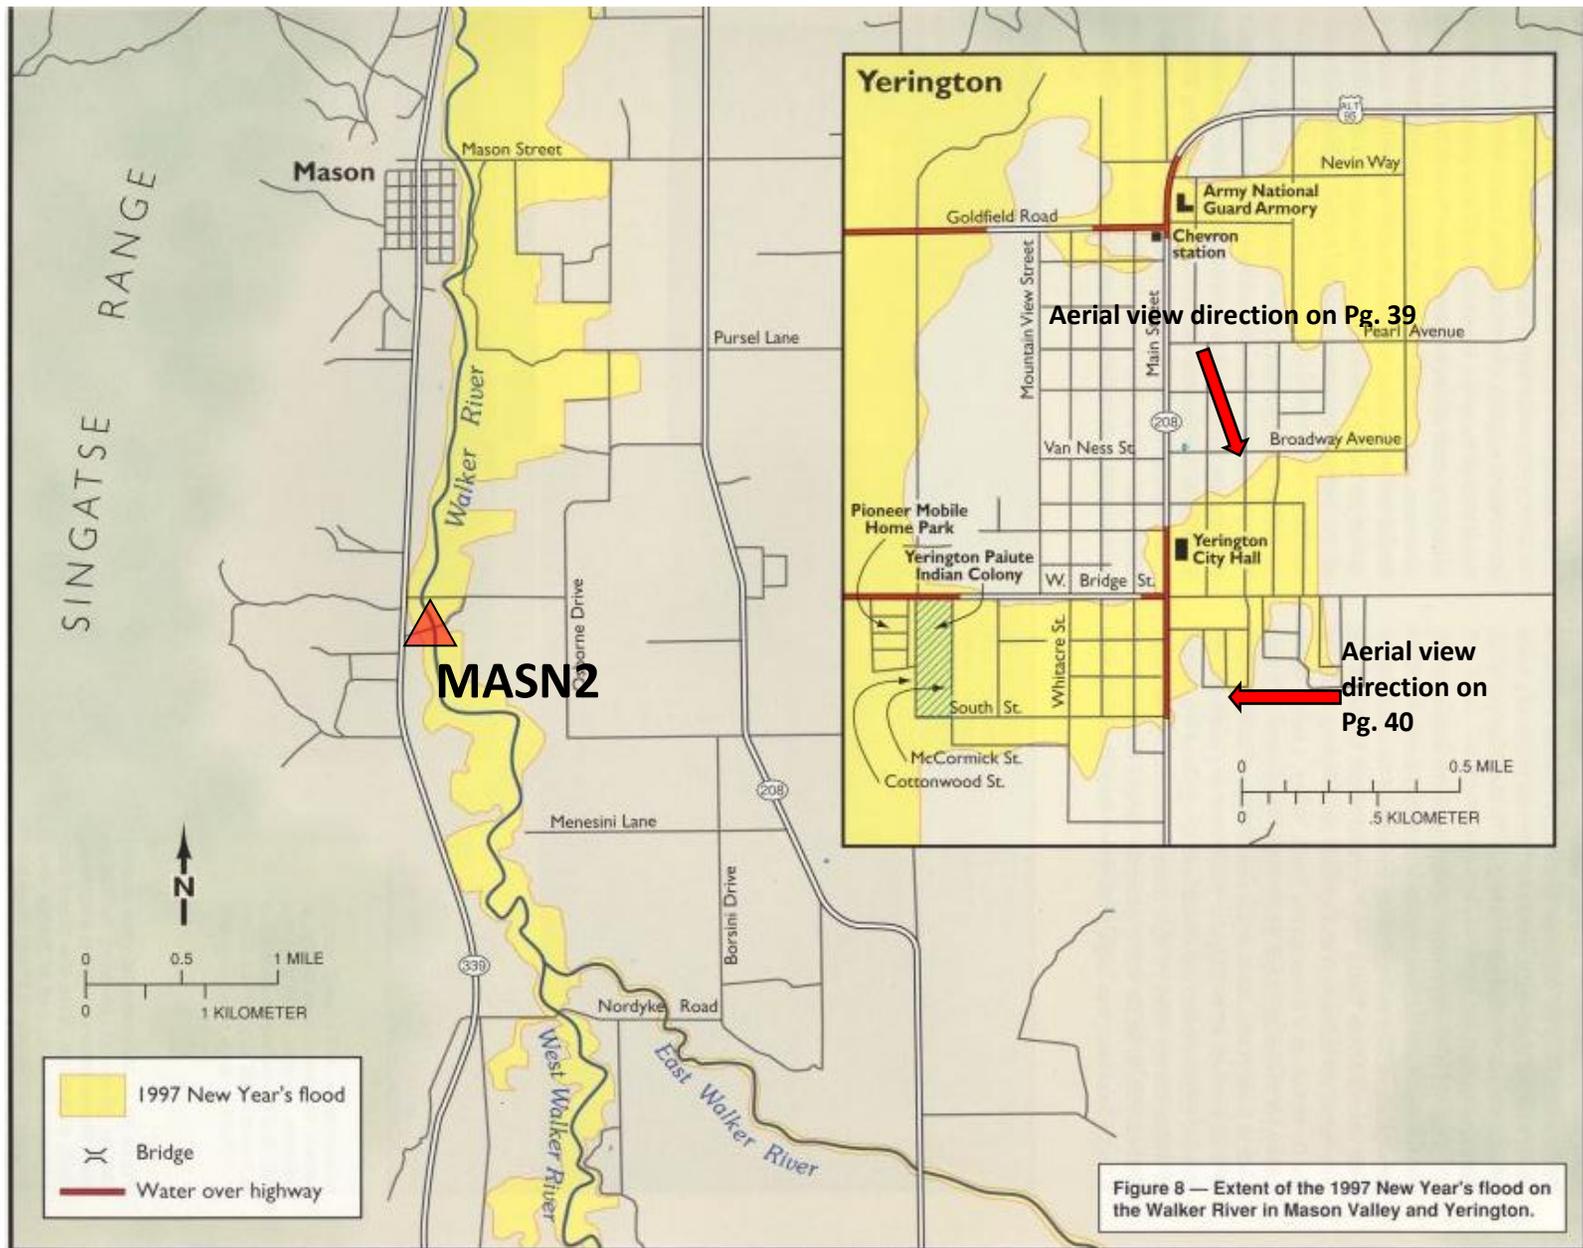
View of the extent of flooding in the Mason Valley-Yerington area on January 4th, 1997, from Mason south to below confluence of East and West Walker Rivers; including inset of City of Yerington; aerial view directions on pages 39 & 40 are shown.

Approx. 3900 cfs. From "1997 New Year's Flood in Western NV"; NV Bureau of Mines & Geology; 1998, Figure 8, pg. 59.

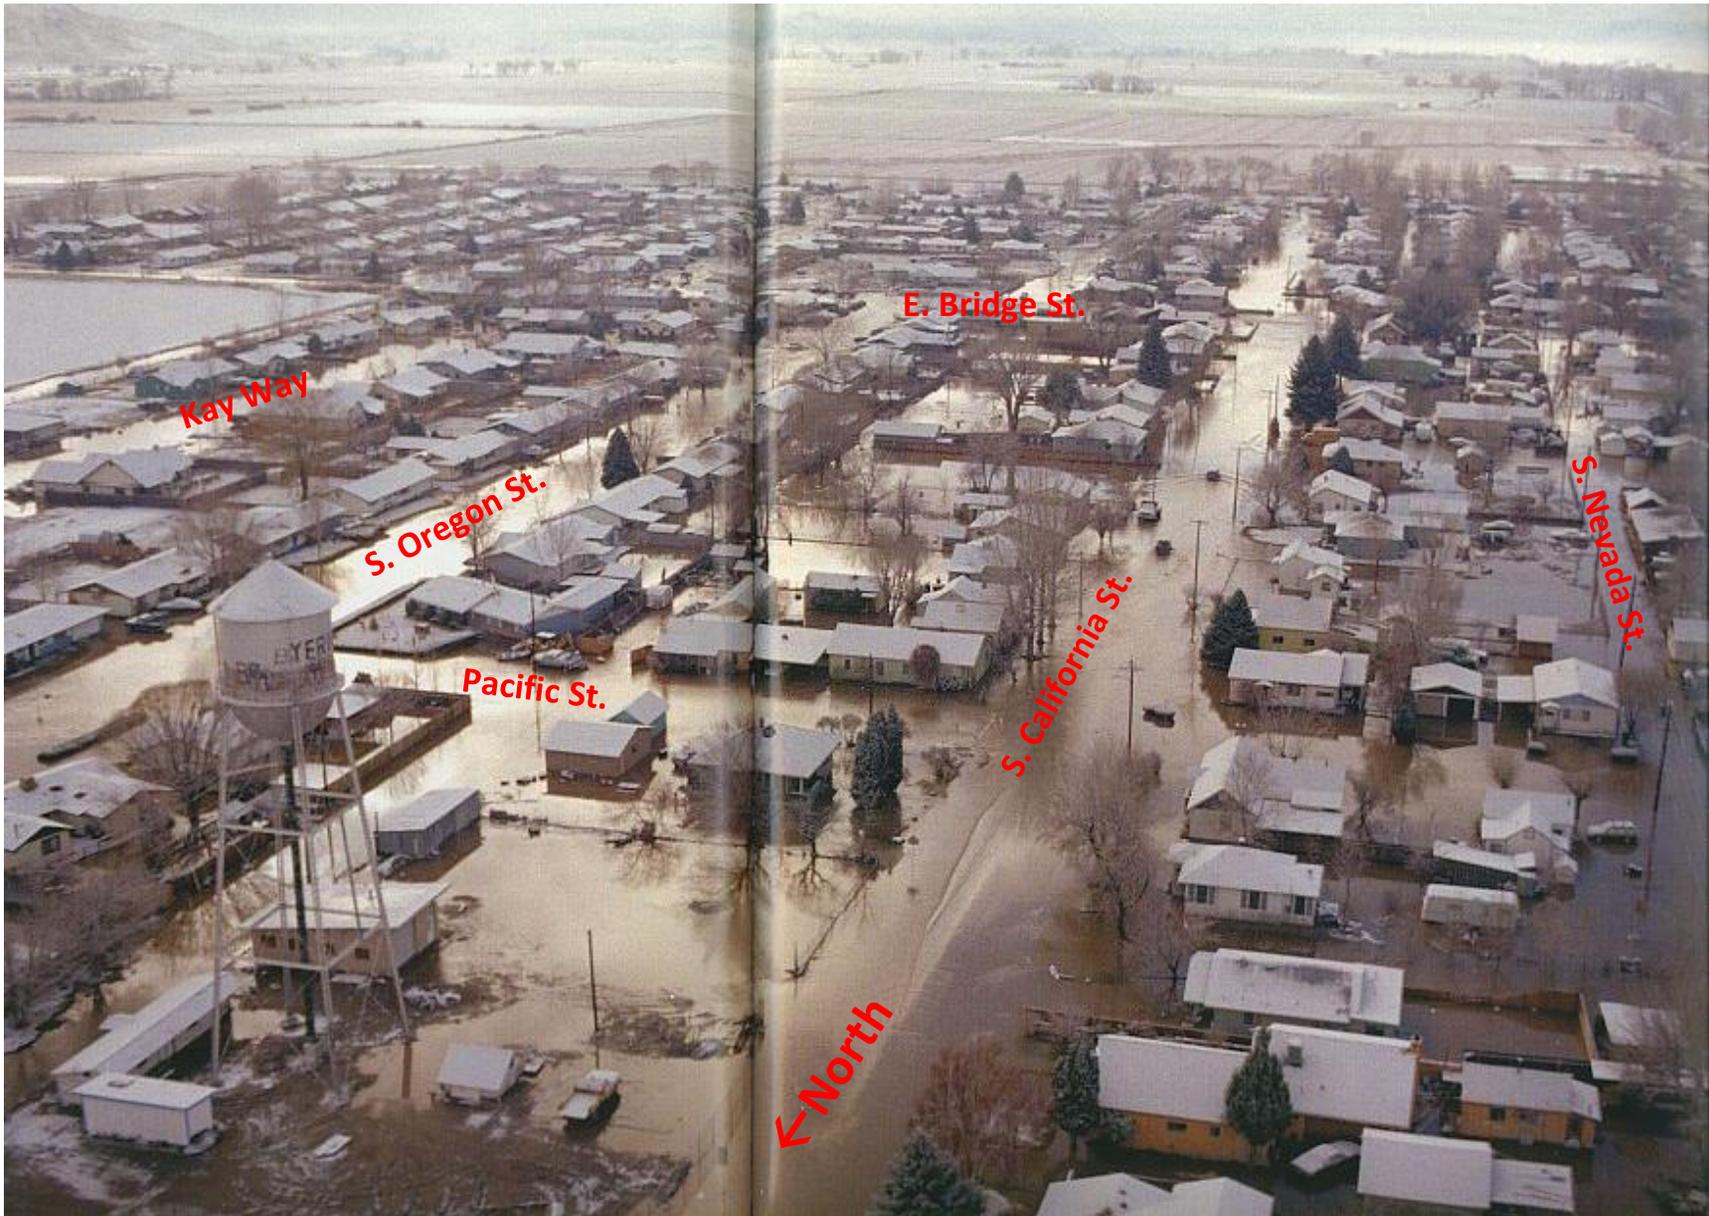
Yerington, January 5, 1997 after flood crest. View is to SSE, from over Broadway Ave.; California St. is to right of water tower; Oregon St. is to its' left. Parts of Yerington were under up to 3 feet of water at the crest the previous day, with nearly 500 homes and businesses flooded and half were extensively damaged (est. 1/4/1997 crest: ~3900 cfs, 12.7 ft w/USGS Rtg 2 for MASN2). Damage to farmland in Mason Valley totaled over \$37 million; repairs to Walker R irrigation structures in Mason Valley were about \$6.4 million; 1997 dollars. Total Damages from January 1997 flooding in Lyon County (from both the Carson and Walker Rivers) totaled about \$49 million, 1997 dollars. Photo from "The Great Flood of '97"; Reno Gazette-Journal, Pgs 70-71 by Mark W. Studyvin.

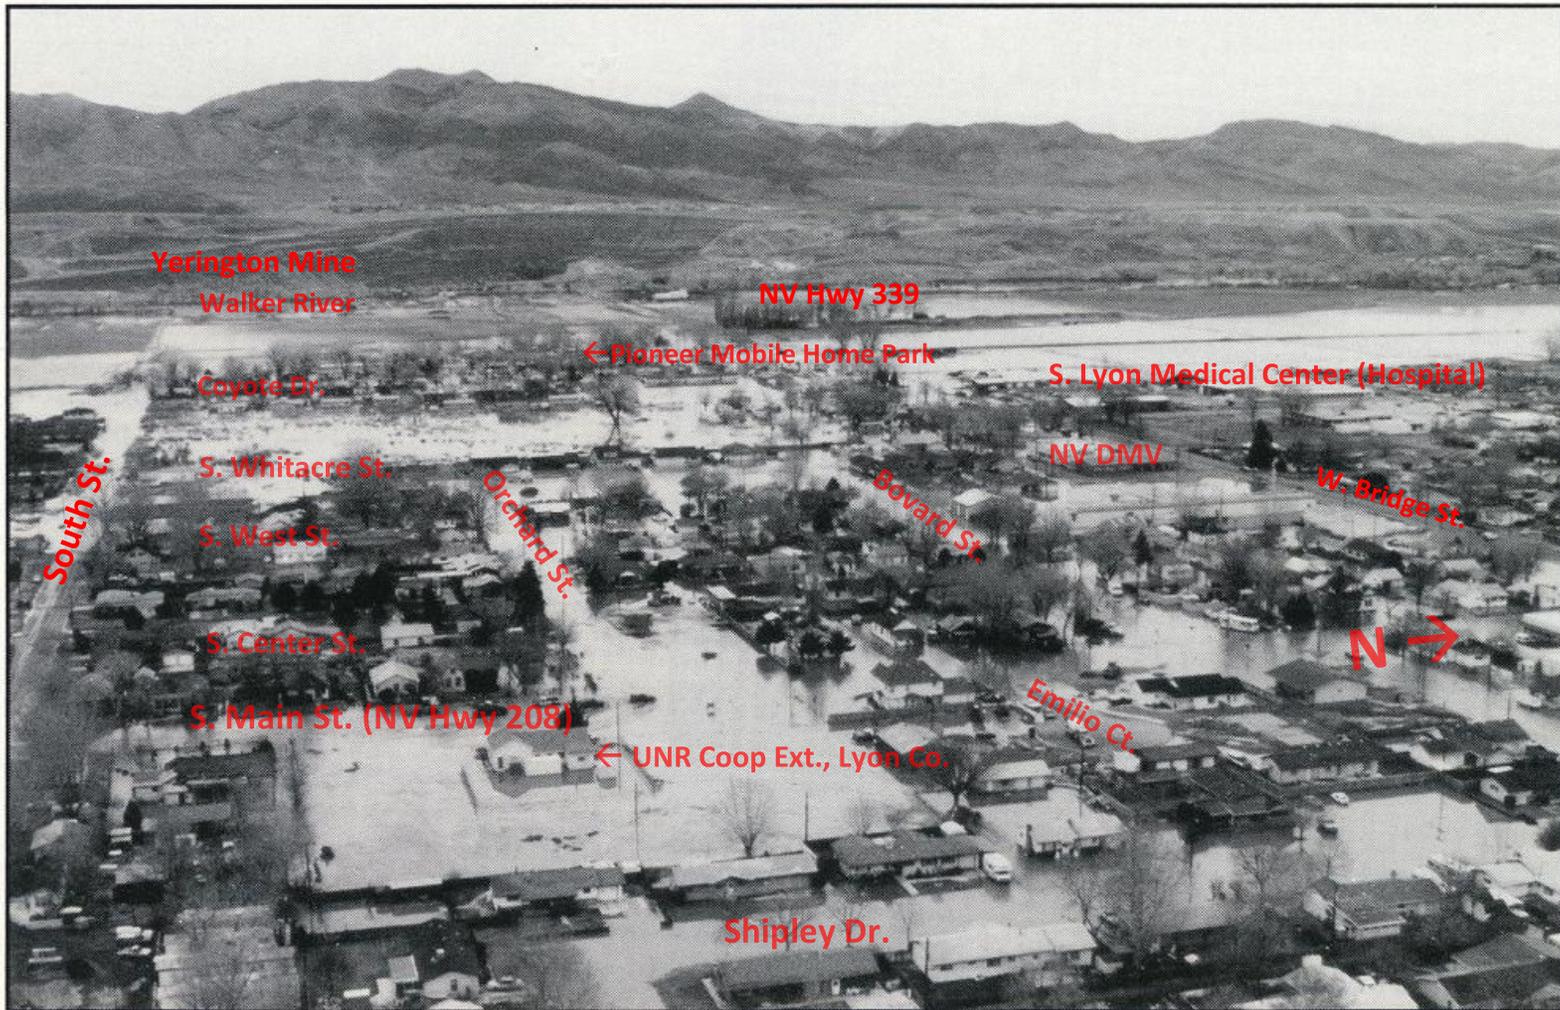
Aerial view looking west towards Anaconda Open Pit Mine showing extent of flooding in southern portion of Yerington, near crest on January 4, 1997 (est. crest: ~3900 cfs, 12.7 feet w/USGS Rtg 2 for MASN2). View is from South St. on L to Bridge St. on R. Shipley Dr. is in foreground. Photo by NV Department of Transportation. From: "1997 New Year's Flood in Western NV"; NV Bureau of Mines & Geology; 1998, page 62.

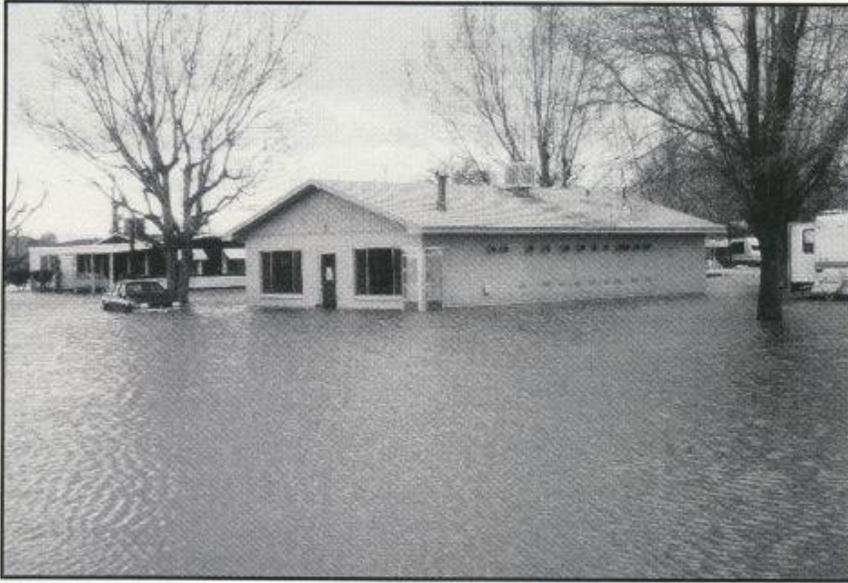
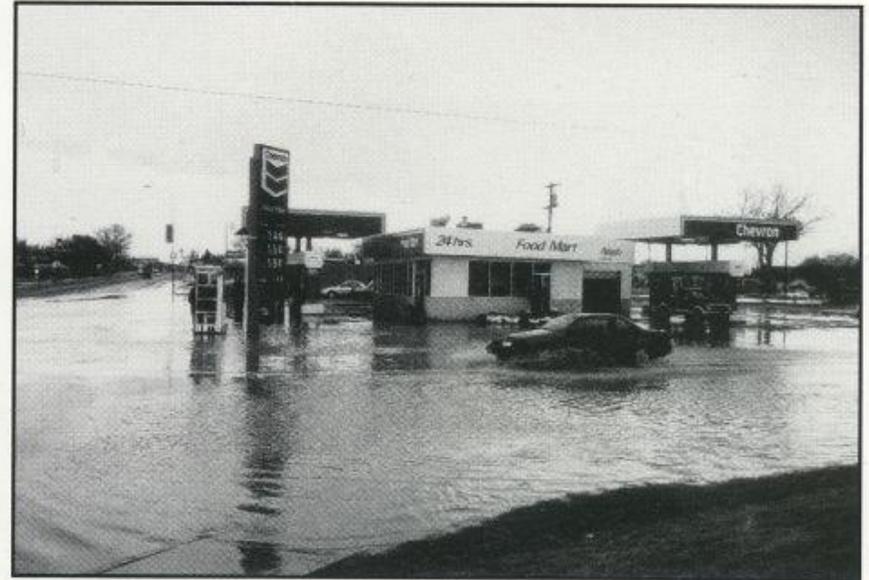
Left: South view of flooded laundromat building and trailers of Pioneer Mobile Home Park in Yerington on West Bridge Street. Floodwaters here reached depths of up to 31 inches as indicated by high water marks left by floodwater. Photo taken 3:00 pm, 1/5/1997. Right: South view along Main Street of flooded gas station at intersection of Goldfield Road and Main Street in Yerington. Photo taken 2:30 pm, 1/5/1997. From: "1997 New Year's Flood in Western NV"; NV Bureau of Mines & Geology; 1998, page 63.
