## Storm Damage Survey results for event at West Yellowstone, August 28, 2010

### Overview

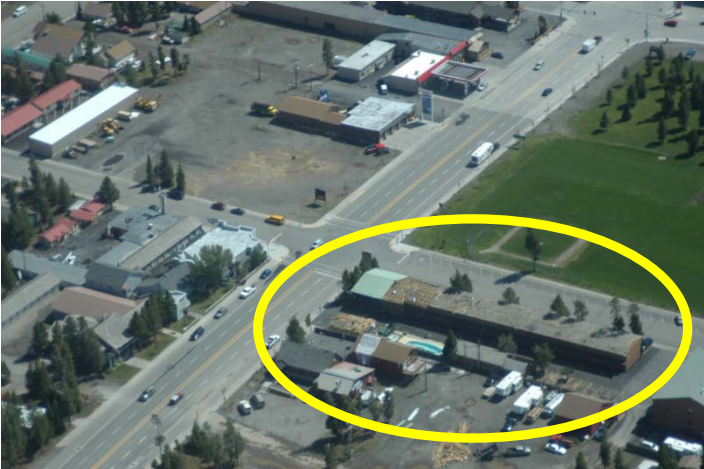
Top left: Roof damage to hotel, most of roof blown off behind the building, extensive clean-up had occurred

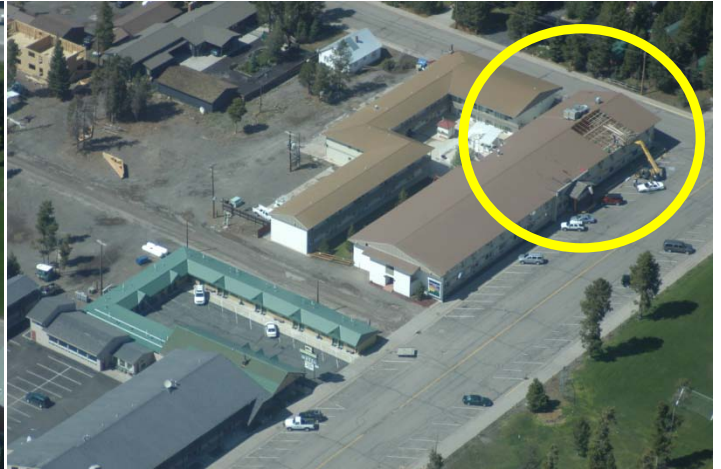
Top right: Roof damage to hotel

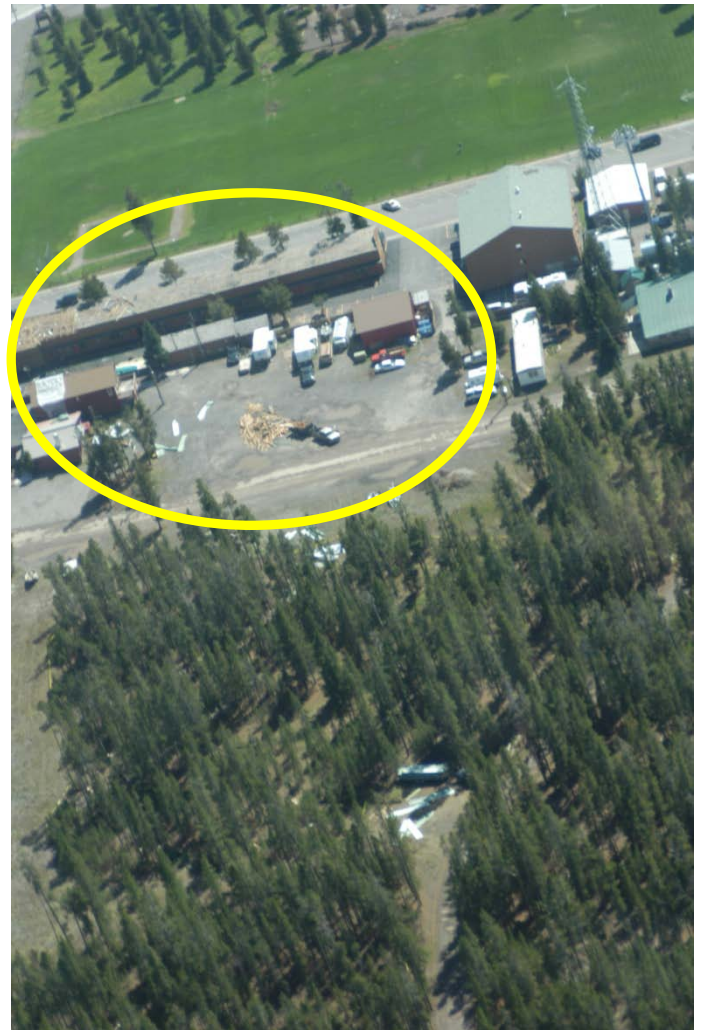
Bottom left: Roof of hotels damaged, few trees down in park

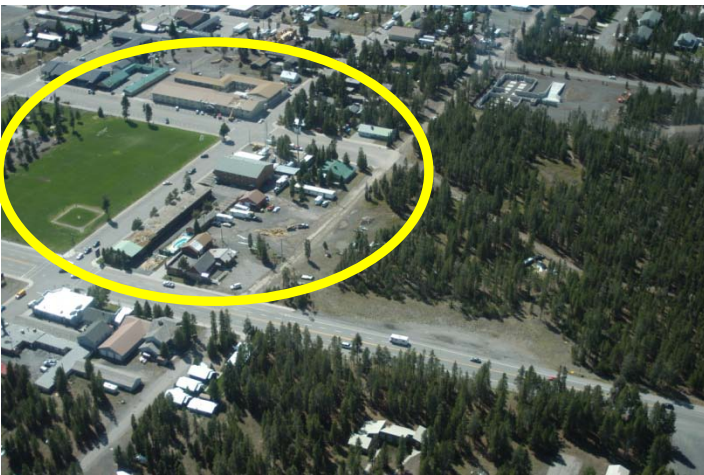
Bottom right: Roof damage with debris blown behind the hotel, debris piled in open lot during clean up of site
