January 6, 2016 EF-0 Hollister Tornado

At 8:50 AM PST on the morning of January 6, 2016, a weak tornado touched down in a field between Highway 156 and Orchard Road approximately 7 miles north of Hollister, CA in San Benito County. Results from a damage survey conducted by the National Weather Service later that day showed the damage to be consistent with a tornado of EF-0 intensity (maximum wind speeds of 75 MPH). The tornado lasted just a minute or two and caused spotty damage along a ¾-mile length path 10-20 yards in width that crossed Orchard Road as it moved to the north-northeast. Two large barns/sheds were moderately-to-significantly damaged along with a fence and some trees.

Rating	EF-0 (estimated 75 MPH)
Begin	8:50 AM PST 36.9373°, -121.3821°
End	8:51 AM PST 36.9402°, -121.3705°
Path Length	0.75 miles (intermittent)
Path Width	10 to 20 yards

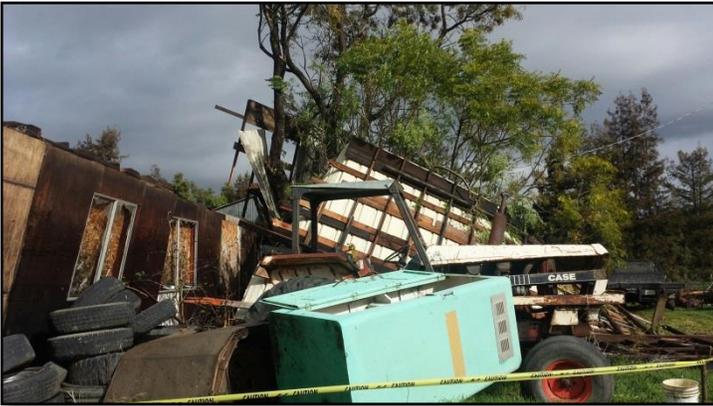
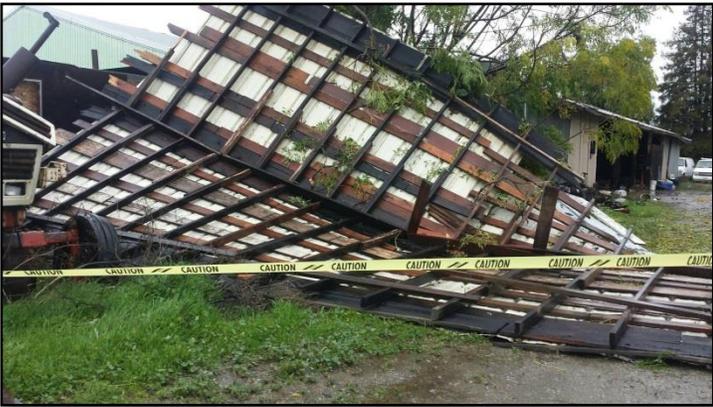
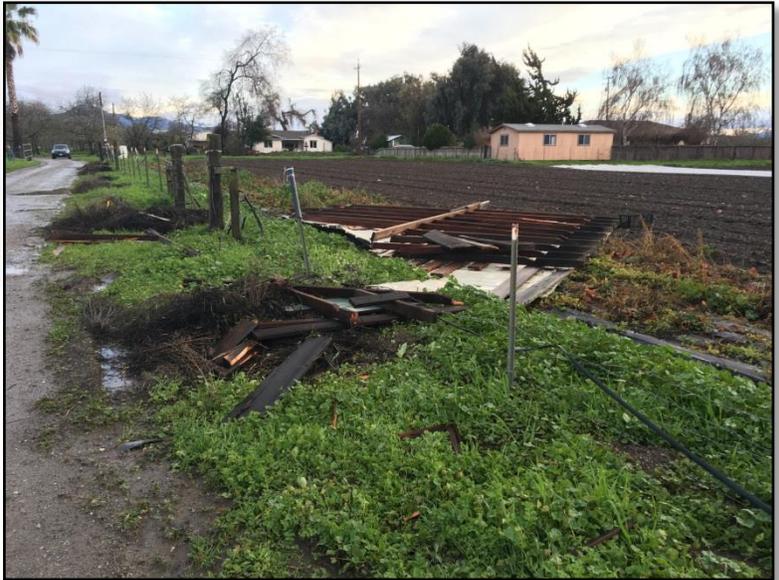
1. **Damage to shed:** A large shed sustained significant damage with its roof blown off into a nearby tree. Additional roofing material was blown approximately 150 feet to the right of the shed with small tree limbs also scattered around the property.

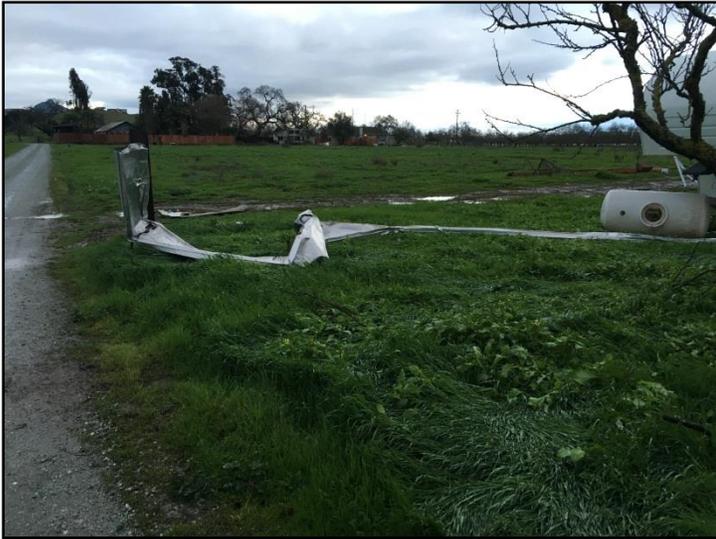
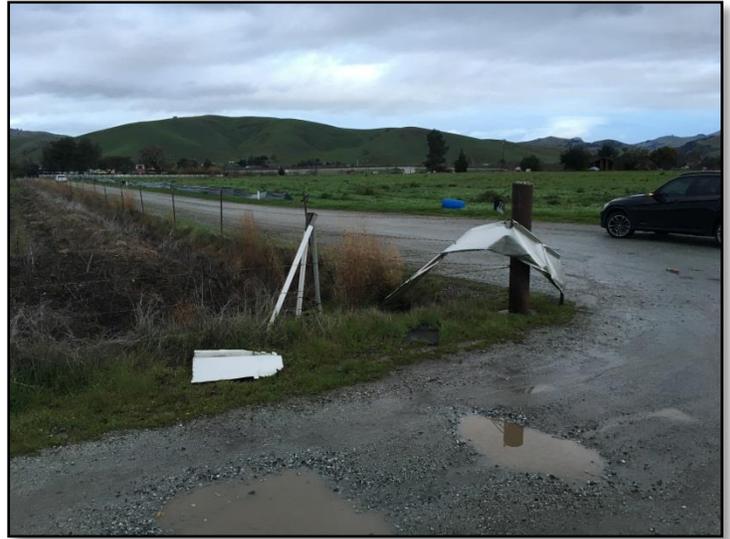
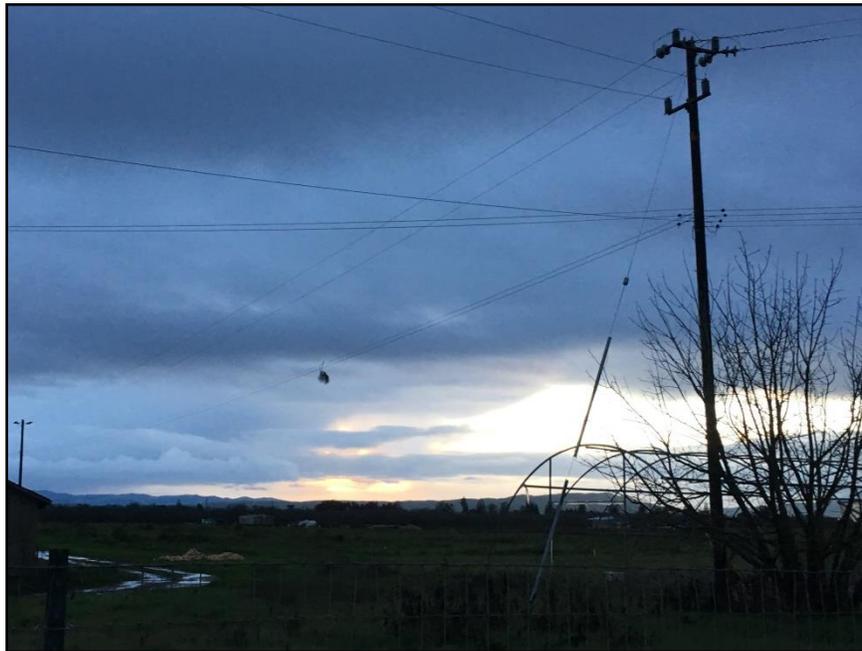
- 2. Large sheet metal debris:** Several large pieces of sheet metal were scattered near the intersection of two private roads along the tornado's path, one wrapped around a steel fence post. Tree limbs were also observed hanging on power lines in an empty field.

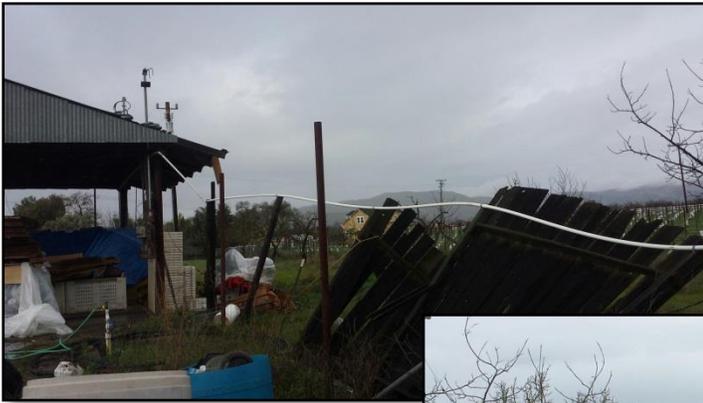
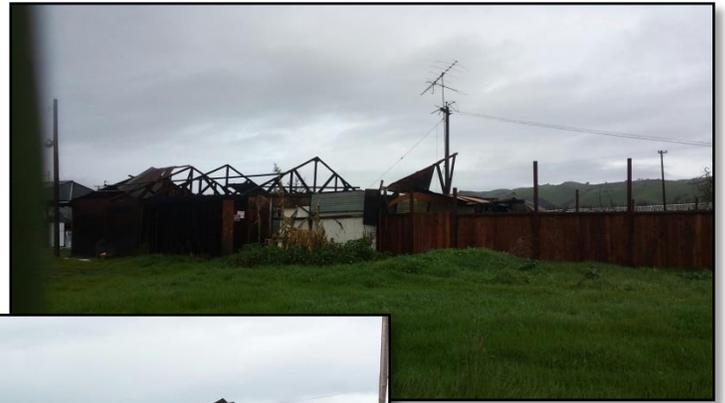
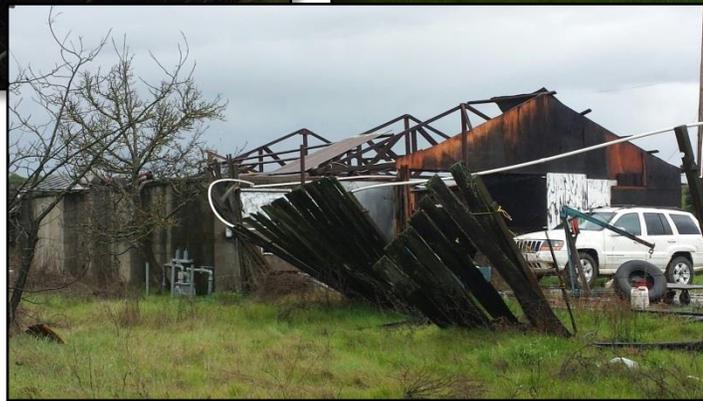
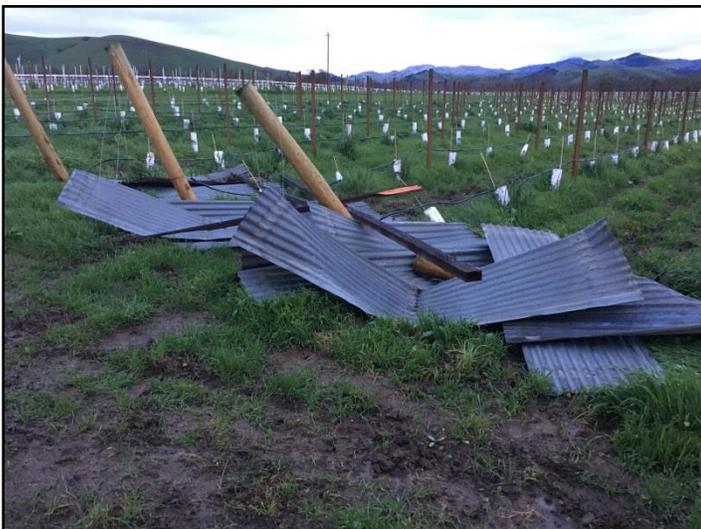
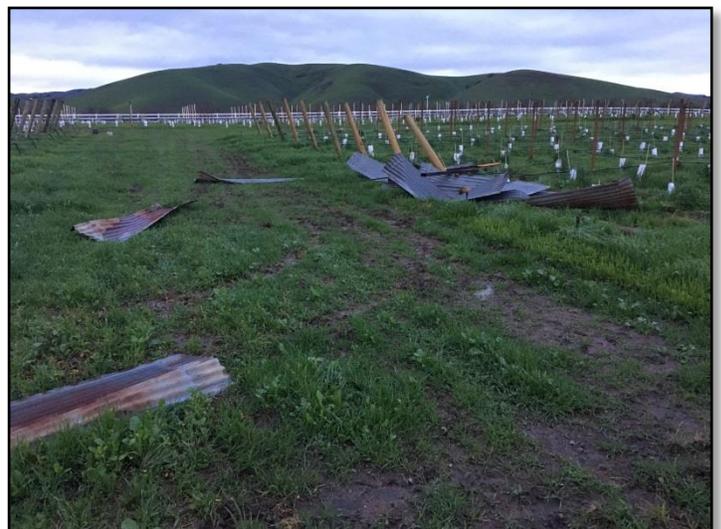
3. **Damage to large barn:** A large barn sustained significant damage with its roof blown off of the structure. Metal and wood roofing material were scattered up to 250 feet away into a nearby vineyard. Fence damage also occurred on the property.

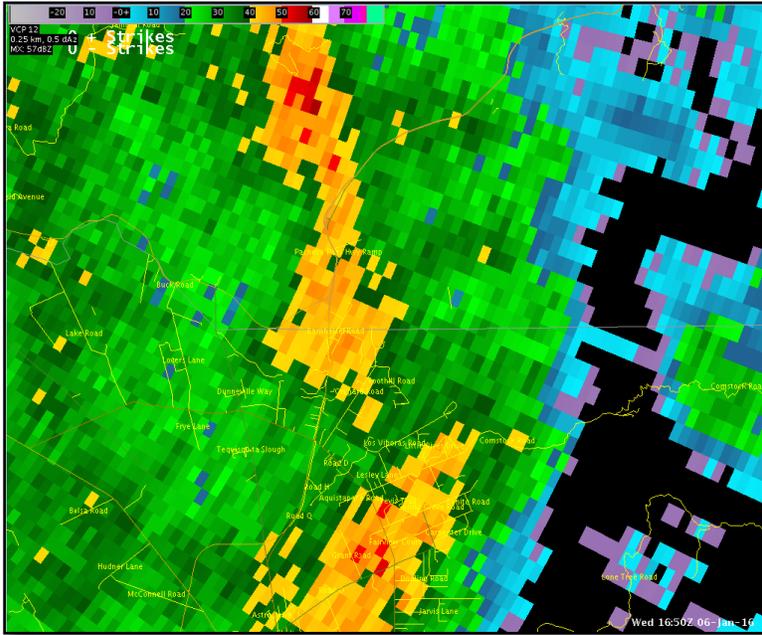
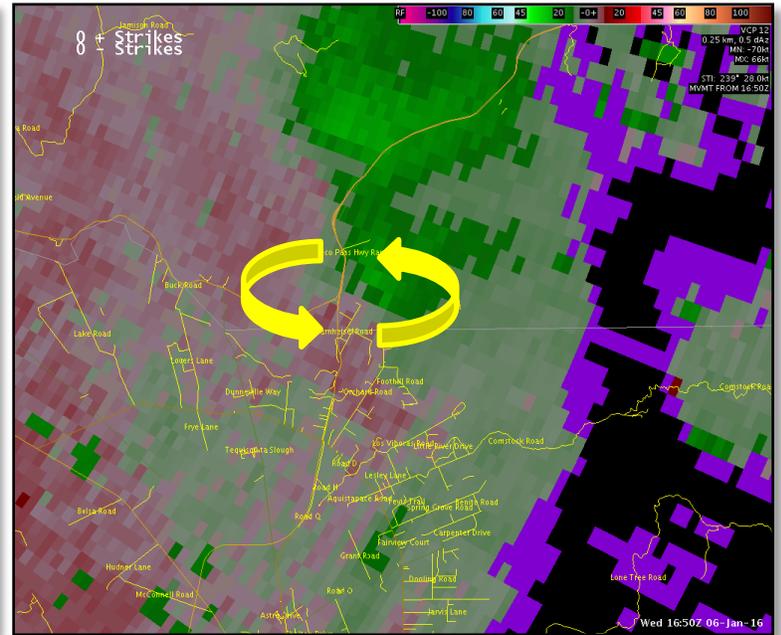
The above images show KMUX radar data from 8:50 AM PST January 6, 2016, the approximate time of the tornado. The left image shows base (lowest scan level) reflectivity and the right image base storm relative motion. In the latter, mesoscale cyclonic rotation can be seen just north of where the tornado touched down. But it is important to note that even the lowest-elevation KMUX scans are centered more than 5000 feet above ground level at this location. Circulations aloft like this are not uncommon in association with lines of convection, but only a small percentage are associated with tornadoes. Especially with brief and weak non-supercell tornadoes such as in the present case, radar beam elevation can severely limit detection capabilities.
