## **35<sup>th</sup> Anniversary of The Caesars Palace Flood of July 3, 1975**

Chris Stachelski  
NWS Las Vegas

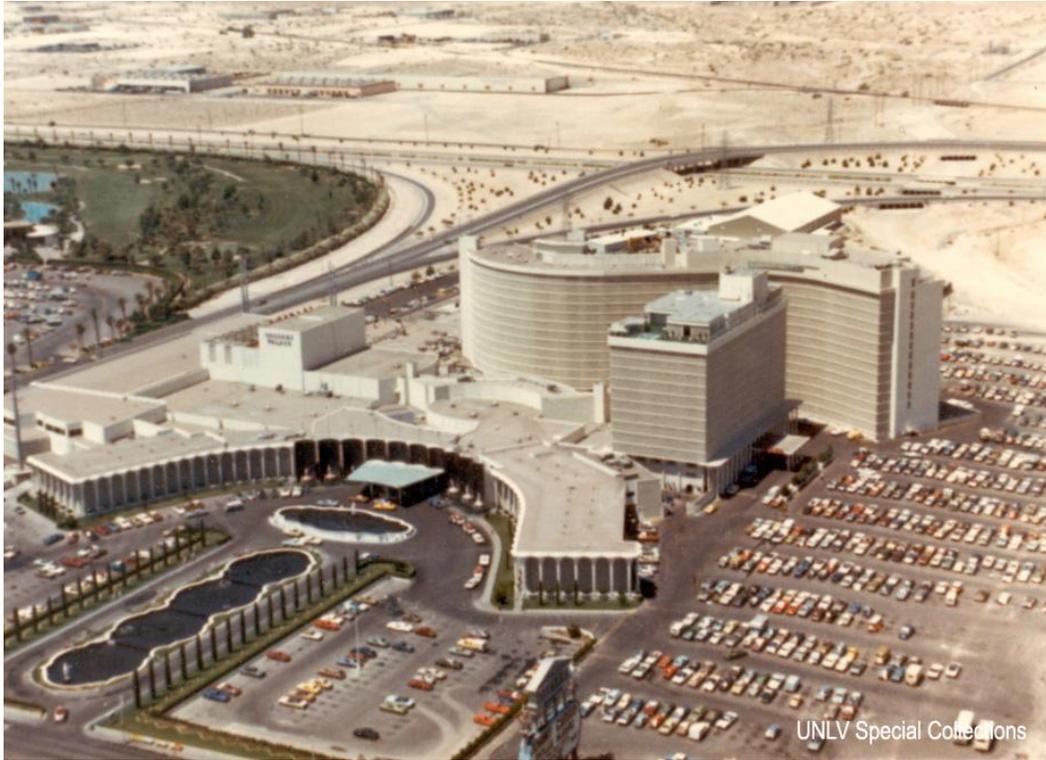
Caesars Palace in 1975 – Photo courtesy UNLV Special Collections.

The photo above shows Caesars Palace in 1975 likely prior to the flood event of July 3rd. This is very similar to what the layout of the Caesars property looked like at the time the flood occurred. To the right of Caesars in this photo (the northern extent of the property) is the parking lot where as many as 700 cars were destroyed by the raging floodwaters of the Flamingo Wash. While Flamingo Wash is dry in this photo, it can be seen in the upper right where it extends out from a bridge that was built over it for Interstate 15. In the photo you can see how the wash comes right at a portion of the parking lot. Note that little development existed in the area just west of Caesars Palace (the upper portion of this photo). Today, this area is one of the most densely developed sections of Las Vegas.

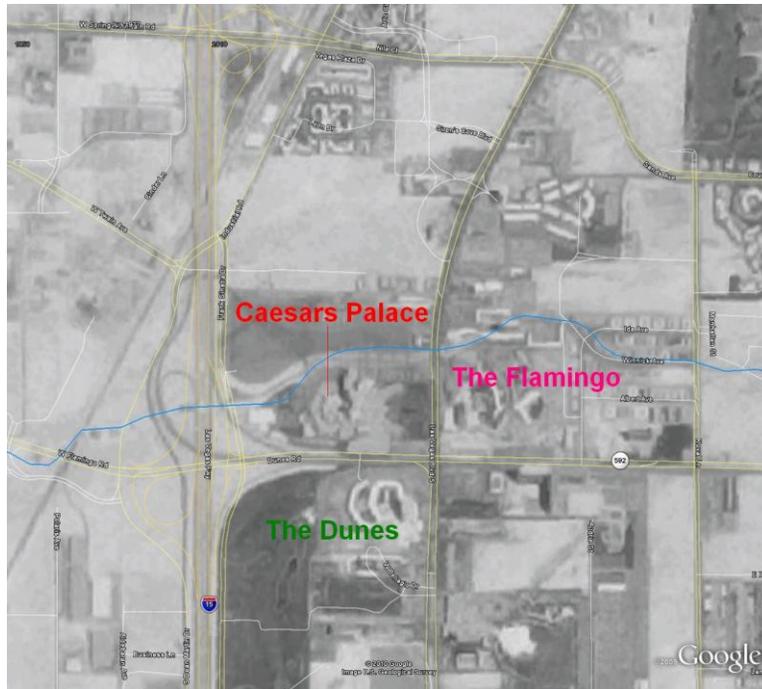
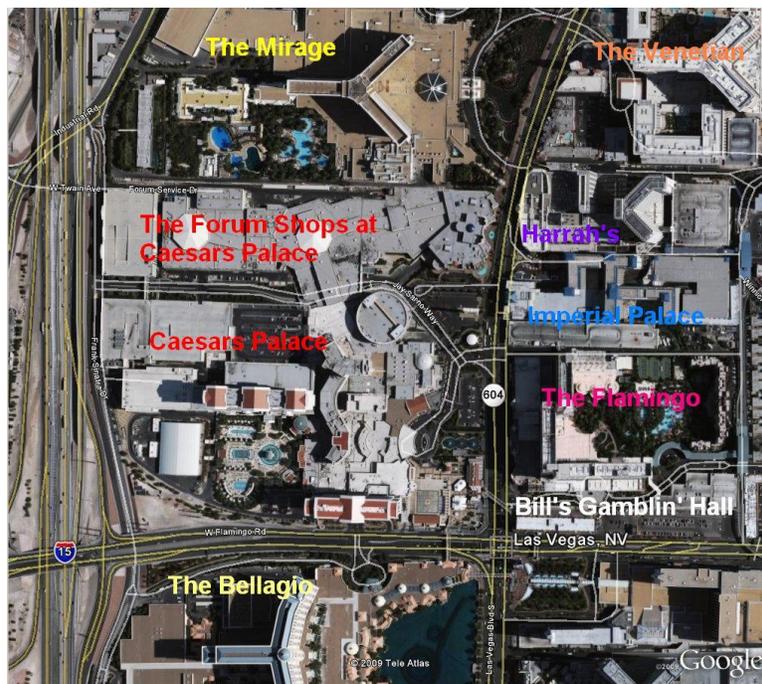
Google Earth image of the central Strip, 1977. Flamingo Wash is the blue line that runs across this image.

Google Earth image of the central Strip, 2010.

These aerial photographs show the central area of the Las Vegas Strip. In the top photograph, note how small of an area Caesars Palace covered in 1977. If you look closely you can make out some of the buildings then in today's Caesars Palace. The Forum Shops now sit in the area where the parking lot was back in the 1970s. Of all of the neighbors Caesars had in the 1970s, only the Flamingo remains today. The Dunes Hotel was demolished in the mid 1990s and in 1998 the Bellagio opened in its place.

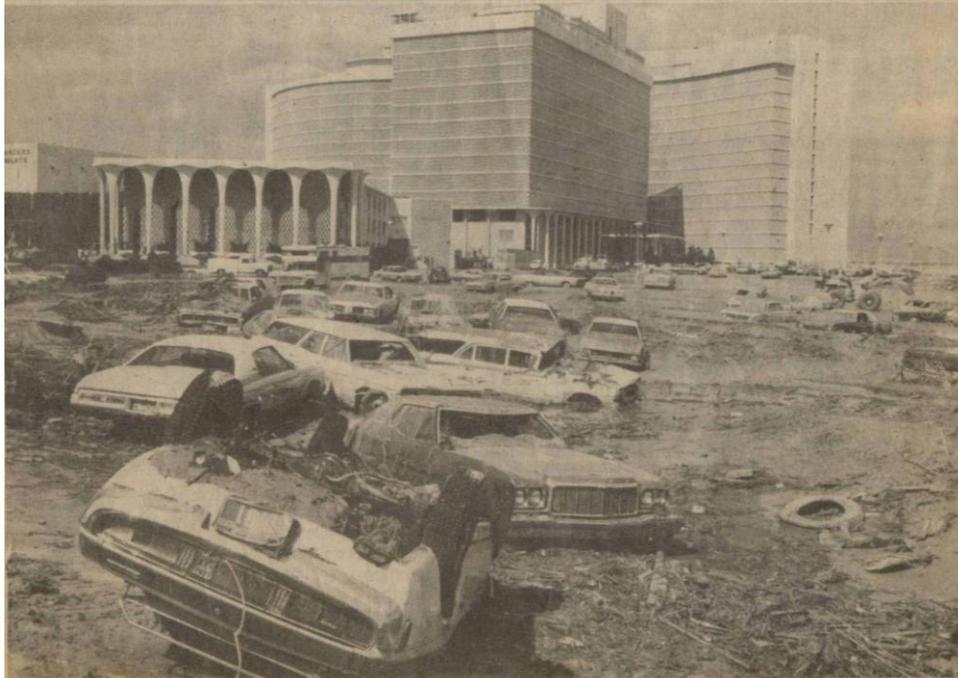
Wrecked cars are tossed across the parking lot at Caesars Palace after the flood.  
Photo Credit: Las Vegas Review-Journal.

downtown Las Vegas, North Las Vegas and in neighborhoods just west of Interstate 15 and further east in Las Vegas along the Flamingo Wash. However, the most significant damage occurred on the Las Vegas Strip where the Flamingo Wash passed just north of the Caesars Palace and Flamingo casinos. Some 700 cars parked in a lot at Caesars were inundated when floodwaters swept down the wash and up against a bridge on Las Vegas Boulevard that went over the wash. Most of the cars parked here ignored a sign that warned of a flood threat in this area. While this was the most noted impact associated with this flood event, two men were killed North Las Vegas when they were swept away by floodwaters. Damage occurred to culverts and pavement along the Northshore Road in the Lake Mead National Recreation Area from water that surged downstream along the Las Vegas Wash. In metropolitan Las Vegas, extensive damage occurred with numerous homes and businesses flooded. Several vehicles were inundated by a surge of water or swept off roadways. Curbs, streets and lawns were flooded, eroded and covered with sediment. Numerous telephone poles were knocked over by the surge of water and erosion. Sewage plants were inundated and thus deactivated due to the influx of water and mud. Damage was estimated in 1975 dollars at \$4.5 million.

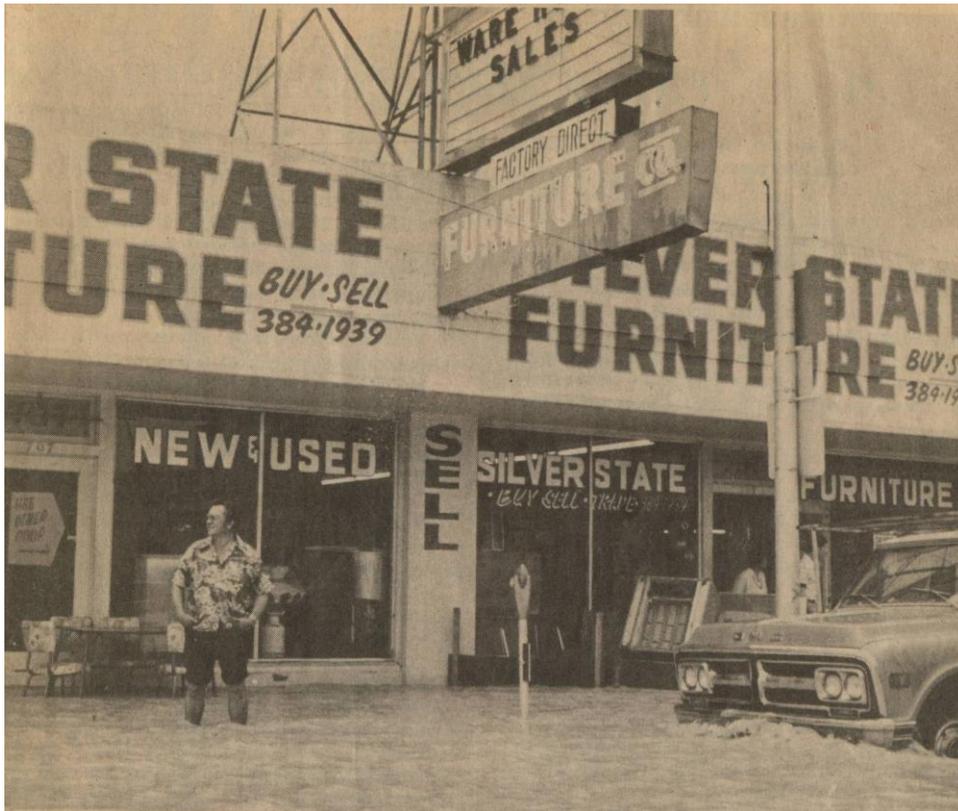
Floodwaters on North Main Street in Las Vegas.  
Photo Credit: Las Vegas Review-Journal.

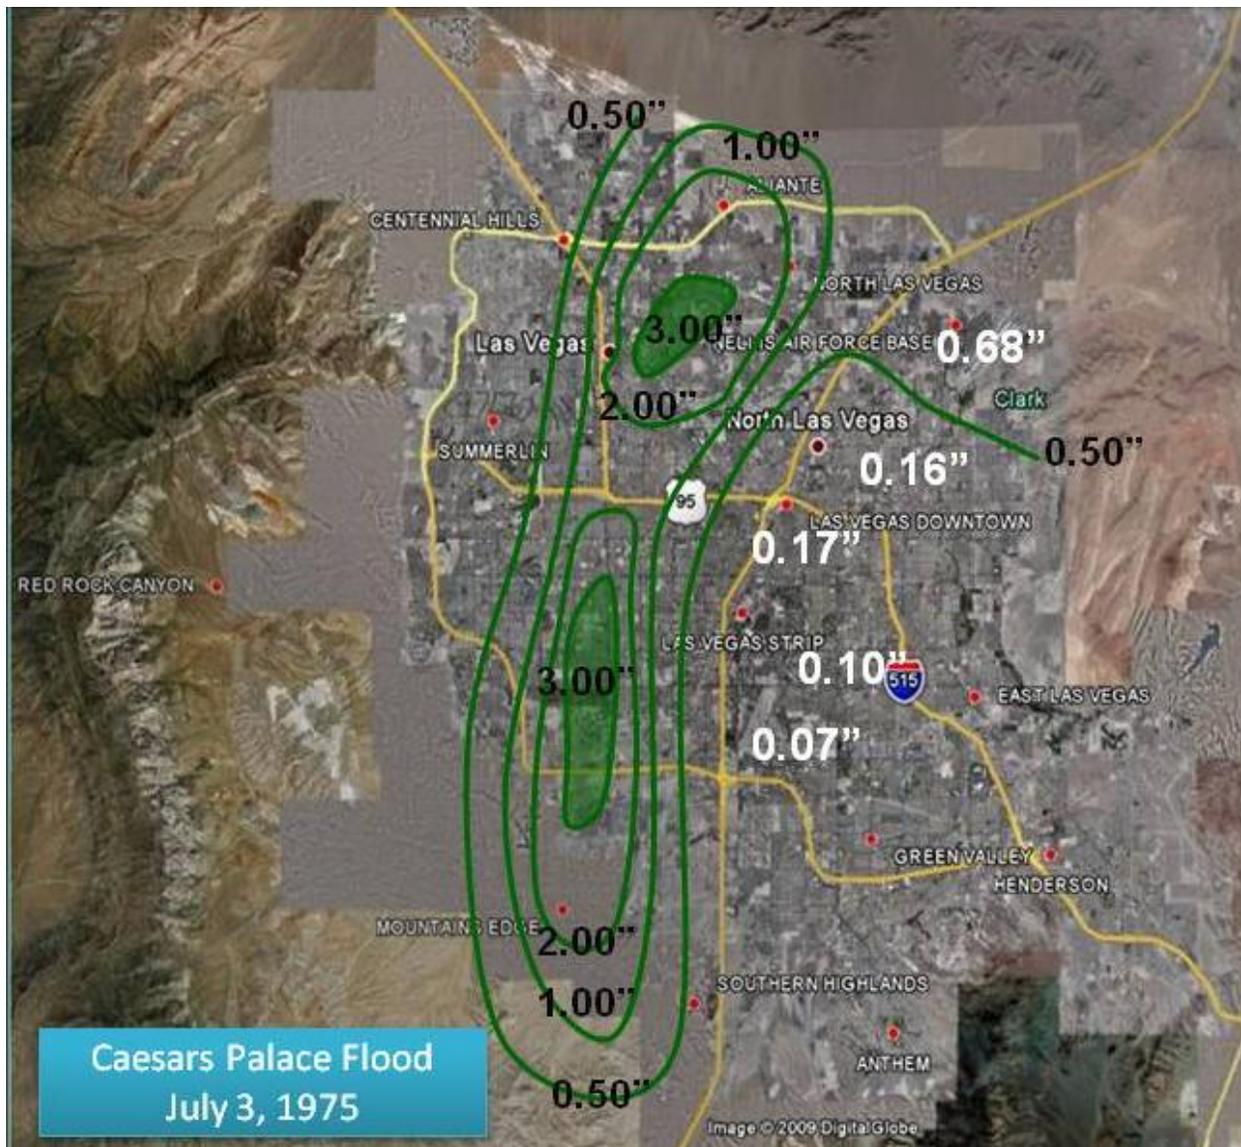
Map of rainfall amounts From July 3, 1975. White numbers are actual values determined from rain gauges and bucket surveys. Green lines denote every half inch of rainfall measured. Black numbers denote values of green lines. Map background from Google Earth shows the Las Vegas Valley today. Values on the map were obtained from a report by Darryl Randerson done in 1976.

Shortly after 12 PM on July 3<sup>rd</sup>, thunderstorms began to develop around the southwest side of the Las Vegas Valley and then began to move northward. Thunderstorms continued to develop for the next few hours with activity being heaviest on the west side of the valley. Between 5 and 6 PM, the thunderstorms finally began to move northward away from the valley. The southeast side of the valley saw very little, if any, rainfall from the thunderstorms. As the thunderstorms moved northward across the west side of the Las Vegas Valley they unleashed heavy rain, with estimated totals in excess of 3 inches, as well as wind gusts of up to 58 mph. While much of the heaviest rain did fall on undeveloped land on the west side of the valley, residential neighborhoods in Las Vegas and North Las Vegas just west of Interstate 15 received at least a half an inch of rain.
