# Baker, MT Tornado of June 11, 2016

## Overview

Updated June 29, 2016

Officials from NOAA's National Weather Service in Billings completed an assessment of the tornado that occurred in the town of Baker, MT (and surrounding areas) the evening of June 11, 2016. The assessment included a survey of the damage, eyewitness reports, and an aerial survey.

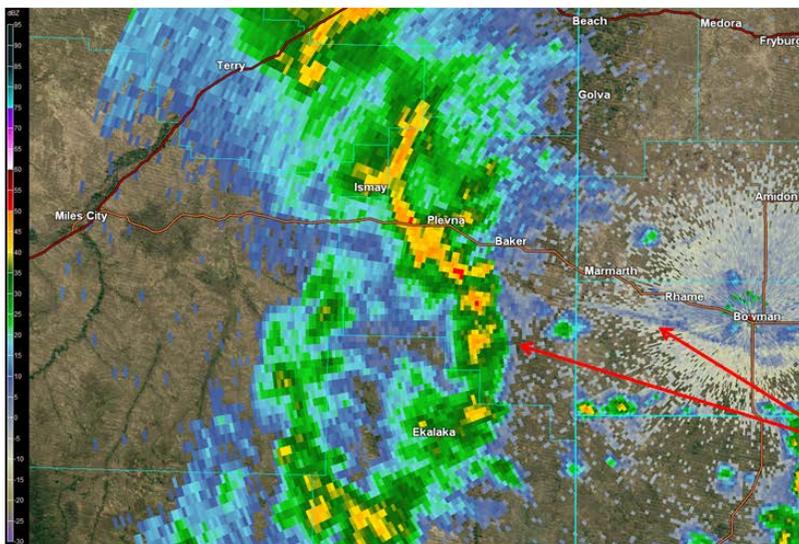
KBPP 0.5° Reflectivity Valid 6:52p.m. MDT

In the case of the storms near Baker, MT on Saturday June 11th, 2016, evidence of these types of boundaries can be seen as early as 6:52 p.m. MDT on the KBPP Bowman, ND radar:

Surface Boundaries

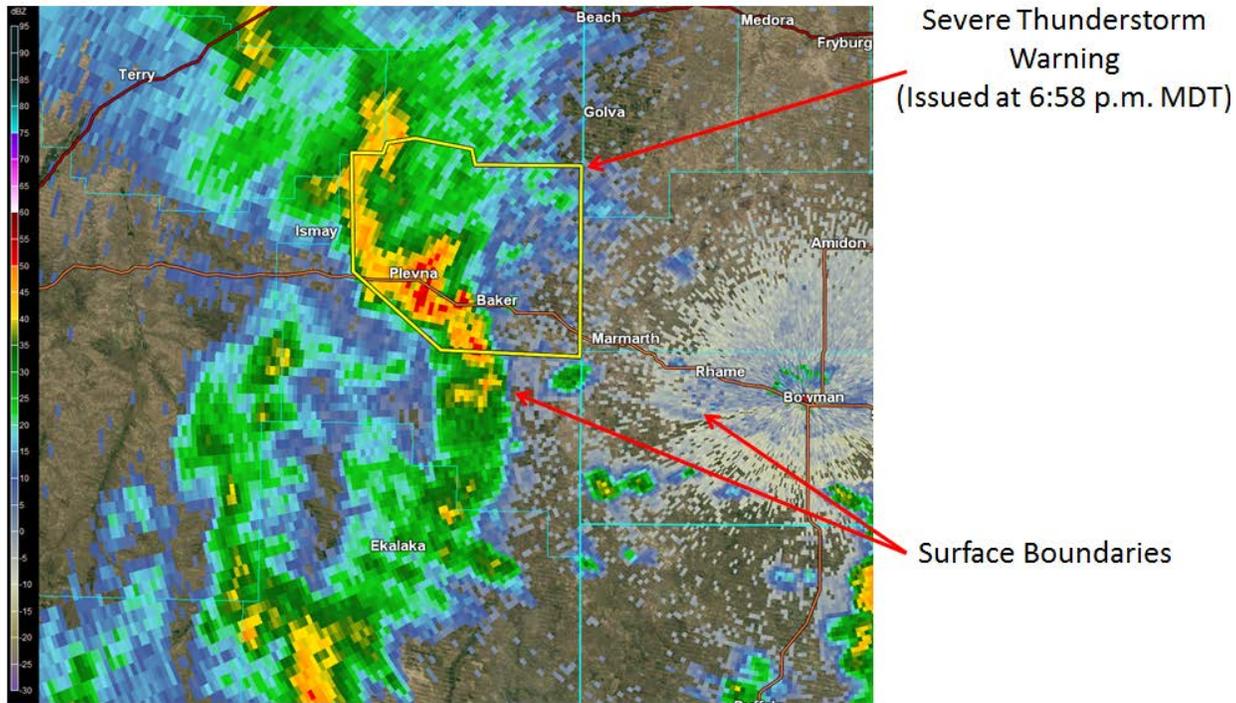
KBPP 0.5° Reflectivity Valid 6:58p.m. MDT

Thunderstorms began to intensify by 6:58 p.m. MDT, prompting the issuance of a Severe Thunderstorm Warning for portions of Fallon County, Montana (including the city of Baker):

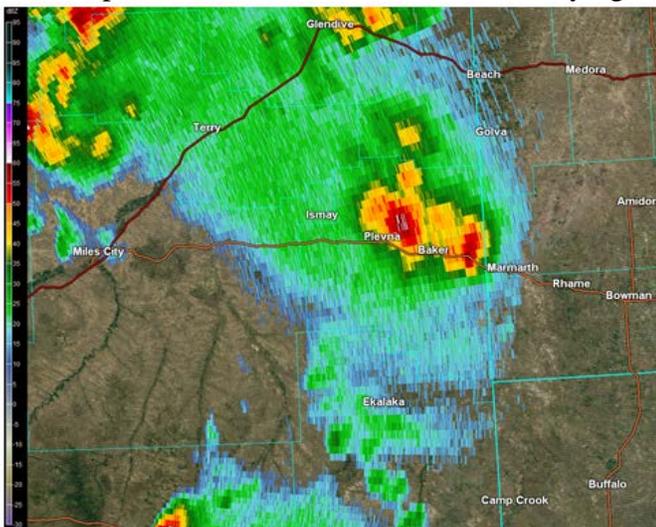
KBLX 0.5° Reflectivity Valid 7:00p.m. MDT

At 7:00 p.m. MDT storms were seen intensifying on the KBLX radar reflectivity:

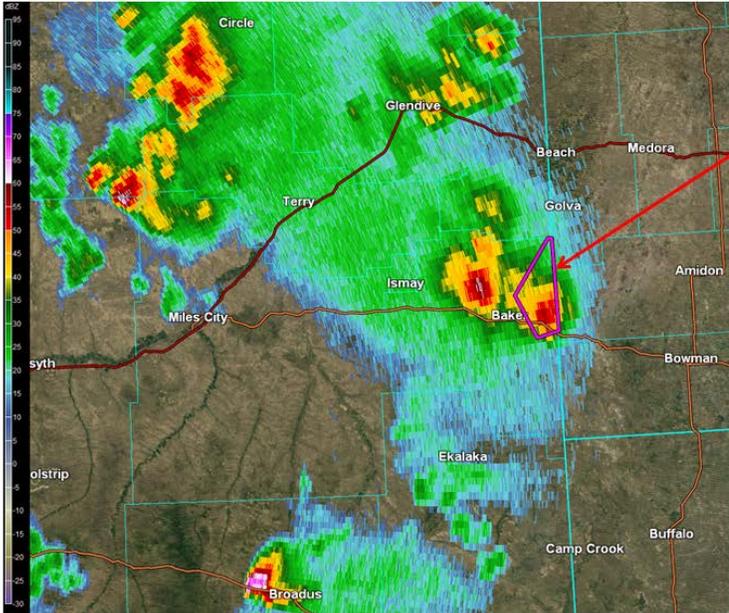
KBLX 0.5° Reflectivity Valid 7:02p.m. MDT

The first spotter reports of a tornado on the ground near Baker came into the Billings NWS office at 7:00pm, triggering the issuance of a Tornado warning at 7:02 p.m. MDT:

Tornado Warning  
(Issued at 7:02 p.m. MDT)
